APPENDIX OF GENERAL RAPORT WP3
ANALITICAL RESEARCHES

UNITO – CCR

NUMBER OF PARTNER:	UNITO - CCR
TYPE OF WORK:	Mural (Object 1)
COUNTRY:	Italy
CITY:	Turin
ADDRESS:	Via Ragazzoni
OWNER / CUSTODIAN:	Turin Municipality
ARTIST:	CORN79, CND, RESER, VESOD,WENS
TITLE OF THE WORK:	No title
YEAR OF EXECUTION:	2011
MATERIALS:	Mixed painting on bricks

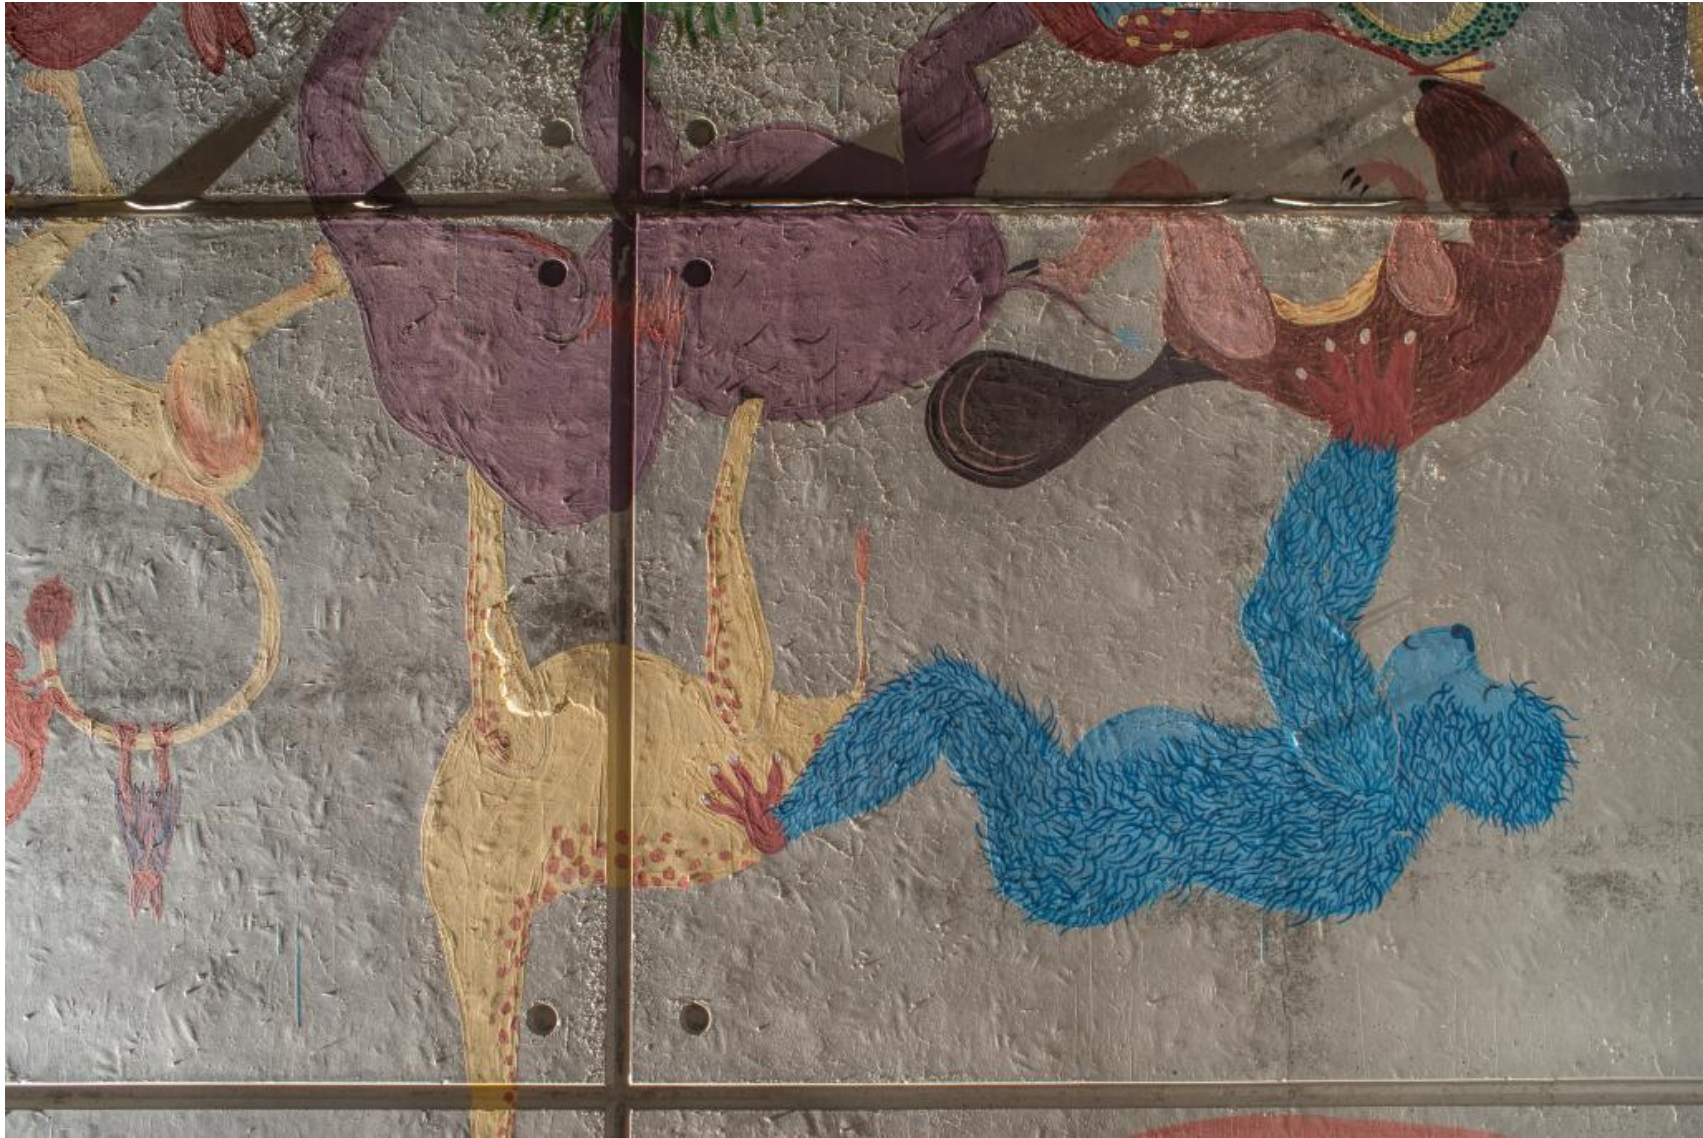
GP2 was collected from the coating applied by brush/roller on unpainted/painted surface (i.e. *d* layer of the GP1 sample), this whitish and fragile coating is flaking off (**fig.3**). FTIR-ATR spectrum has shown the characteristic absorption of an acrylic emulsion (probably p(*n*BA-MMA) to be confirmed by Py-GC-MS) with likely chalk (**fig.4**) and imaging analyses have allowed to highlight its presence and the bad state of conservation (flaking, cracking) (**fig. 5-6**).

Fig. 5 “Two dragons carrying an egg (new creature)” – particular – digital photo under raking light

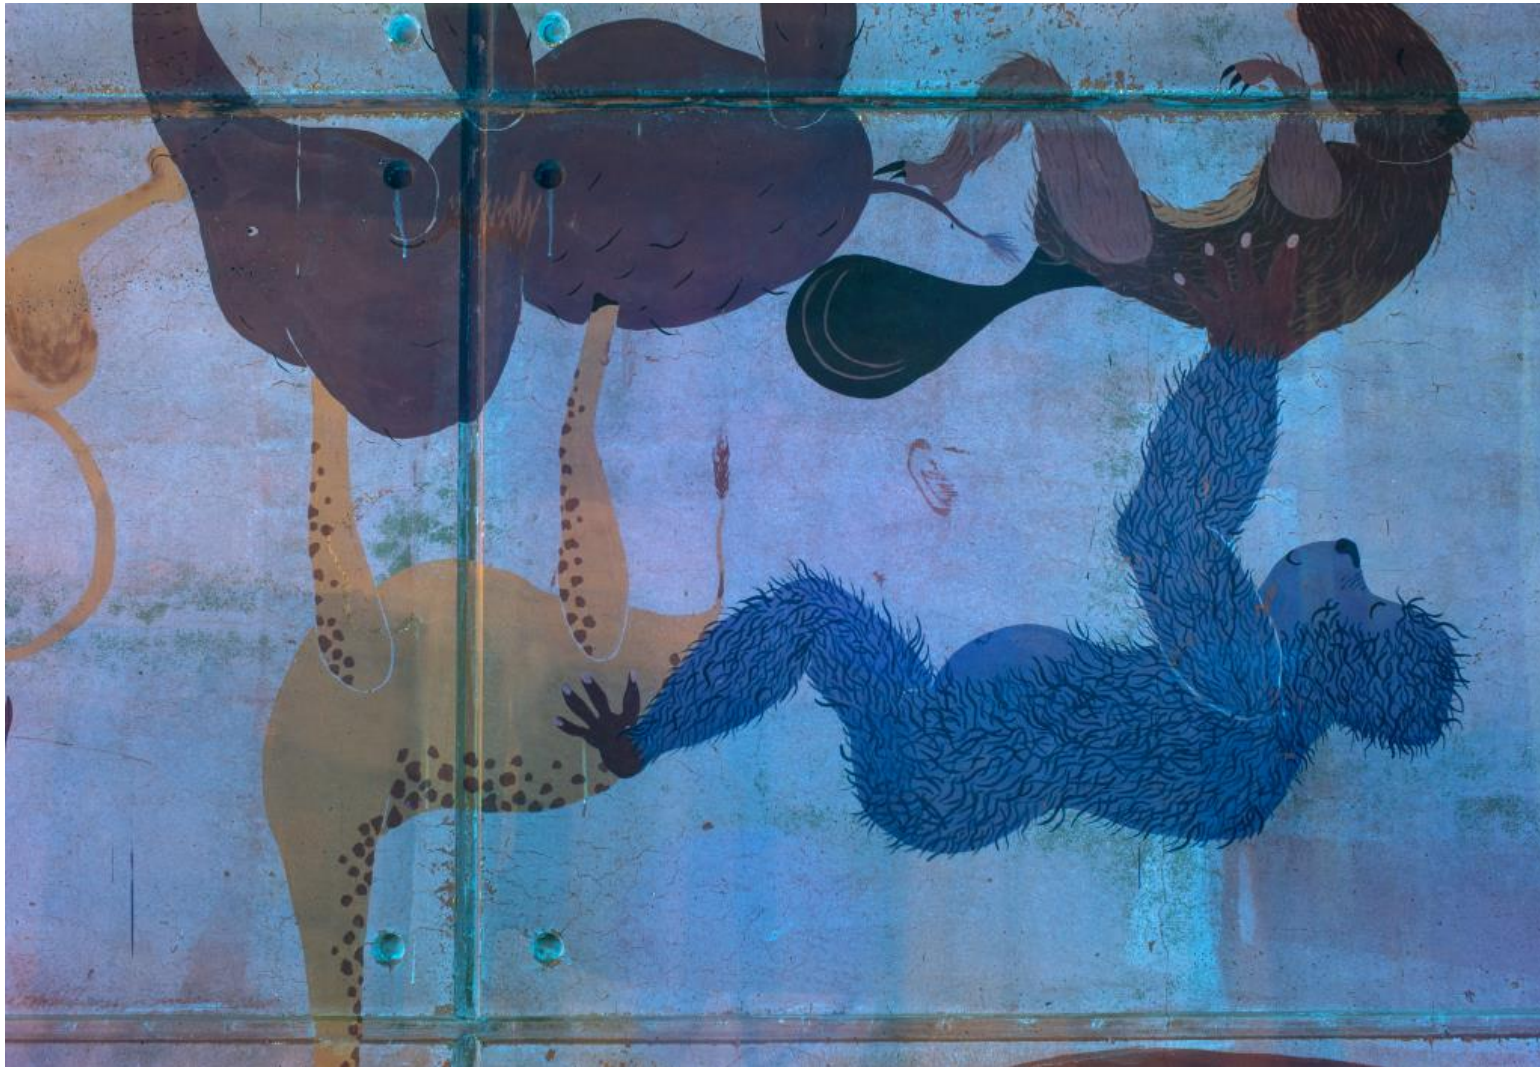
Fig. 6 “Two dragons carrying an egg (new creature)” – particular – ultraviolet fluorescence photo

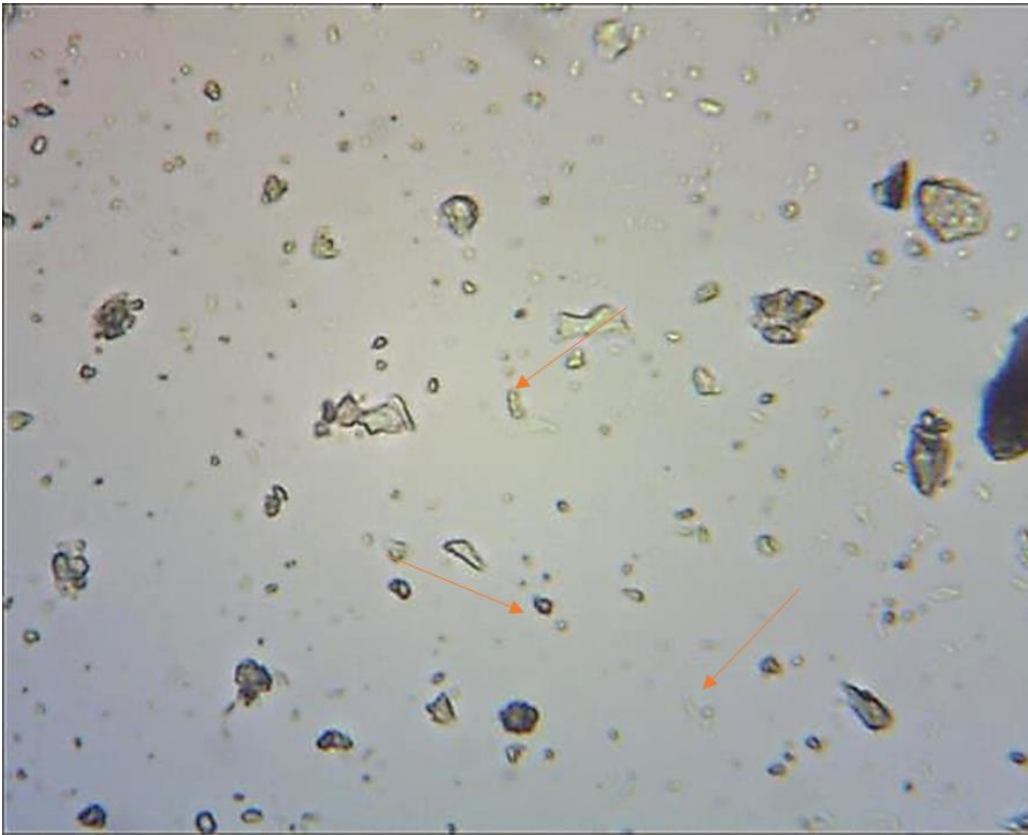
GP5 was taken several times during the 2019th year from a thin dark grey and compact patina that is spread on not pigmented areas of concrete support following a sort of grid and it is associated with cracks (**fig.2**). Analysis has shown a significant presence of filamentous fungi and yeast, being the black mould *Aureobasidium* the most dominant organism (**fig. 11-14**)

Fig.11 “Two dragons carrying an egg (new creature)” – sample GP5 – transmitted Visible light – magnification 400x : erratic and motile spherical cells, sometimes present in 2-3 cells chain

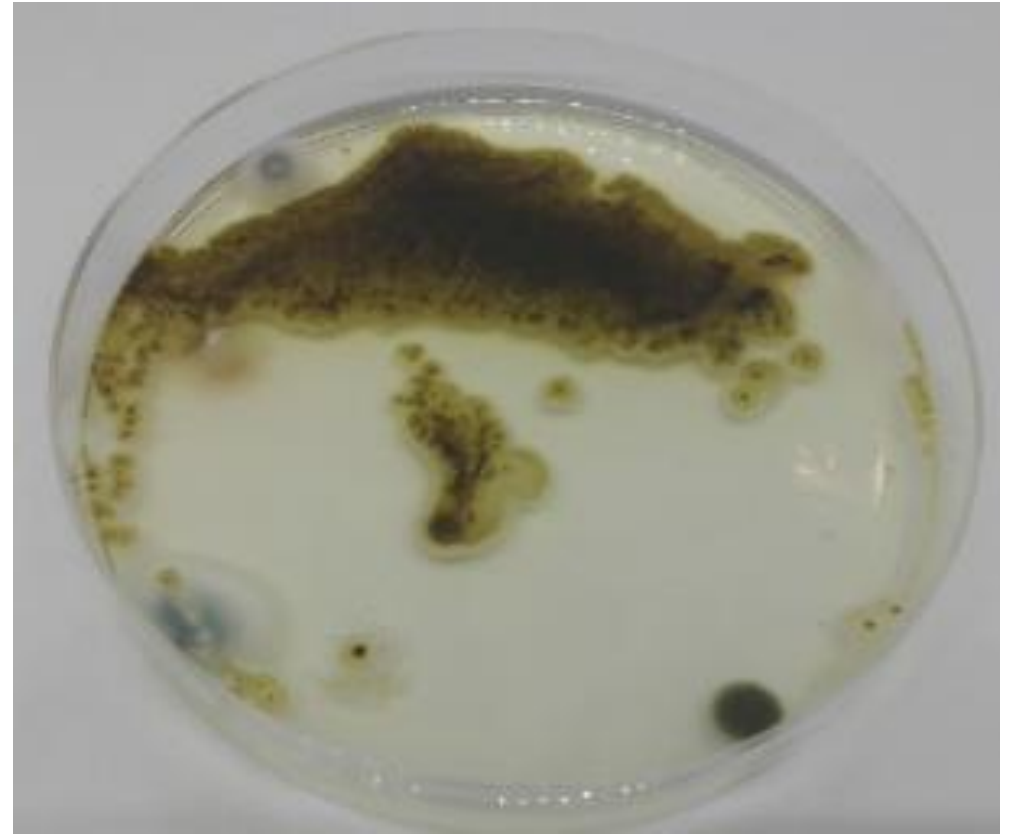
An investigation on concrete preparation techniques has highlighted the use of mineral oil for the detachment of concrete from molds. This procedure leaves in some surface areas dark patinas that could get harder and darker with aging. Probably this organic patina could be subsequently colonised by microorganisms, which enhance the surfaces darkening. In particular some fungal species such as *Aureobasidium*, *Epicoccum*, *Penicillium* and yeast such as *Rhodotorula* are known to effectively degrade mineral or vegetable oil.^{1,2,3,4}

The presence of a biofilm on the surface might contribute to the degradation of the substrate by progressive darkening, water accumulation (and subsequent frost weathering), acidification and leaching.

Fig.12: *Aureobasidium* colonies on agar plate from samples collected in July 2019

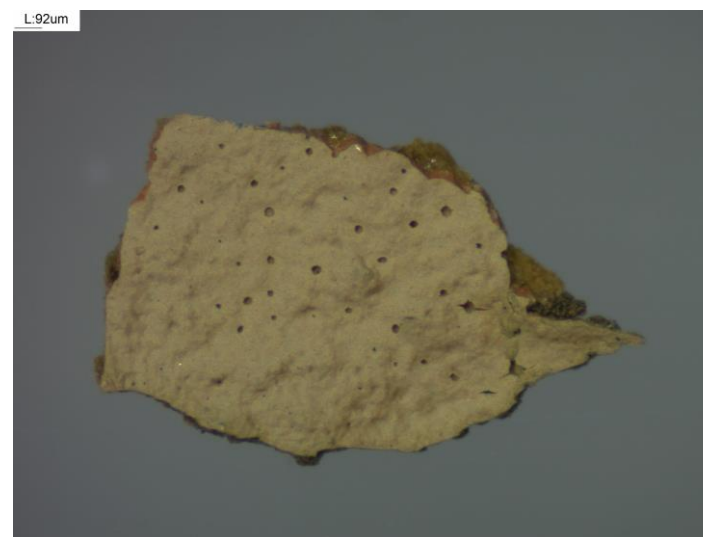
K2 sample was collected along a crack of a pale yellow area (spray paint) (**fig.4,6-8**) that was originally light orange.

Fig. 8 “ Big Sacral Bird ” – sample K2 – SM – magnification 45 x

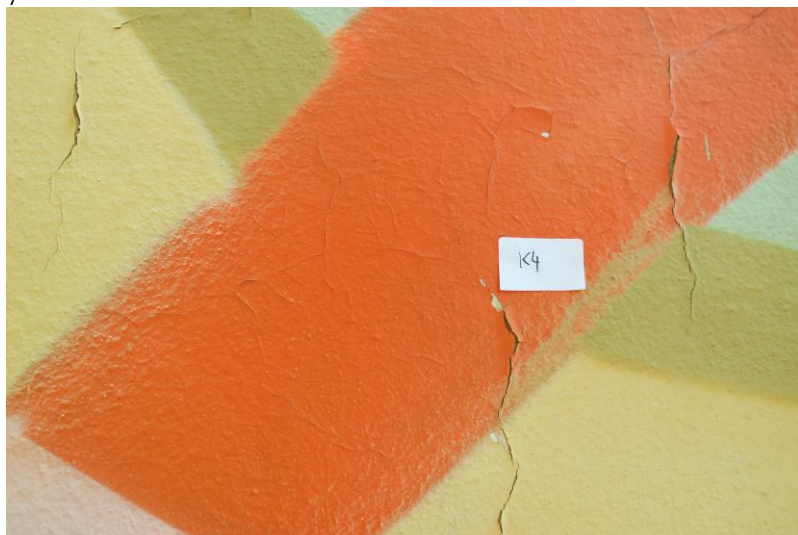
K4 sample was collected along a crack of an orange area (spray paint) (fig.4,13-14) that was originally lighter.

Fig. 13 “ Big Sacral Bird ” – sample K4 – after sampling

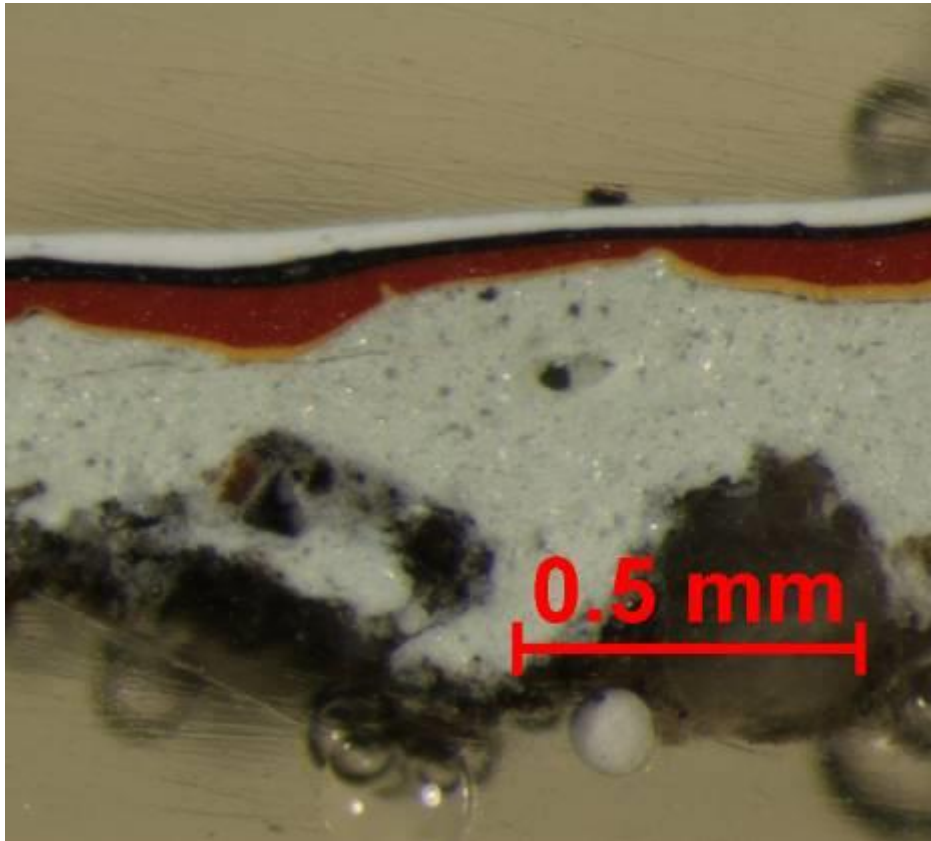
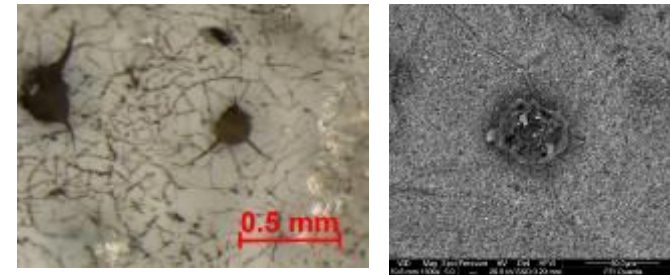
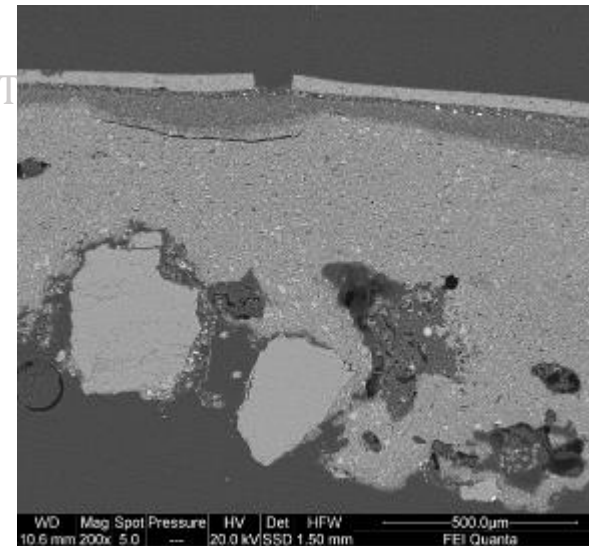
Cracks and voids affecting the paints are due to biological colonization. This colonization does not grow on the paint but is already present on the substrate; the paint layer did not affect organisms growth and them continued to grow, affecting the integrity of the paint layer.

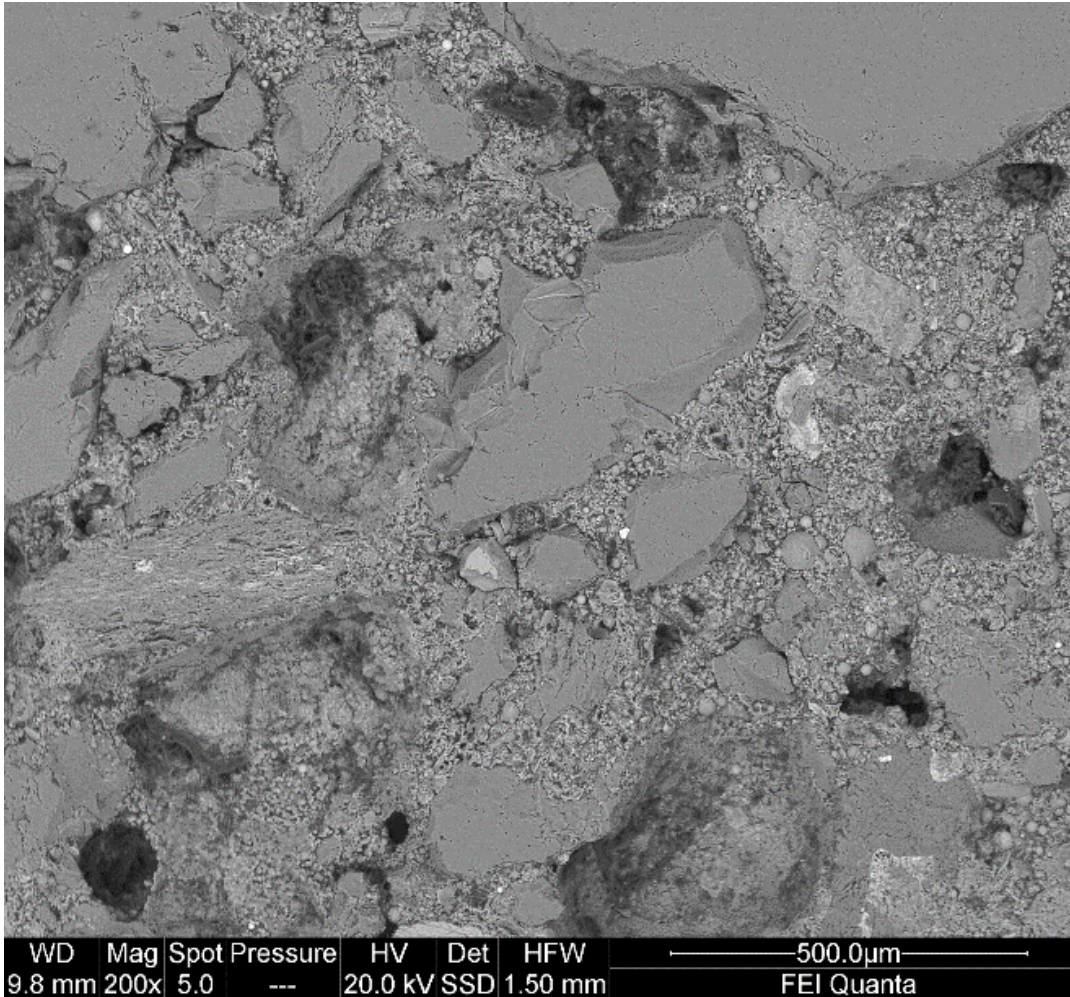
The cement based mortar is of poor quality: high porosity, low adhesivity, high salt content and highly decohesioned.

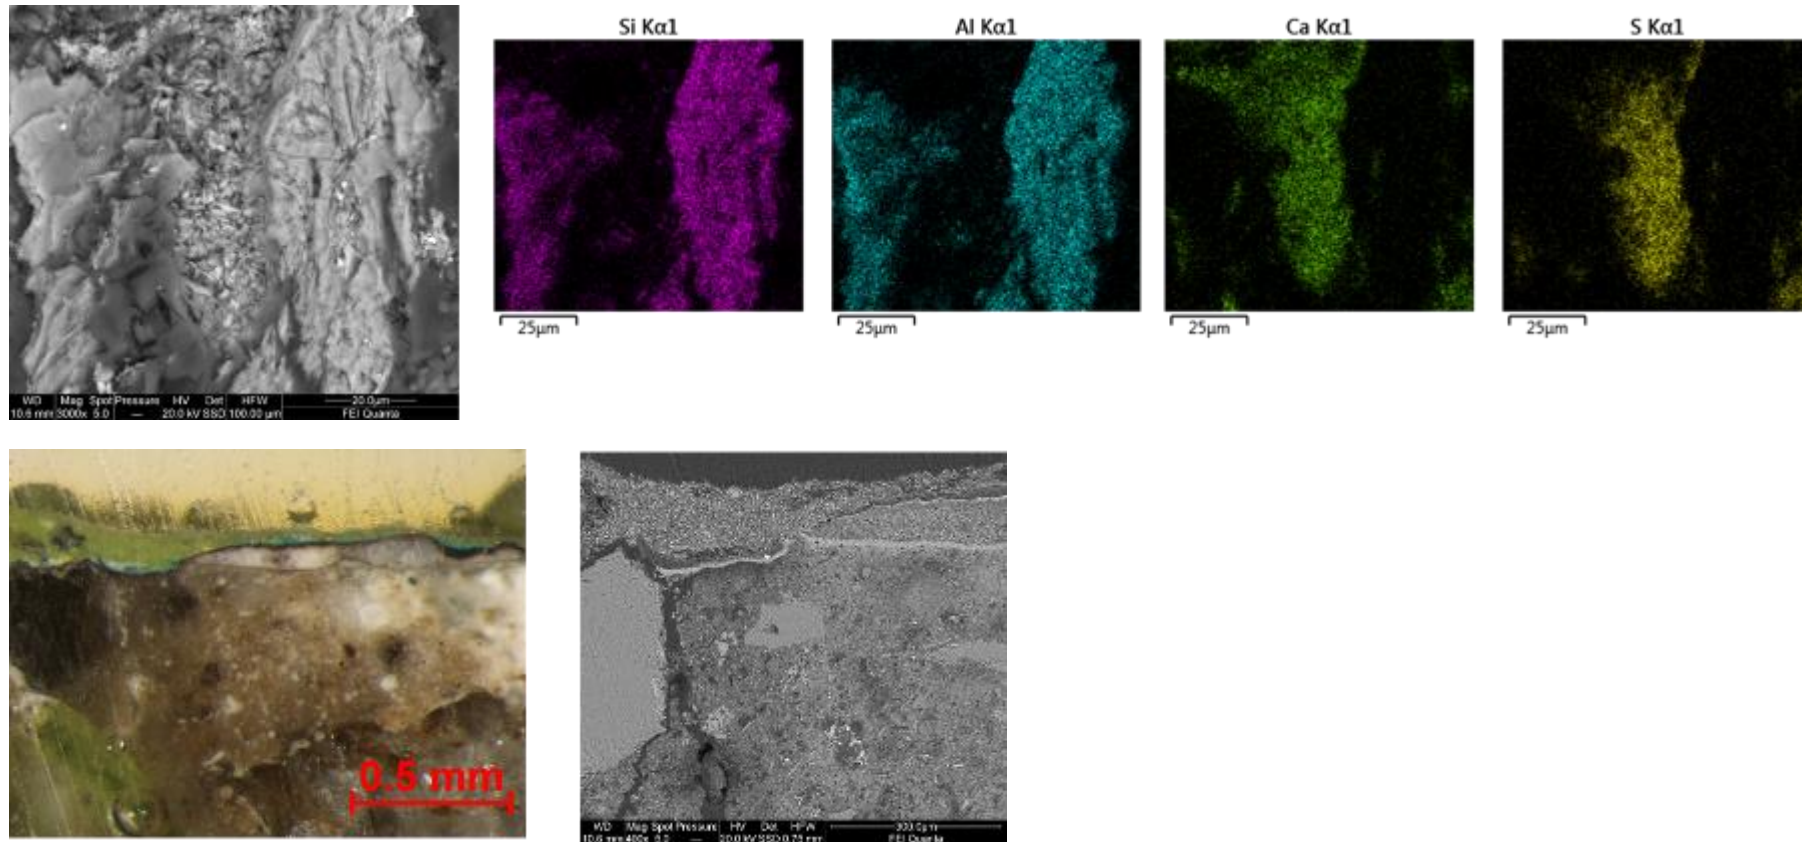
By SEM-EDX, gypsum crystallization in the paint layer is confirmed. Lining mortar is of poor quality, with fractures and voids and also with soluble salts.

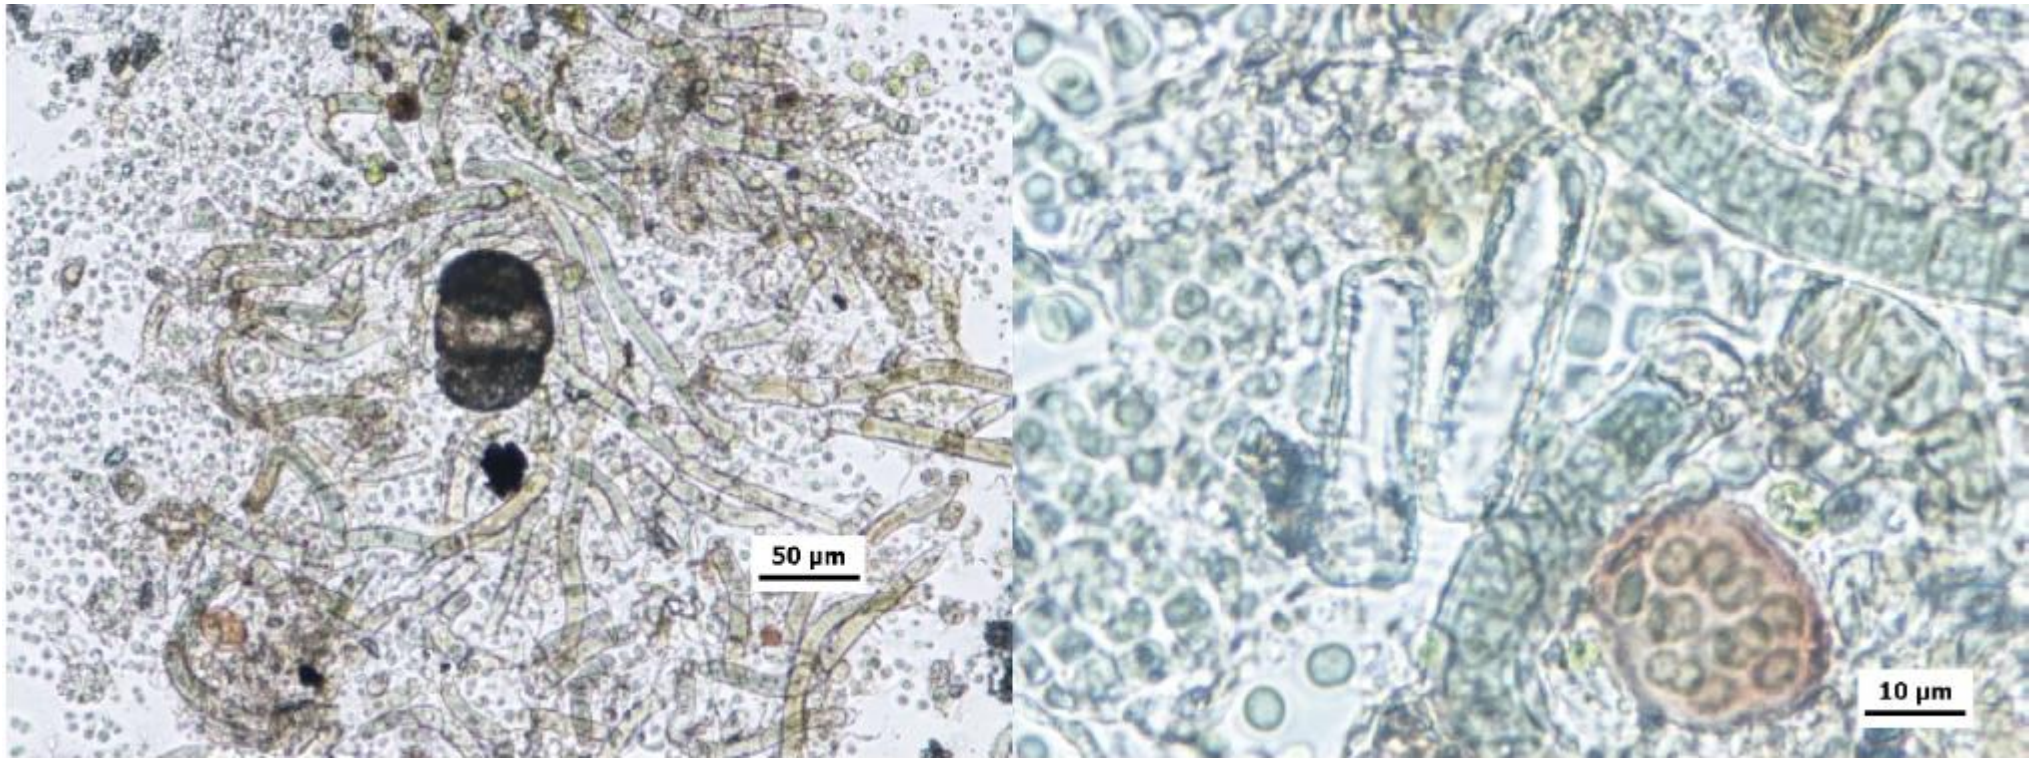
Micrographs taken under optic microscopy of the sample DE-NCS. On the left, in the center of the micrograph, there is a dark structure, which is a pollen grain of a gymnosperm mixed with cyanobacteria and some, but very few, green algae. On the right, there are diatoms (in the center) mixed with cyanobacteria: Scytonema are the filaments, those that are grouped into a brown-red wall could be Gloeocapsa and the rest could be Nostoc.
