# Preventive Conservation in an Outdoor Sculpture Collection

Sagita Mirjam Sunara<sup>1</sup>, Neven Peko<sup>2</sup>, Ivana Miletić Čakširan<sup>3</sup>

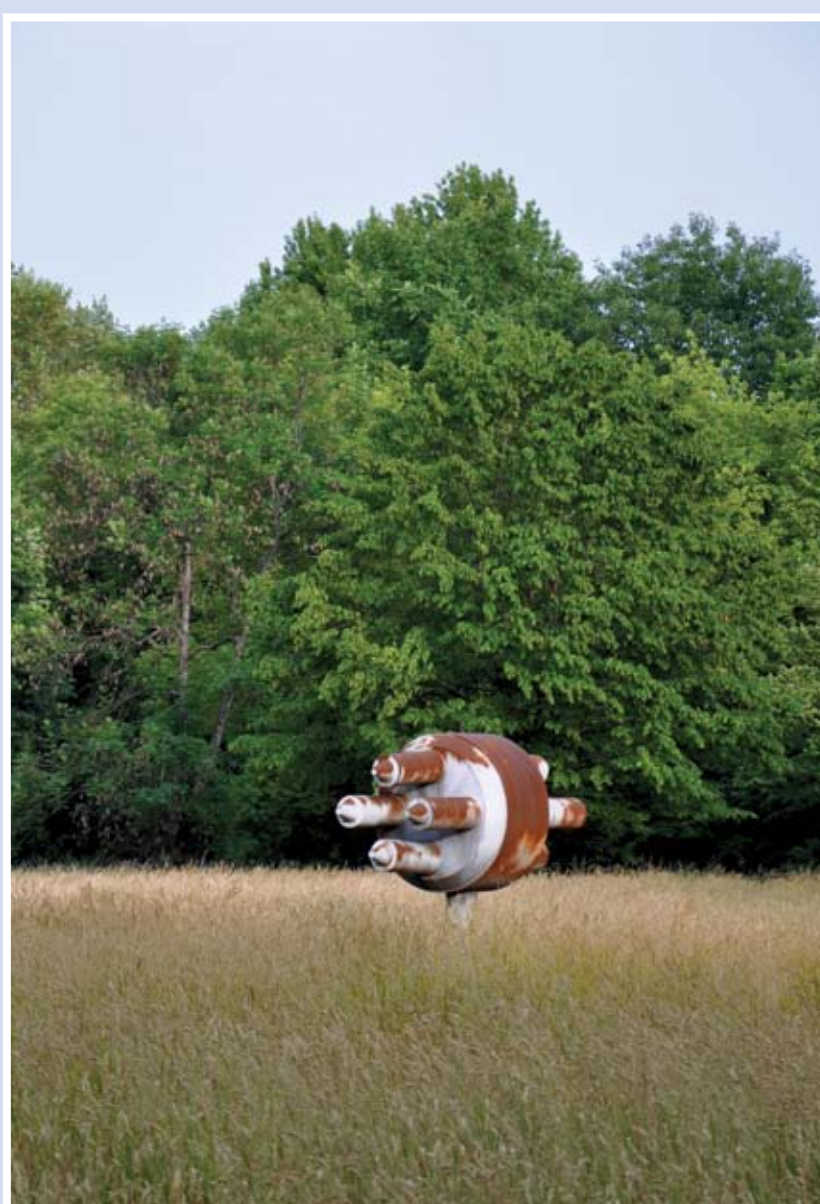
Figure 1 Josip Zeman's galvanized steel sculpture *Dark Visions I* of 1983 is severely corroded (photo: S. M. Sunara, May 2016)

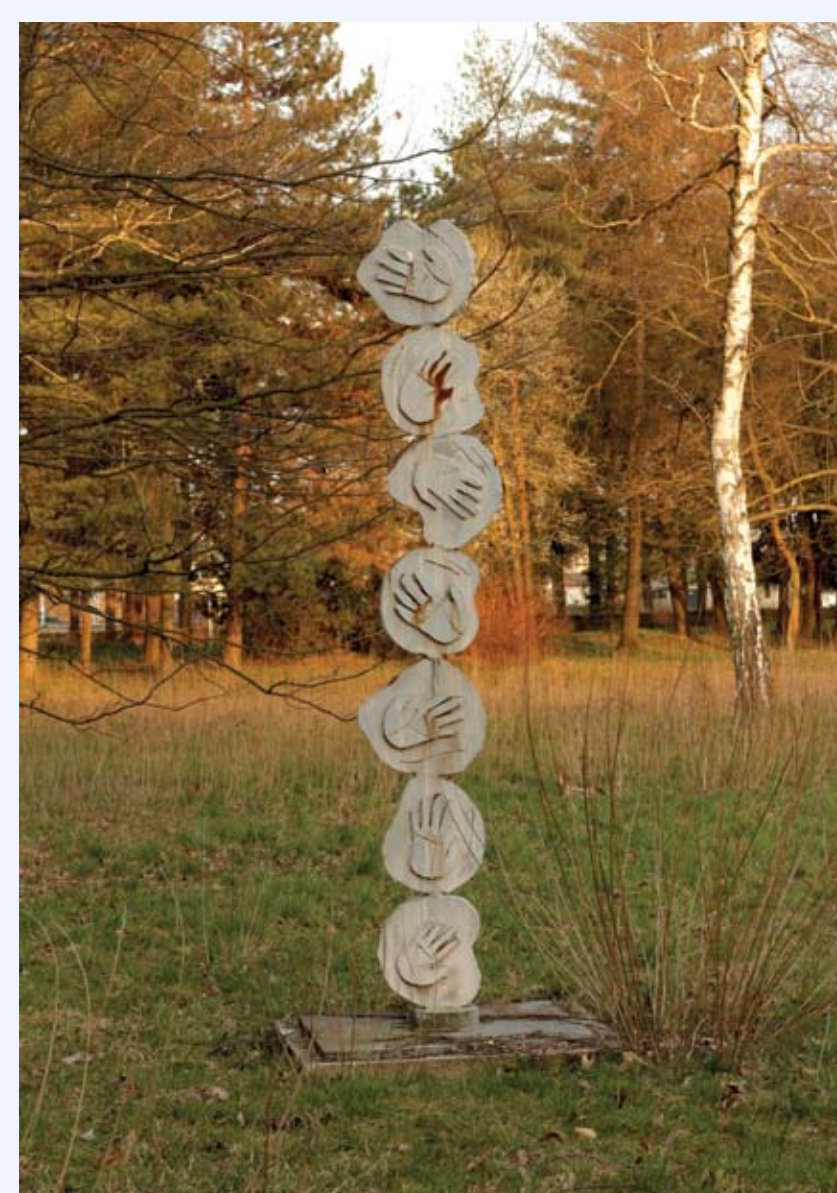
Initially, there were more sculptures, but some were stolen after the Colony ended and probably sold off as scrap metal (Fig. 2 and 3). In 2013 the production of 3D scans of the smaller sculptures was initiated, as they face the greatest risk of theft. The scanning of all of the sculptures is planned. Although in recent years the City of Sisak has taken over the responsibility for stewardship of the collection through its cultural institutions, the

Figure 2 The upper part of Jure Žaja's *In Memory of George of Dalmatia* (1979) was stolen in 2015 (photo: N. Peko, March 2015)

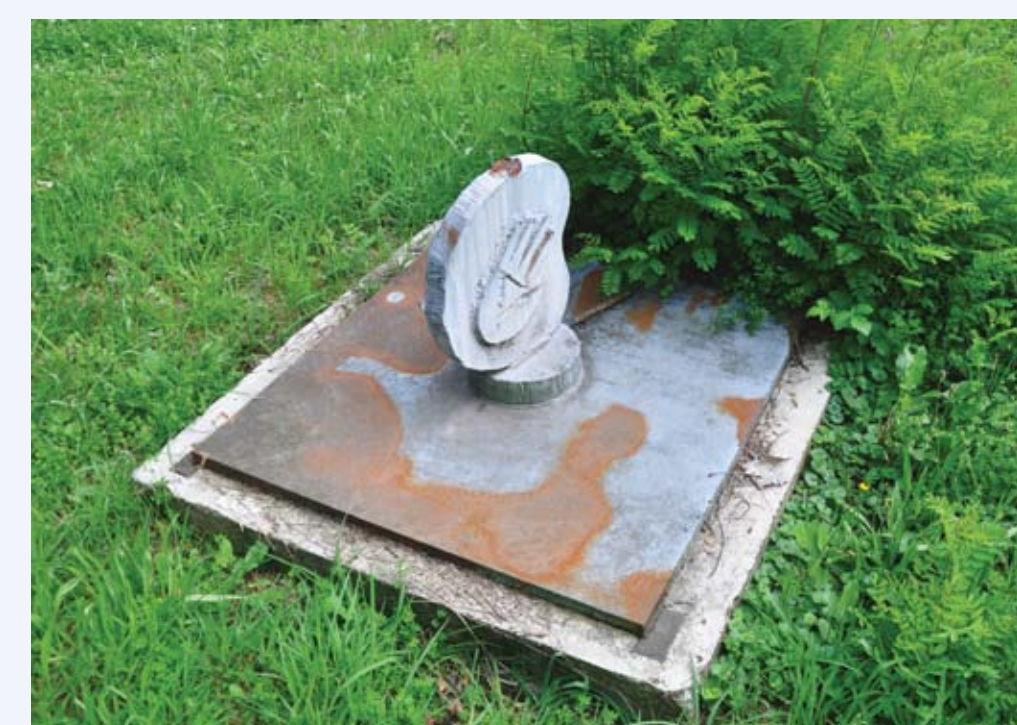
Figure 3 Only a small part of Žaja's sculpture *In Memory of George of Dalmatia* has been preserved (photo: S. M. Sunara, July 2018)

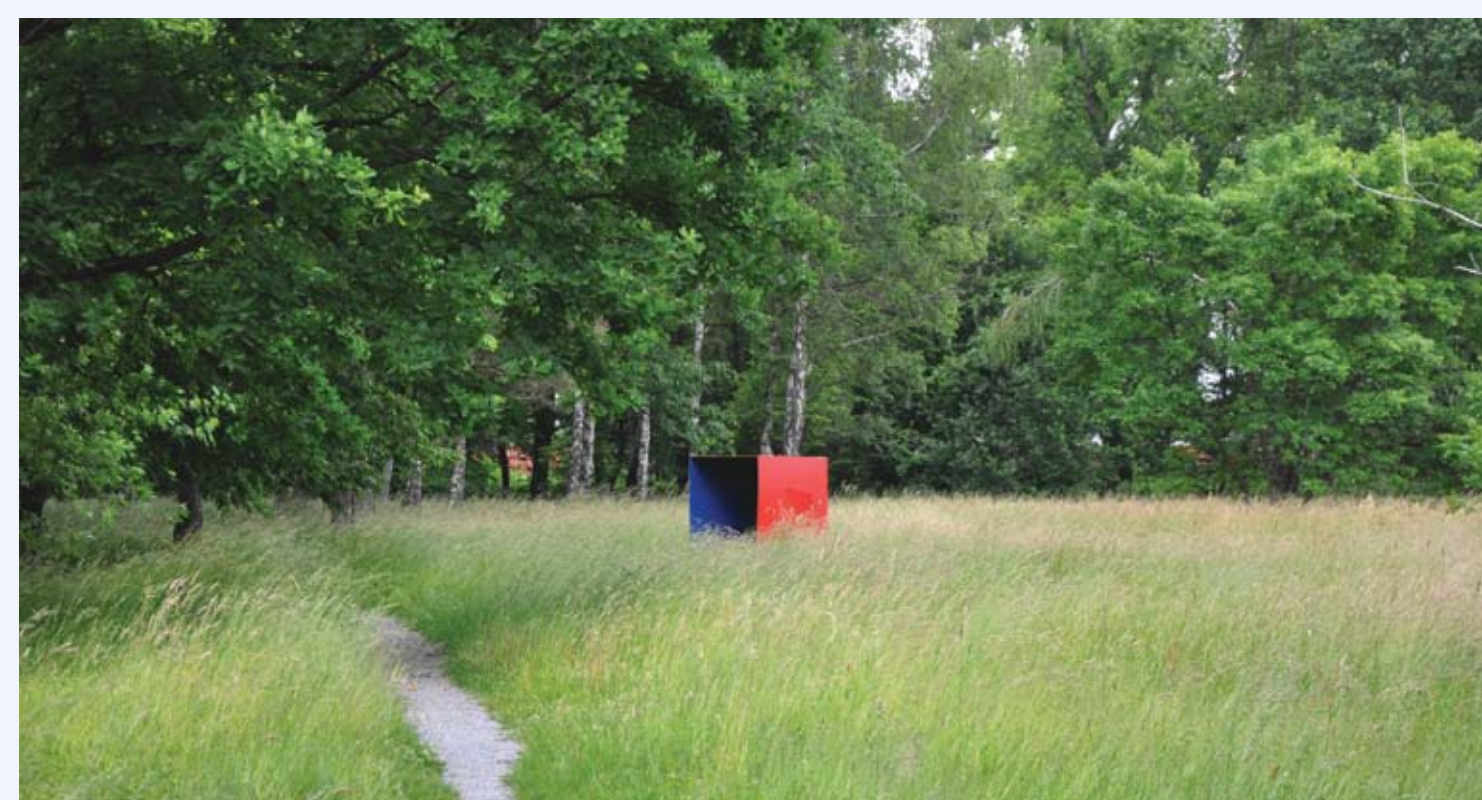
Figure 4 Josip Diminić's sculpture *Object II* (1979) was restored during the 2014 conservation-restoration workshop. The grounds in which the sculpture is installed are not regularly maintained (photo: S. M. Sunara, May 2016)

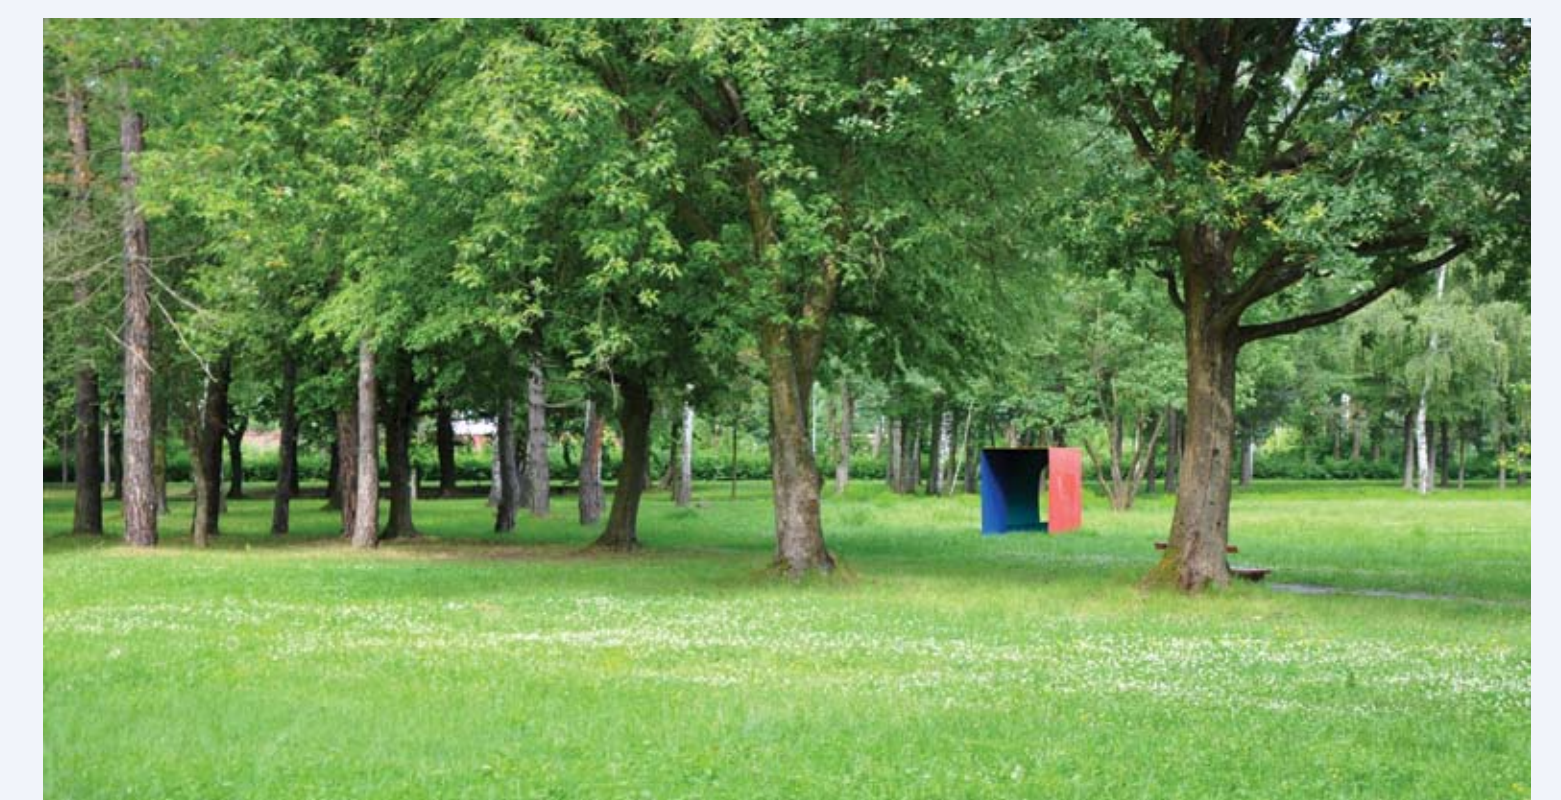
Two sculptures suffered damage due to negligence of the construction workers during public works. When public works are undertaken, sculptures should be fenced off and regularly checked. The City of Sisak recently ordered the lower branches of the trees that surround the large green area where a number of sculptures are installed to be cut. This intervention has made the sculptures more visible and thus better protected from vandalism (Fig. 4 and 5).

Figure 5 The lower branches on the trees surrounding Diminić's restored sculpture have recently been cut away, making the sculpture visible from afar (photo: S. M. Sunara, July 2018)

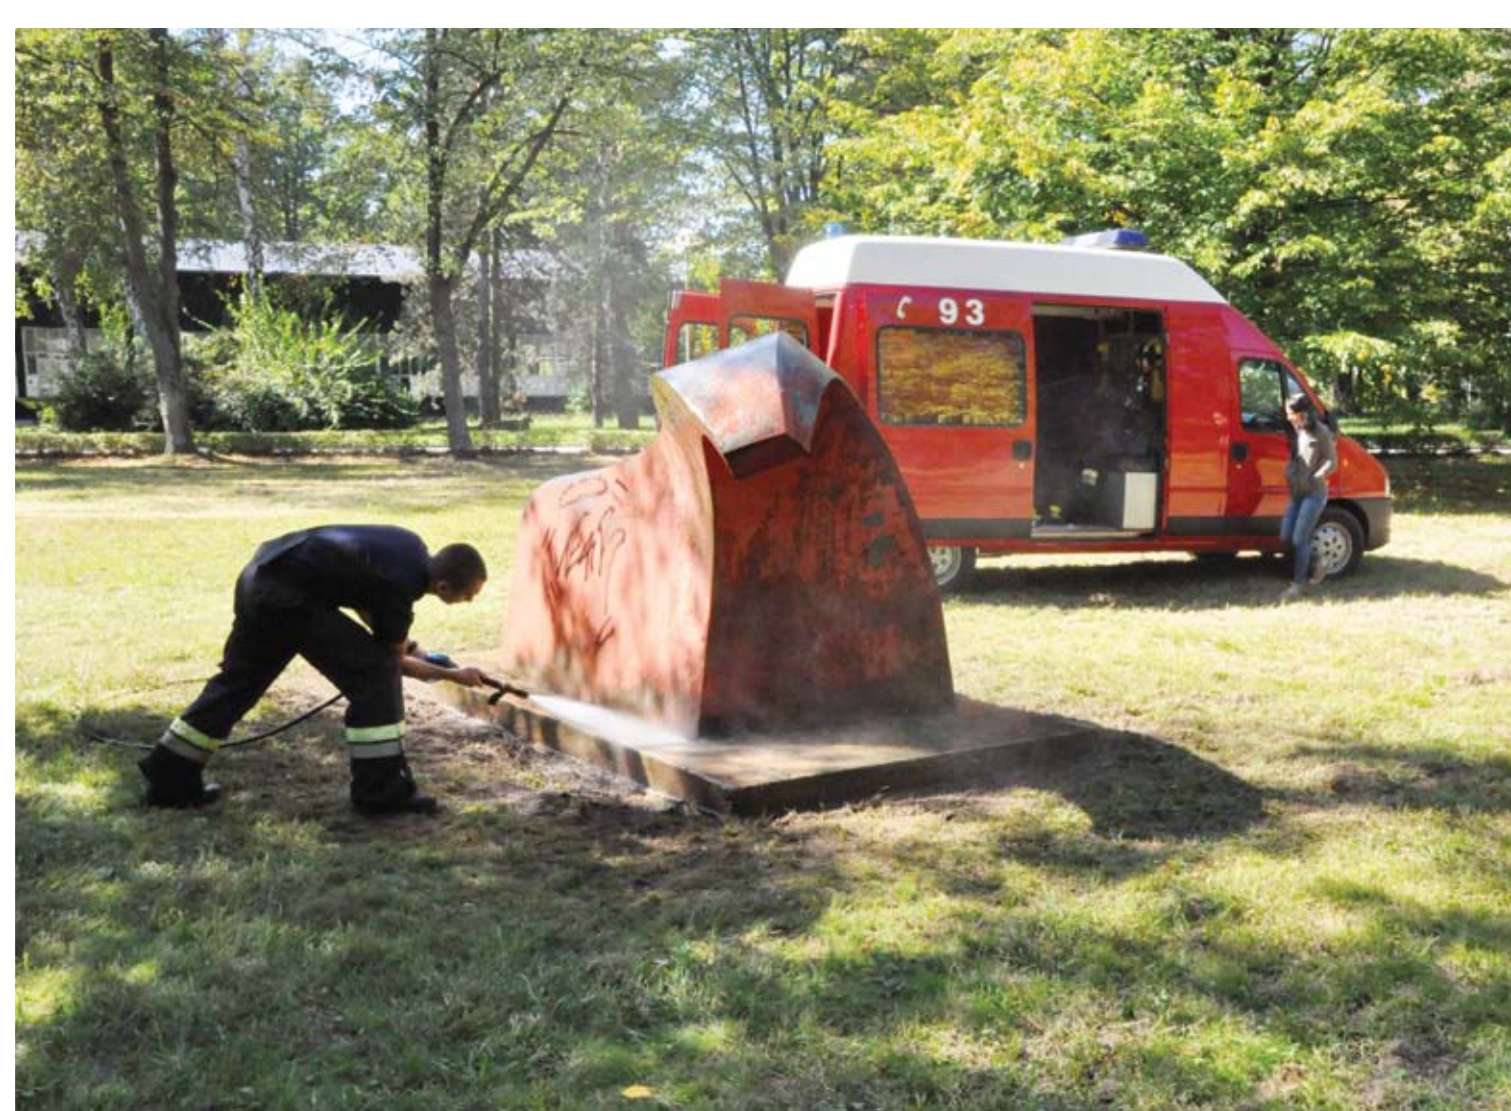
Figure 6 Wet cleaning of Peruško Bogdanić's sculpture *Riderless* of 1983 (photo: S. M. Sunara, September 2013)
