Preventive Conservation in an Outdoor Sculpture Collection

This poster describes some of the measures that can be undertaken to minimize or prevent damage to outdoor artworks. It focuses on the Sculpture Park of Sisak Steelworks, Croatia, a collection of 38 sculptures produced within the scope of the artists' colony that the factory organized between 1971 and 1990. The sculptures are made of steel. Many of them are painted, and several are galvanized. They are placed around the workshops of the former Sisak Steelworks and in the green areas of the nearby workers' housing estate. For years the sculptures were left to the ravages of time and weather (Fig. 1). In 2012 a project aimed at protecting and preserving the collection was initiated. First, the sculptures were inscribed in the Cultural Objects Register of the Republic of Croatia. Next, professional assistance had to be ensured. Collaboration was established with the conservation-restoration study programme in Split. Implementation of preventive conservation measures has been an important segment of the work of students and faculty in the Park, which is conducted during annual conservation-restoration workshops.

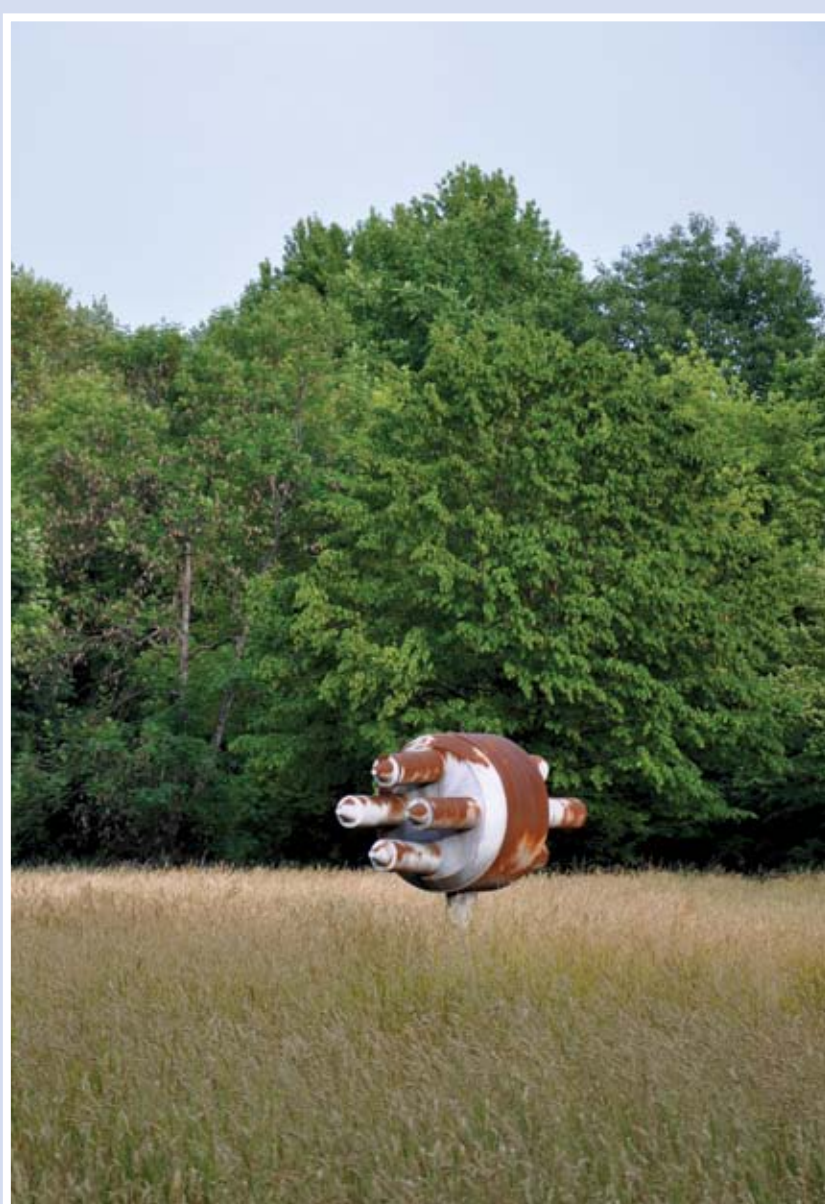
Figure 1 Josip Zeman's galvanized steel sculpture *Dark Visions I* of 1983 is severely corroded (photo: S. M. Sunara, May 2016)

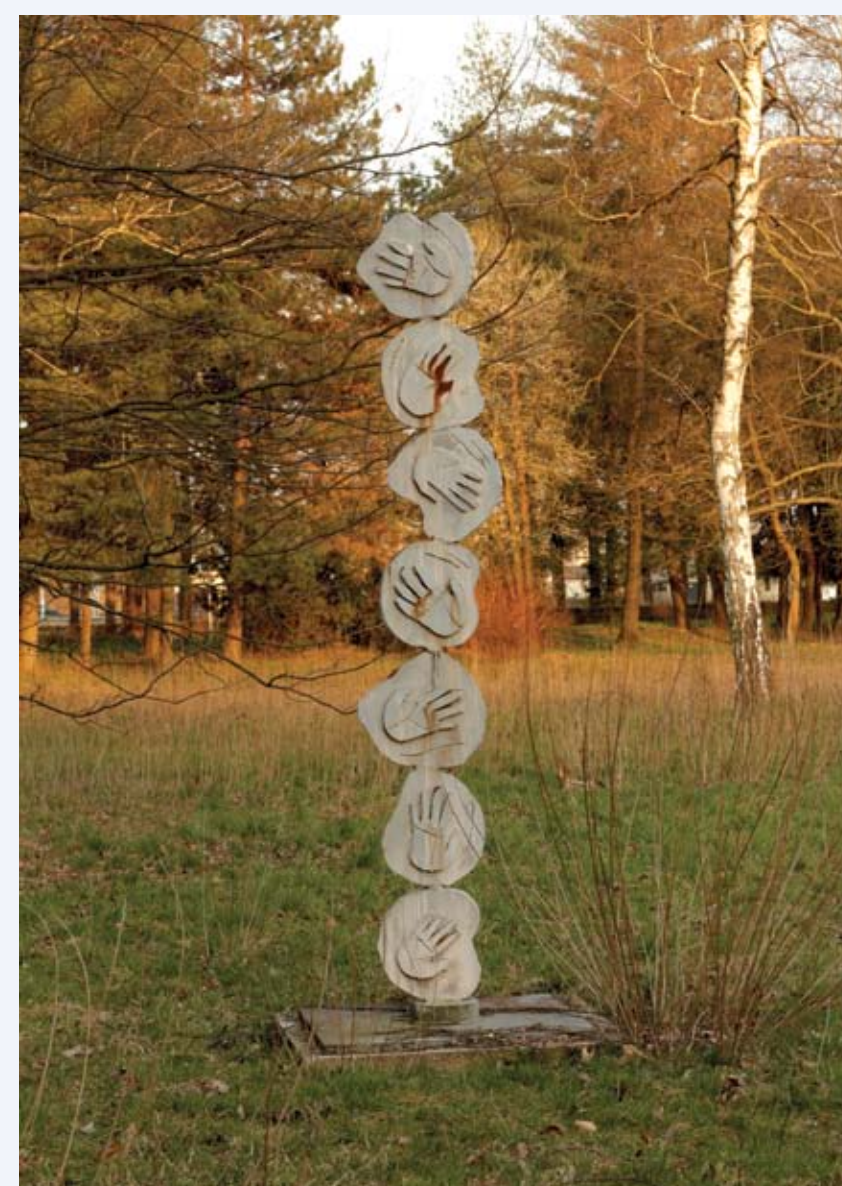
Initially, there were more sculptures, but some were stolen after the Colony ended and probably sold off as scrap metal (Fig. 2 and 3). In 2013 the production of 3D scans of the smaller sculptures was initiated, as they face the greatest risk of theft. The scanning of all of the sculptures is planned. Although in recent years the City of Sisak has taken over the responsibility for stewardship of the collection through its cultural institutions, the

Figure 2 The upper part of Jure Žaja's *In Memory of George of Dalmatia* (1979) was stolen in 2015 (photo: N. Peko, March 2015)

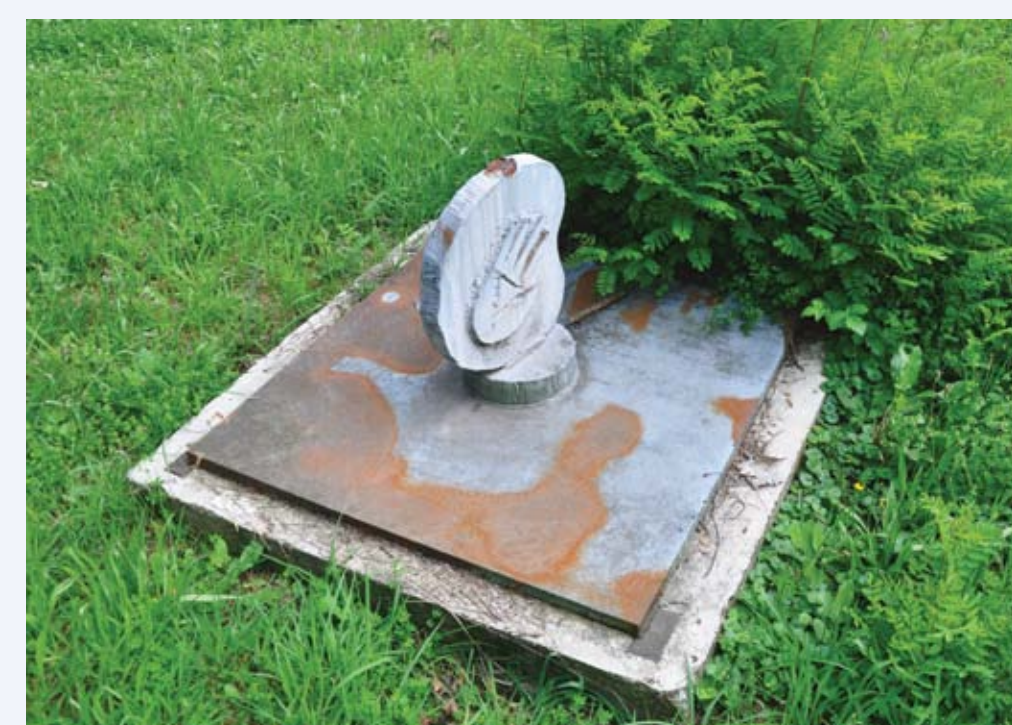
Figure 3 Only a small part of Žaja's sculpture *In Memory of George of Dalmatia* has been preserved (photo: S. M. Sunara, July 2018)

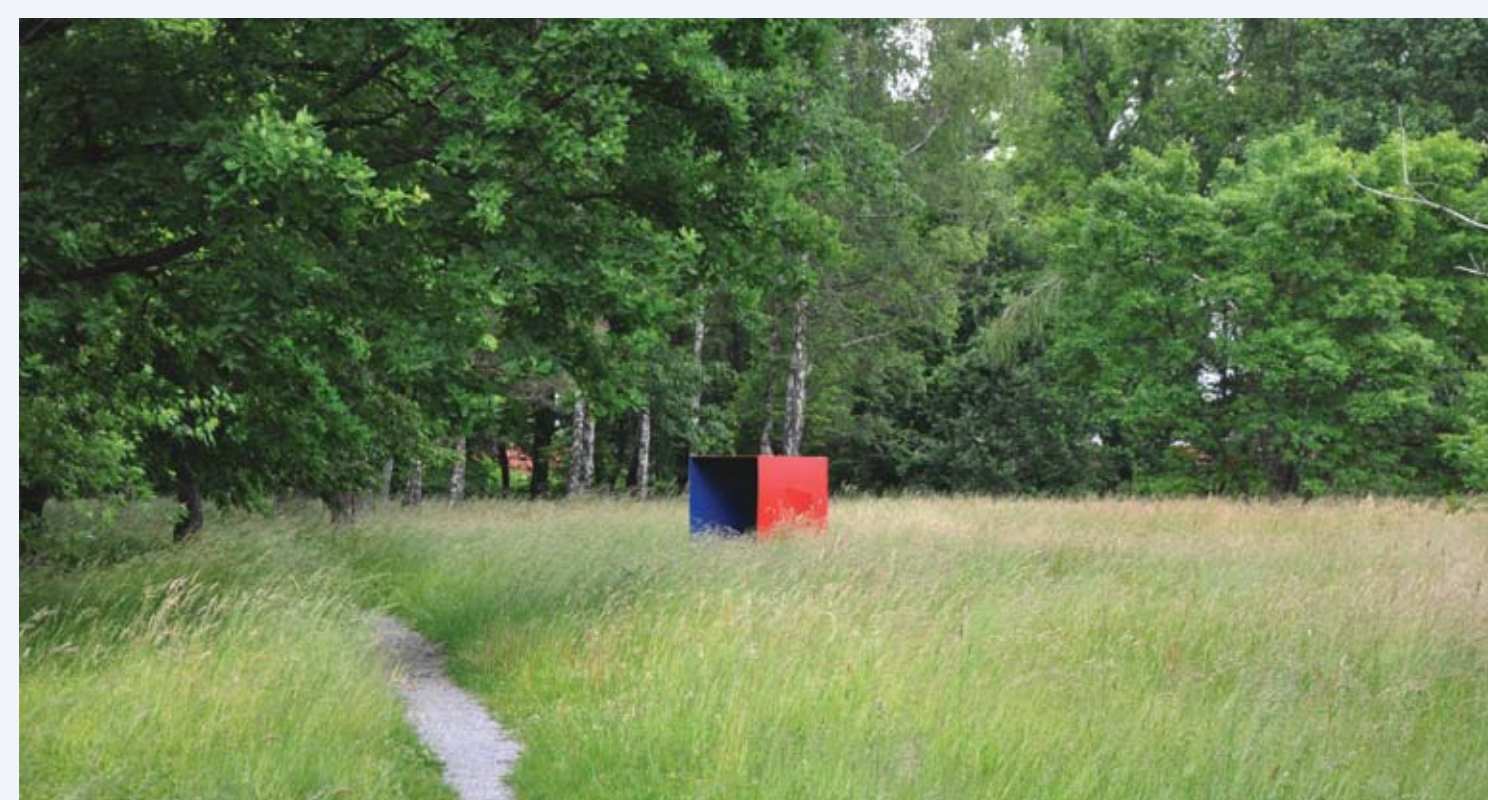
Figure 4 Josip Diminić's sculpture *Object II* (1979) was restored during the 2014 conservation-restoration workshop. The grounds in which the sculpture is installed are not regularly maintained (photo: S. M. Sunara, May 2016)

Two sculptures suffered damage due to negligence of the construction workers during public works. When public works are undertaken, sculptures should be fenced off and regularly checked. The City of Sisak recently ordered the lower branches of the trees that surround the large green area where a number of sculptures are installed to be cut. This intervention has made the sculptures more visible and thus better protected from vandalism (Fig. 4 and 5).

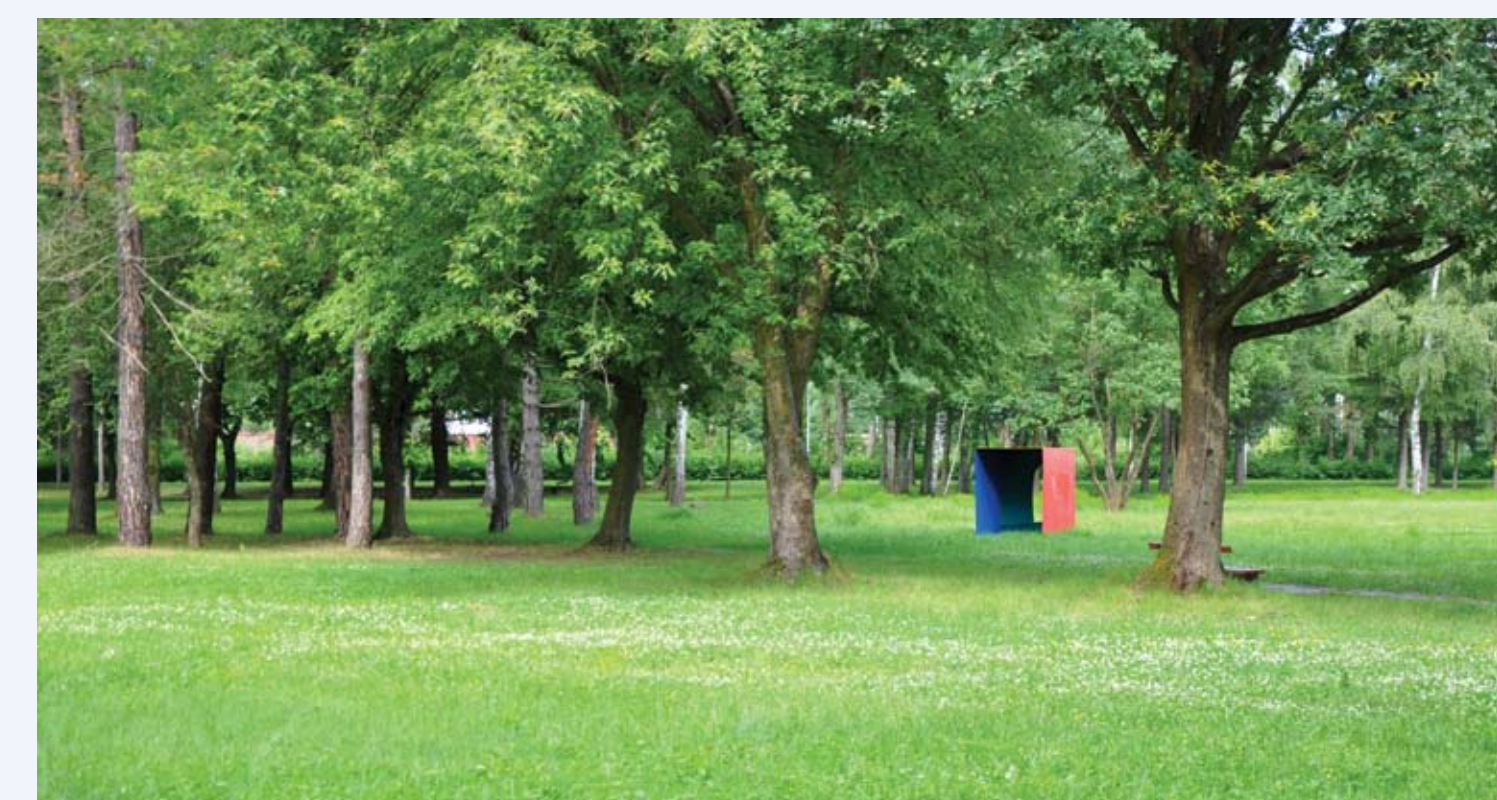
Figure 5 The lower branches on the trees surrounding Diminić's restored sculpture have recently been cut away, making the sculpture visible from afar (photo: S. M. Sunara, July 2018)

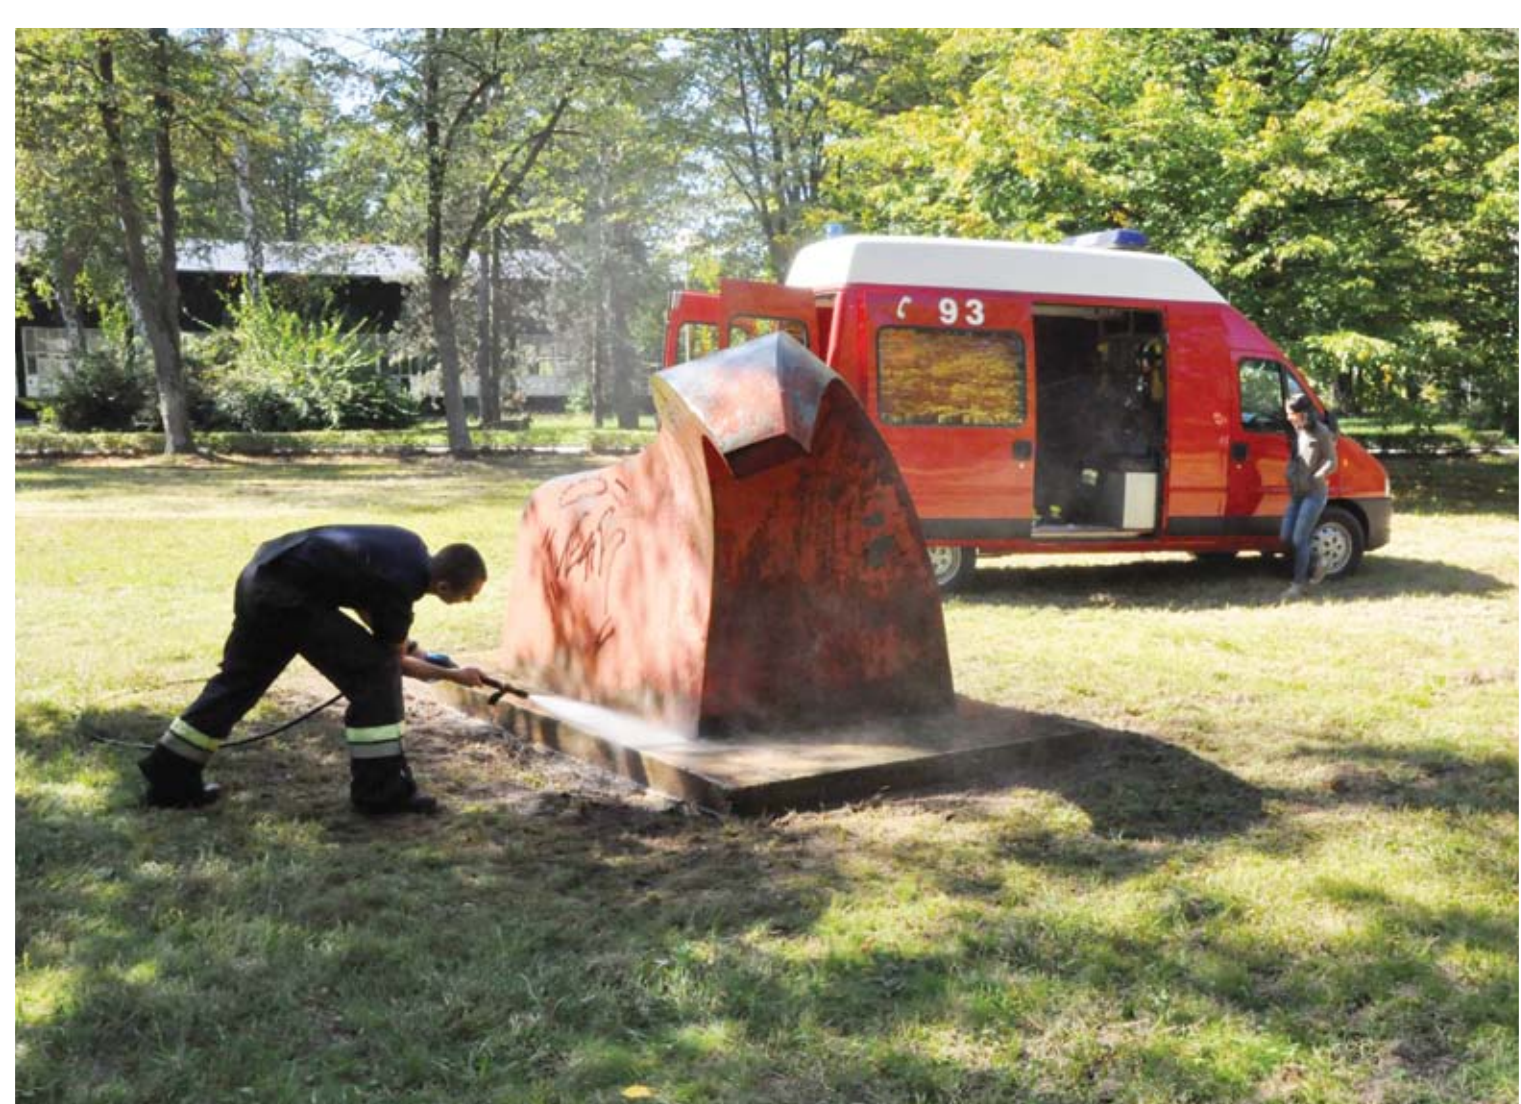
Figure 6 Wet cleaning of Peruško Bogdanić's sculpture *Riderless* of 1983 (photo: S. M. Sunara, September 2013)
