UNITO – CCR

CAPuS PROJECT – DETERIORATION (WALL PAINTING)

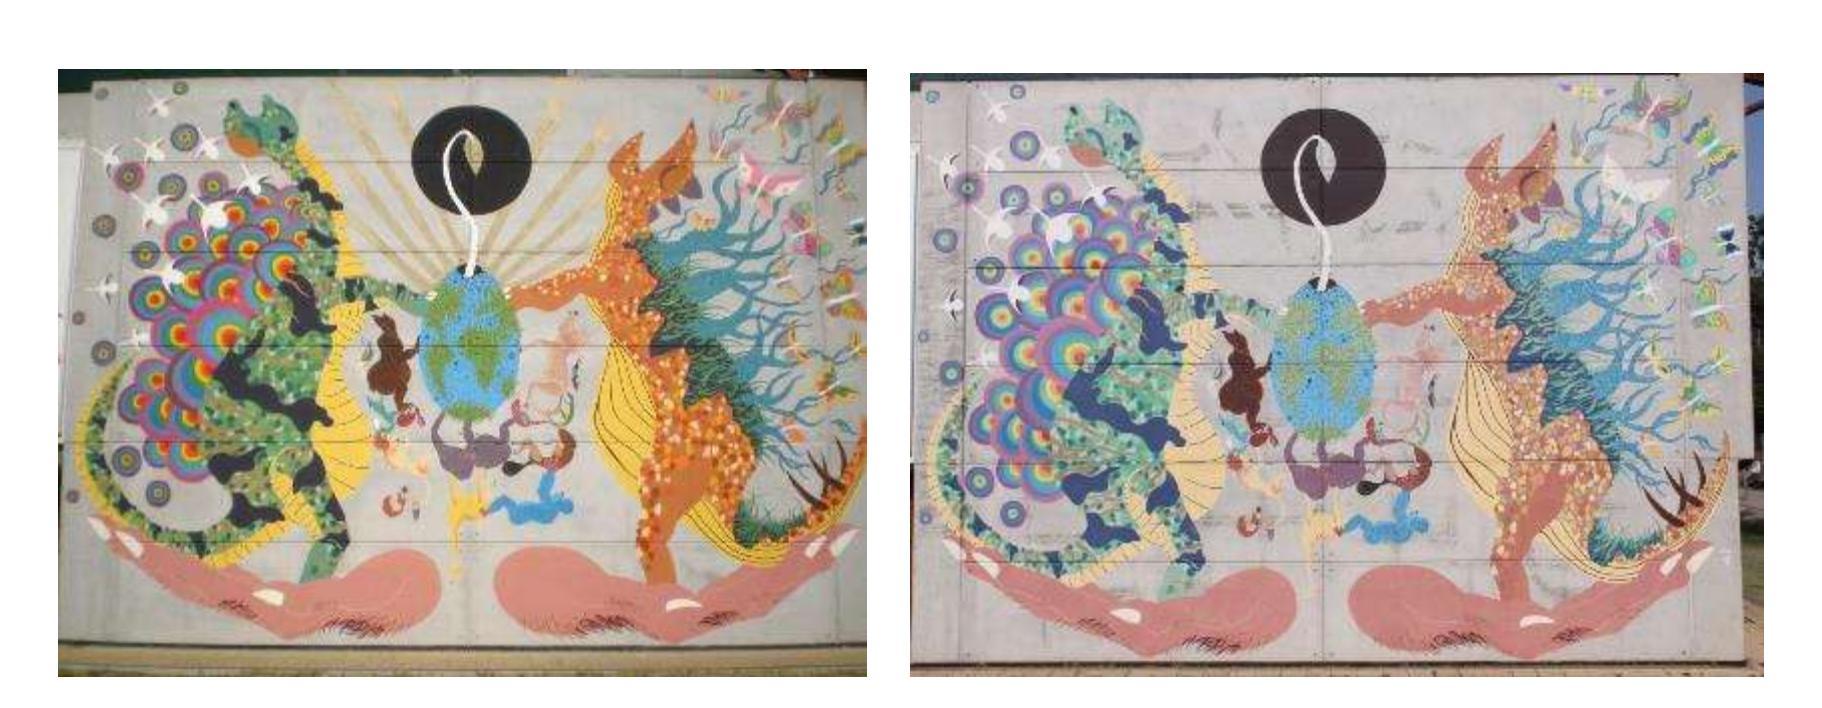
FIG. 1: "TWO DRAGONS CARRYING A NEW CREATURE" BY GOLA HUNDUN IN 2012 (LEFT) AND 2019 (RIGHT). GENERAL CHROMATIC ALTERATION AND FADING. MANY CRACKS, FLAKING AND BLISTERING (BOTH COLORS AND COATING)

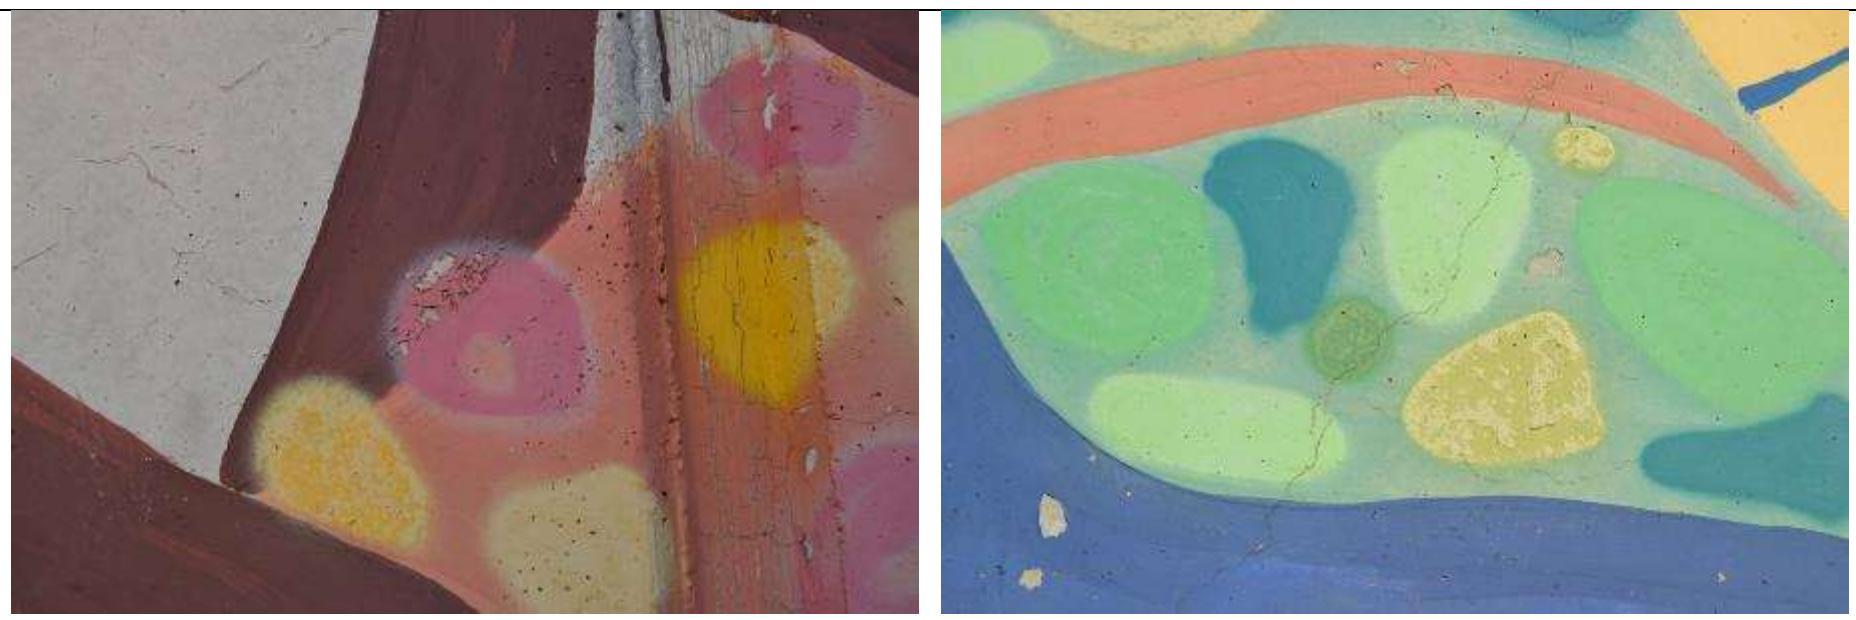
FIG 2: CRACKING AND FLAKING OF THE COATING (AND CONSEQUENTLY OF THE COLOR)

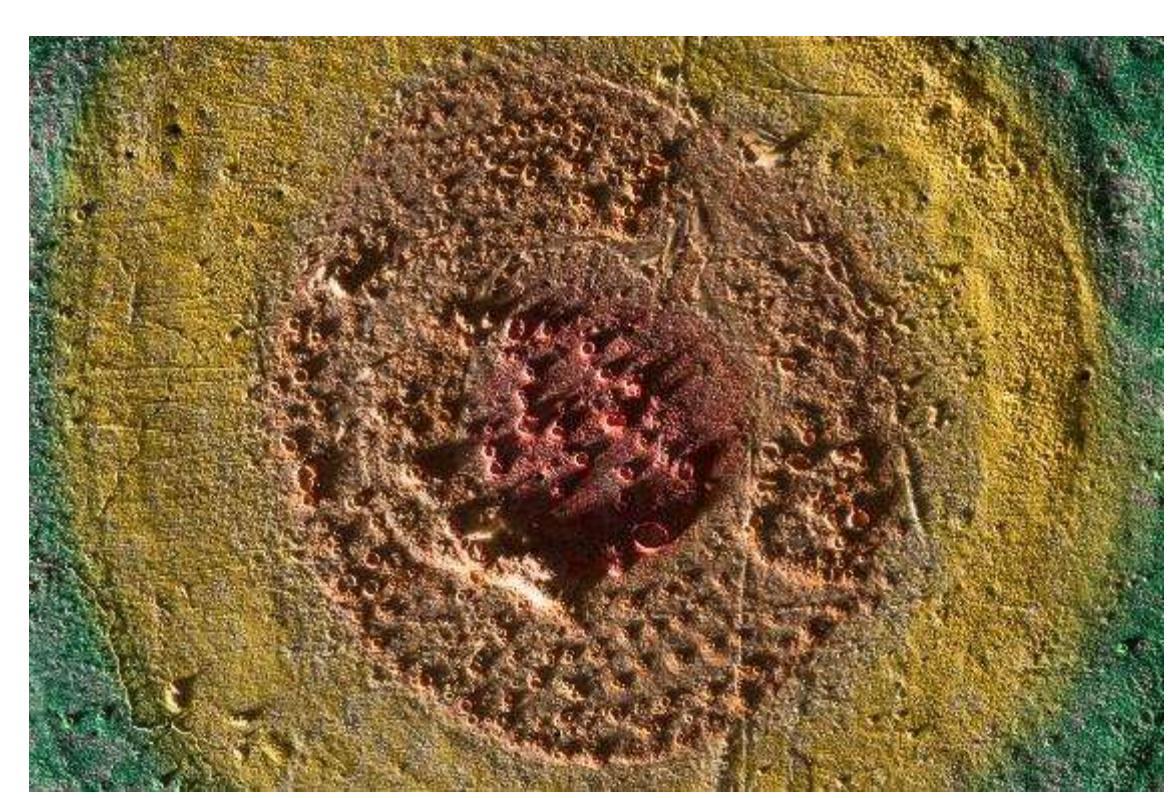
FIG. 5: BLISTERING (RAKING LIGHT)

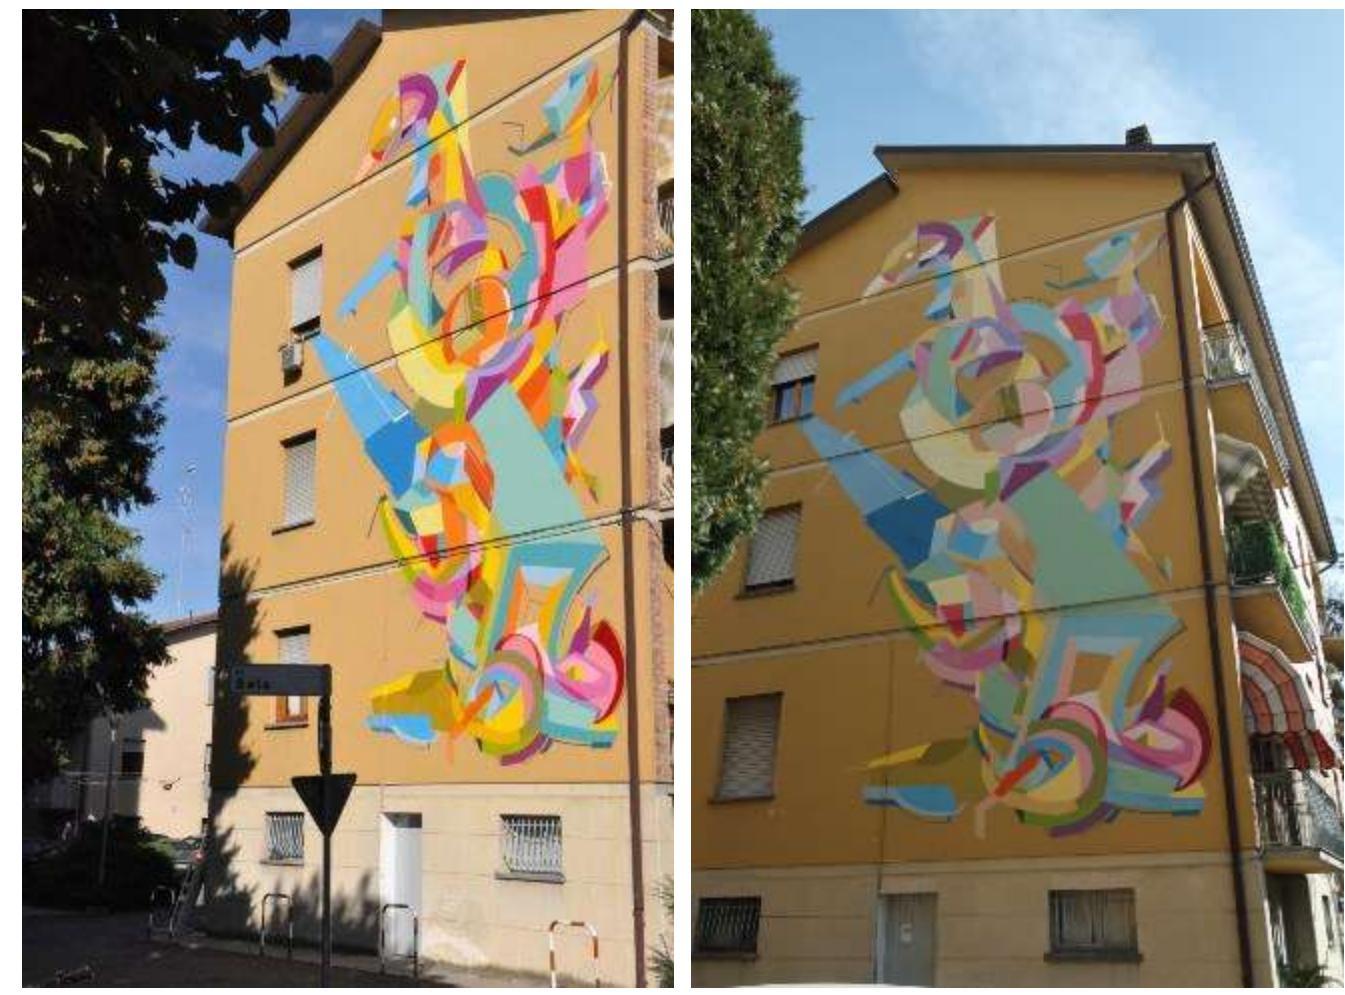
FIG 1: "BIG SACRAL BIRD" BY KENOR IN 2010 (LEFT) AND TODAY (FEBRUARY 2019); CHROMATIC ALTERATIONS, FADING ESPECIALLY OF ORANGES AND PINK (TOTAL FADING)

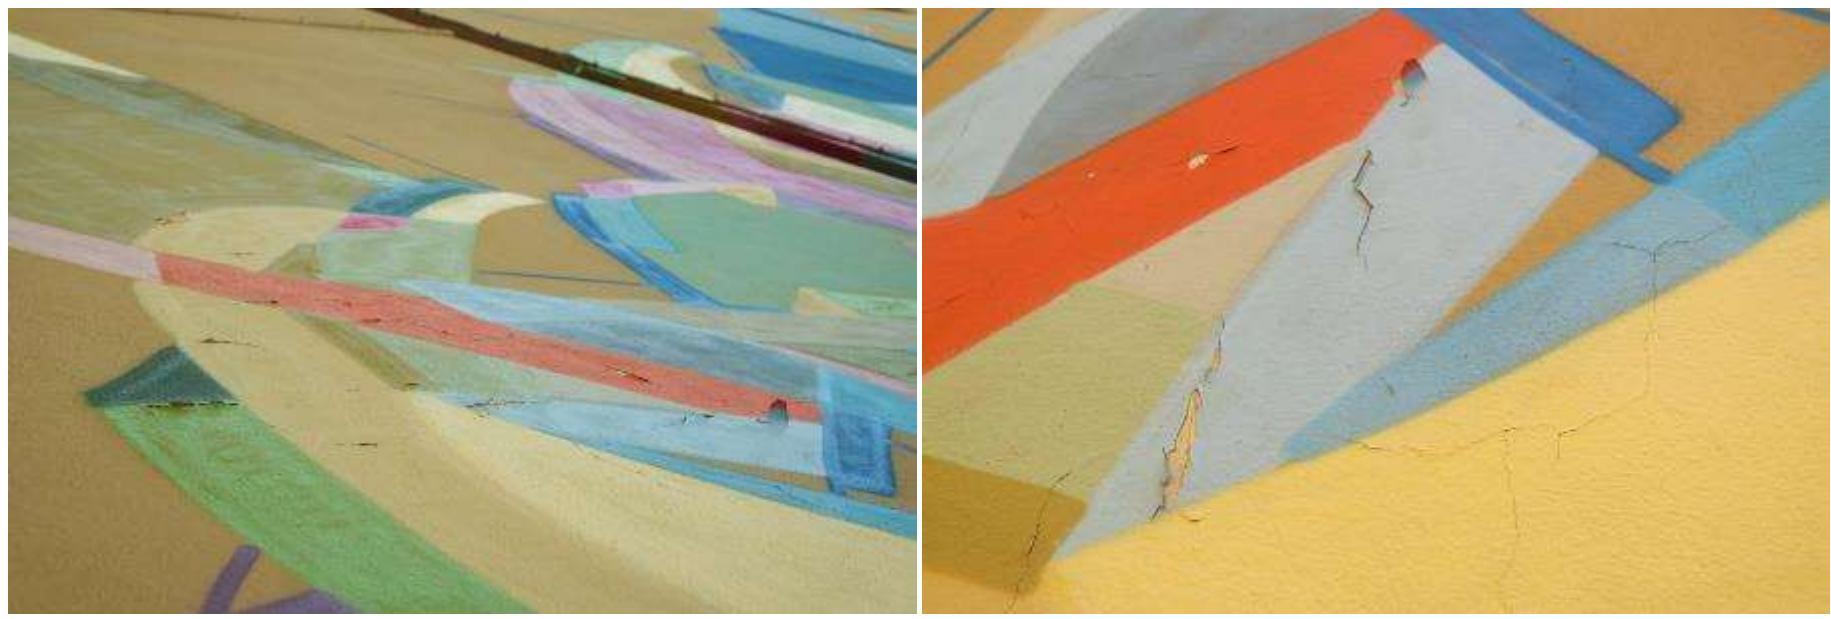
FIG 2: CRACKING AND FLAKING (LEFT: RAKING LIGHT) WITH LACUNAS

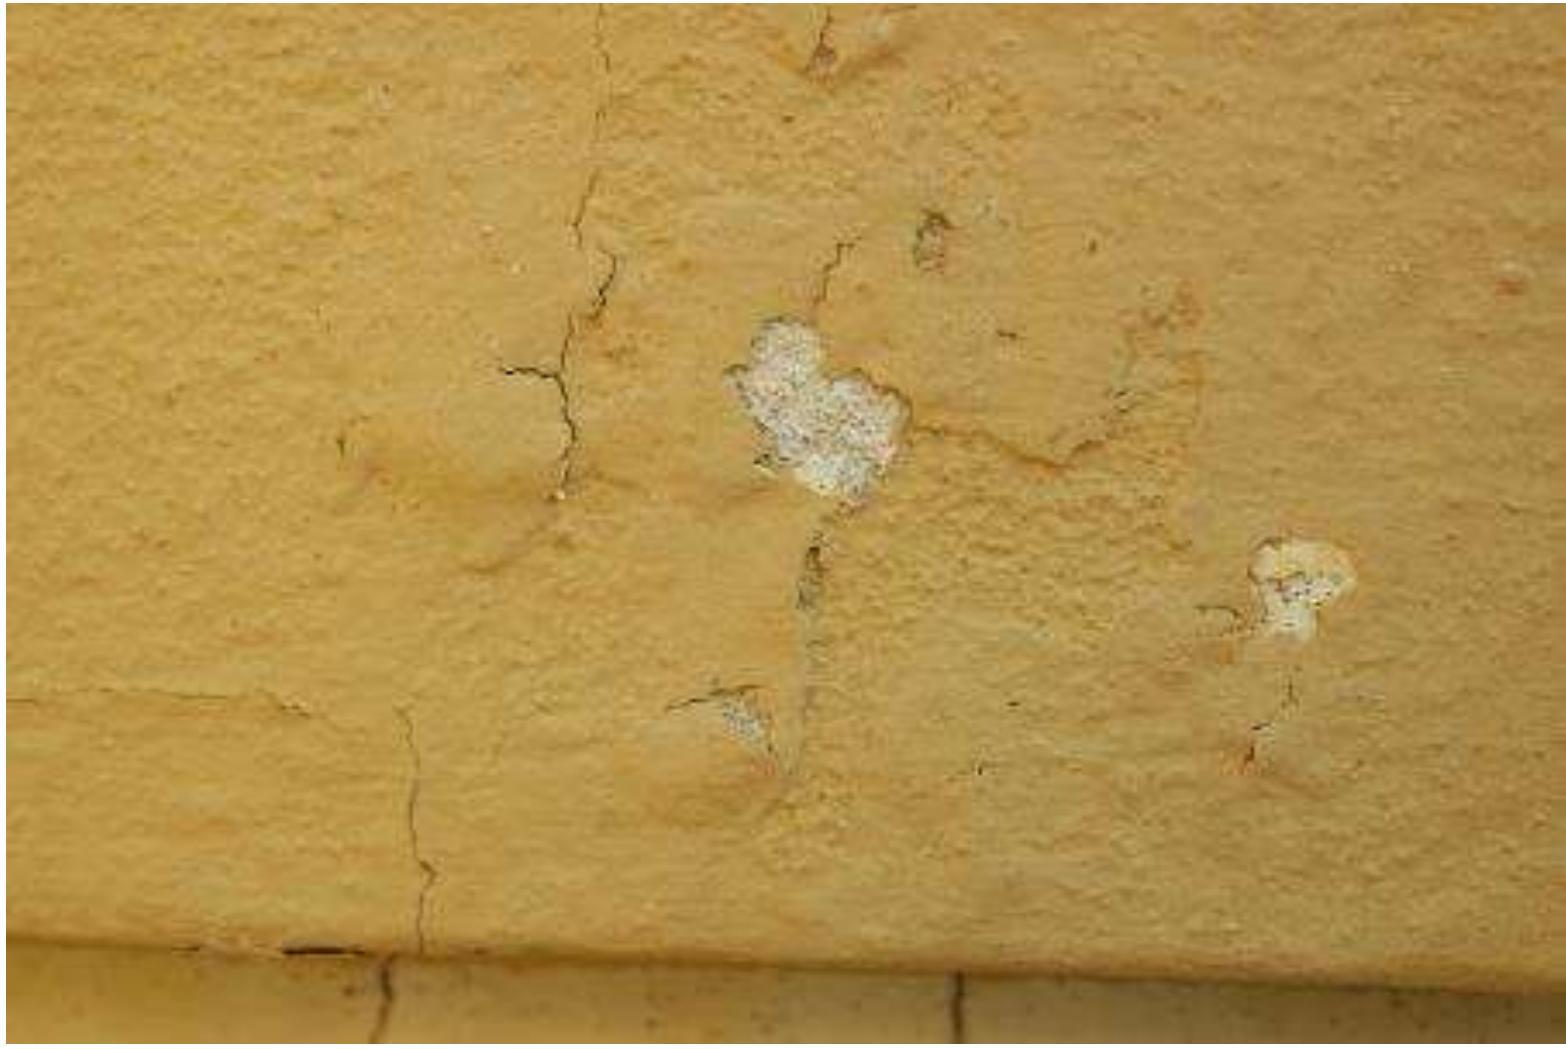
FIG 3: SUBFLORESCENCE

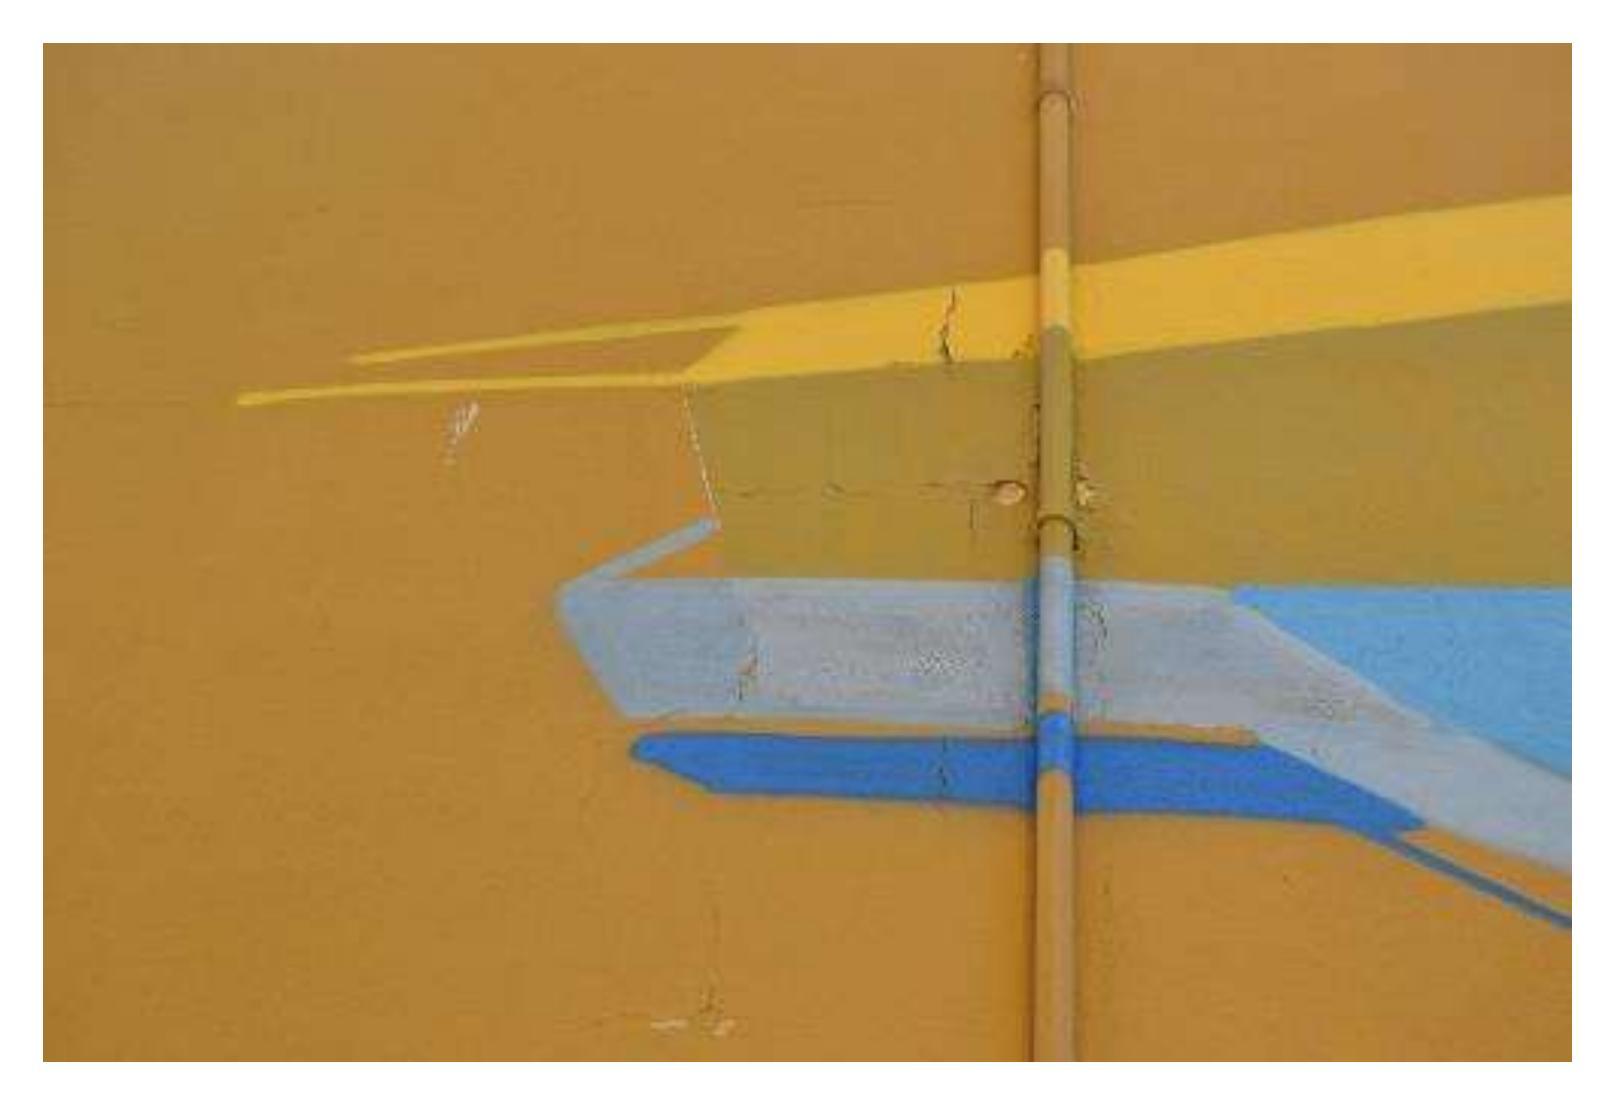
FIG. 4: CRACKING

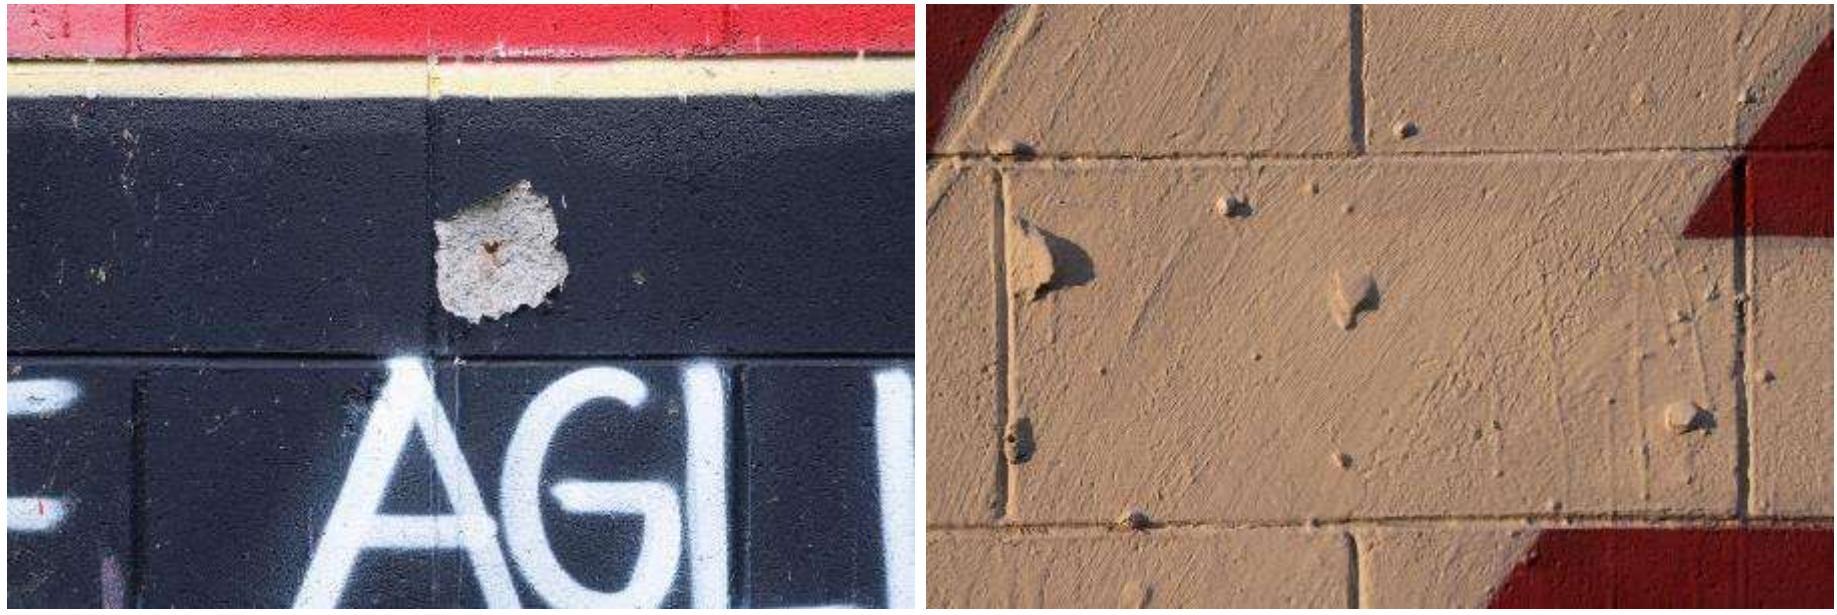
FIG 2 A AND B: LOSSES AND SCALING CAUSED BY UNSUITABLE REINFORCED CONCRETE BRICKS INERTS (METAL AND GLASS PIECES)

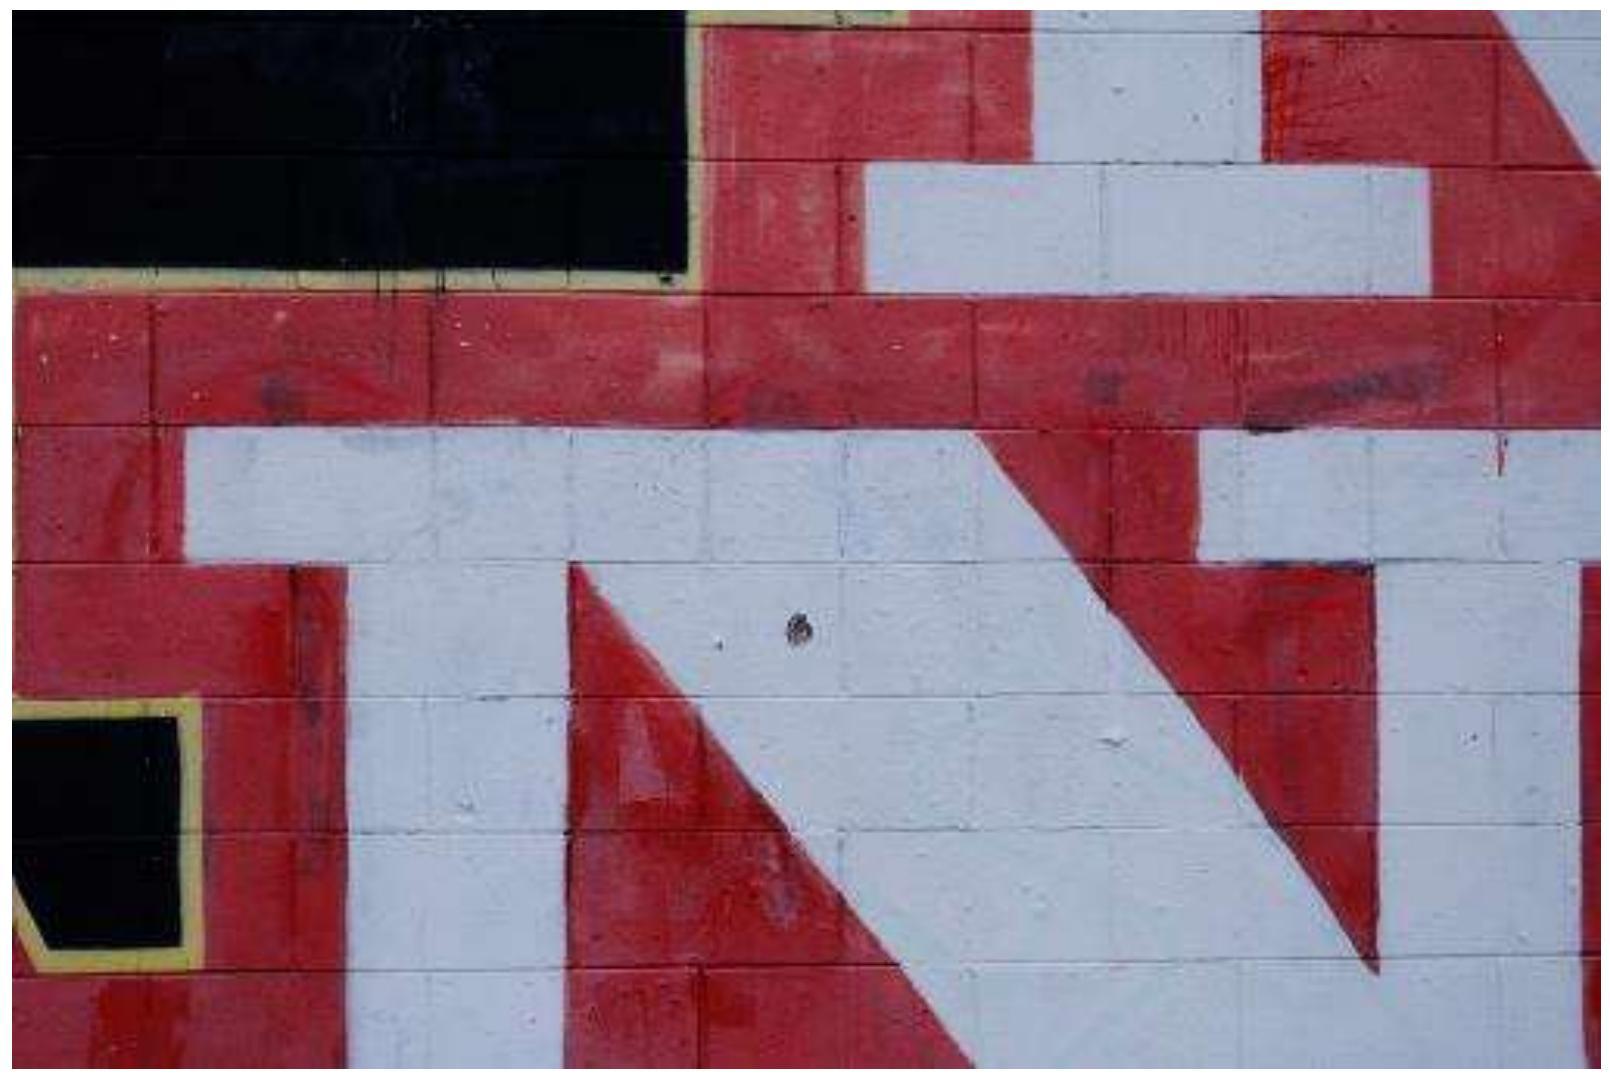
FIG. 3: REPAINTING ON VADALISATIONS AND LACUNAS

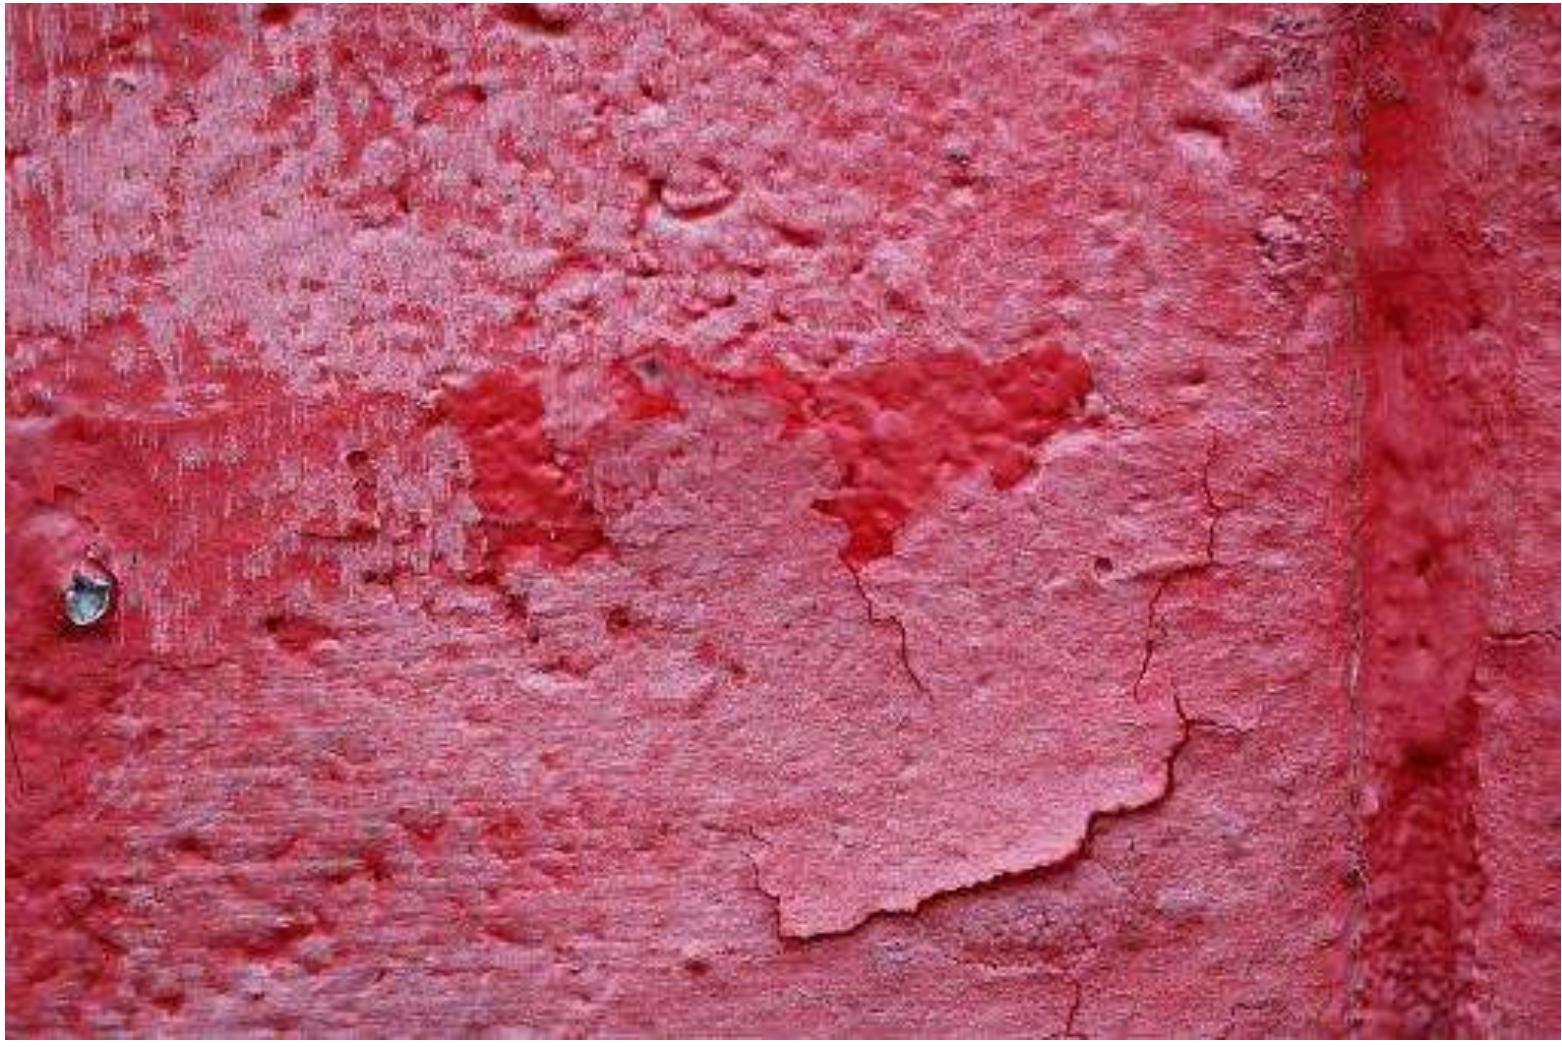
FIG. 4 : FLAKING ON REPAINTED AREAS

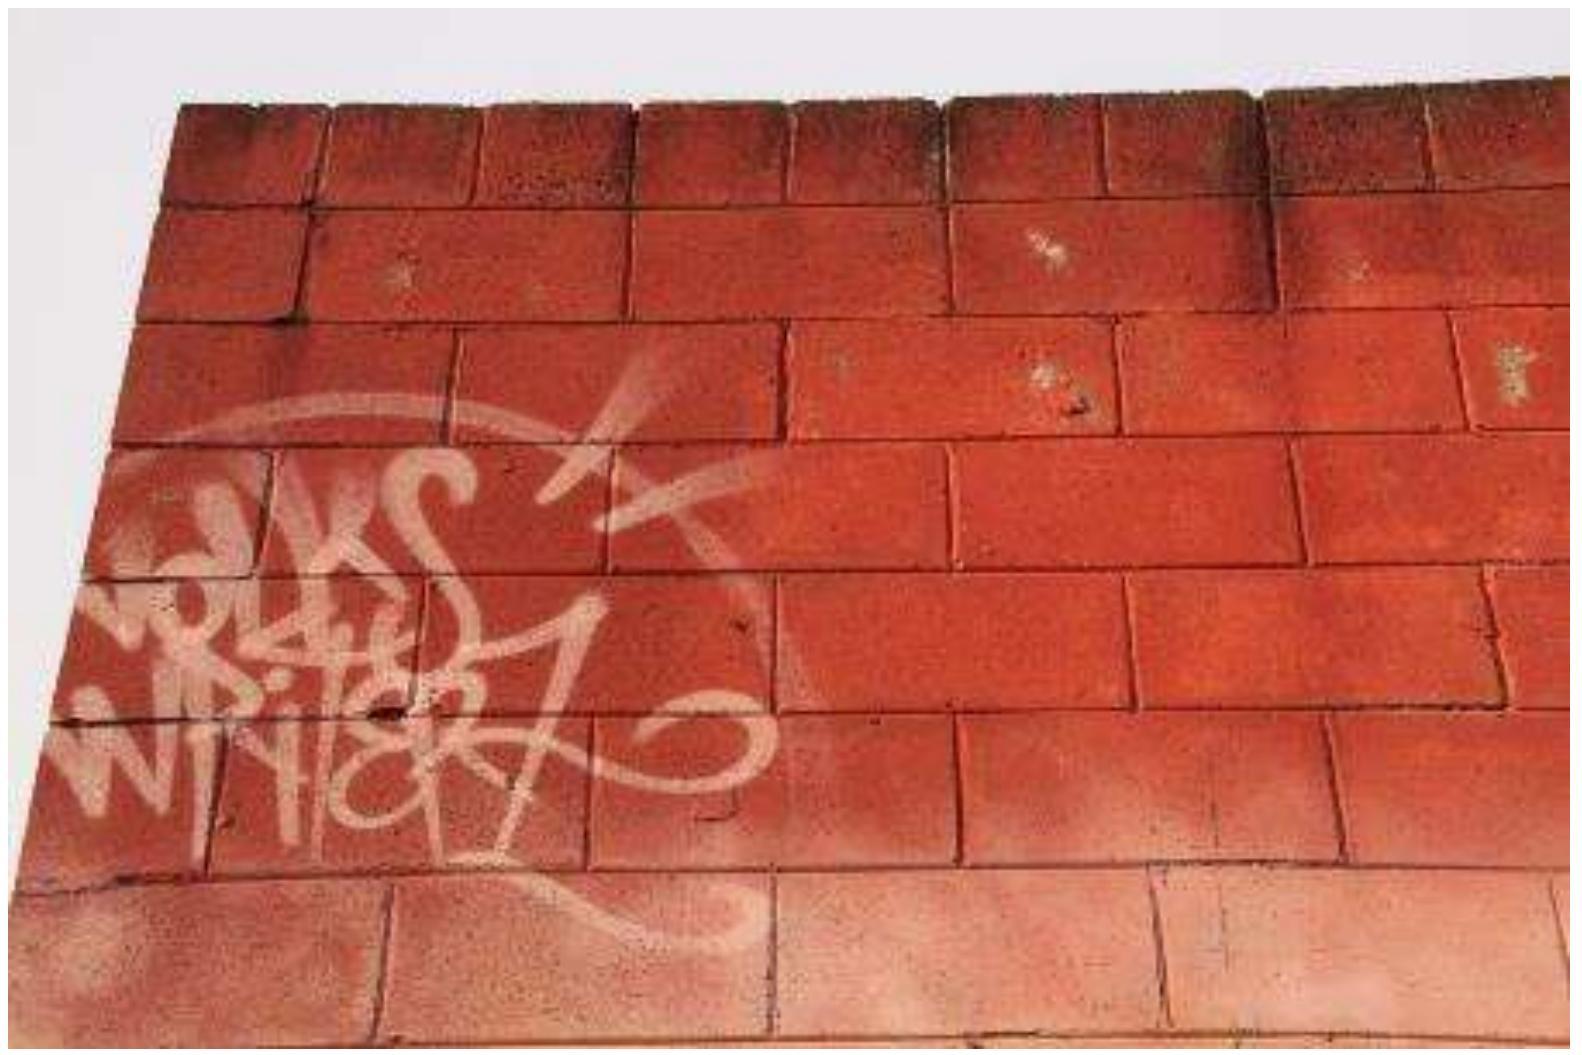
FIG. 5: SPRAY DISCOLORATION ON THE UPPER PART WITH BLACK AREAS (RAINFALL WASHOUT)

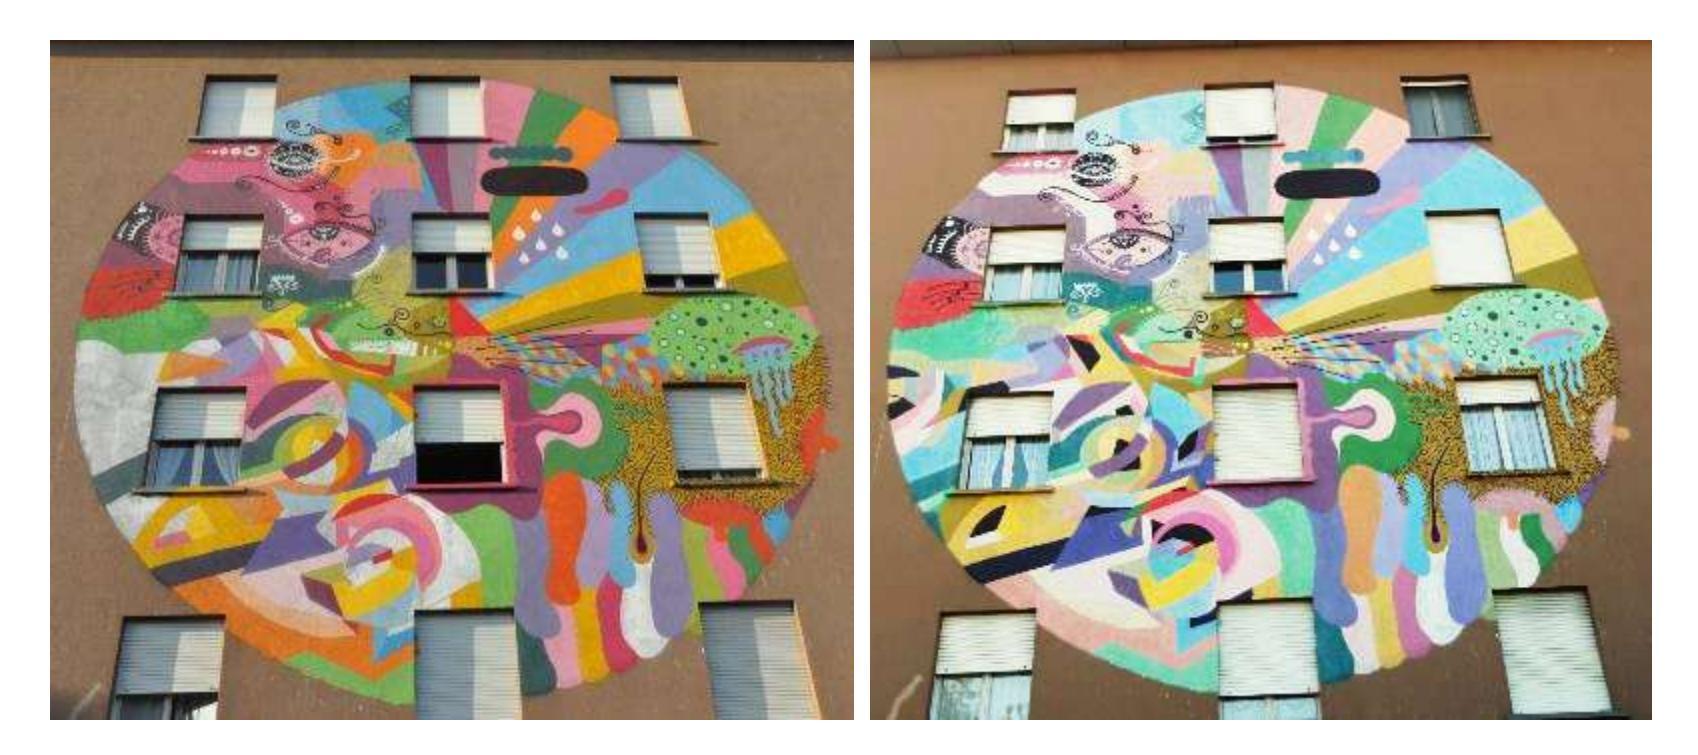
Fig. 1: "MANDALA" BY KENOR, ZOSEN, GOLA HINDUN AND H101 IN 2010 (LEFT) AND 2019 (RIGHT). GENERAL FADING (TOTAL FOR ONE DARK PINK) AND CHROMATIC ALTERATION FOR DARK ORANGE AND PLUM PURLPLE (THE ONE AROUND THE CENTRAL WINDOW)

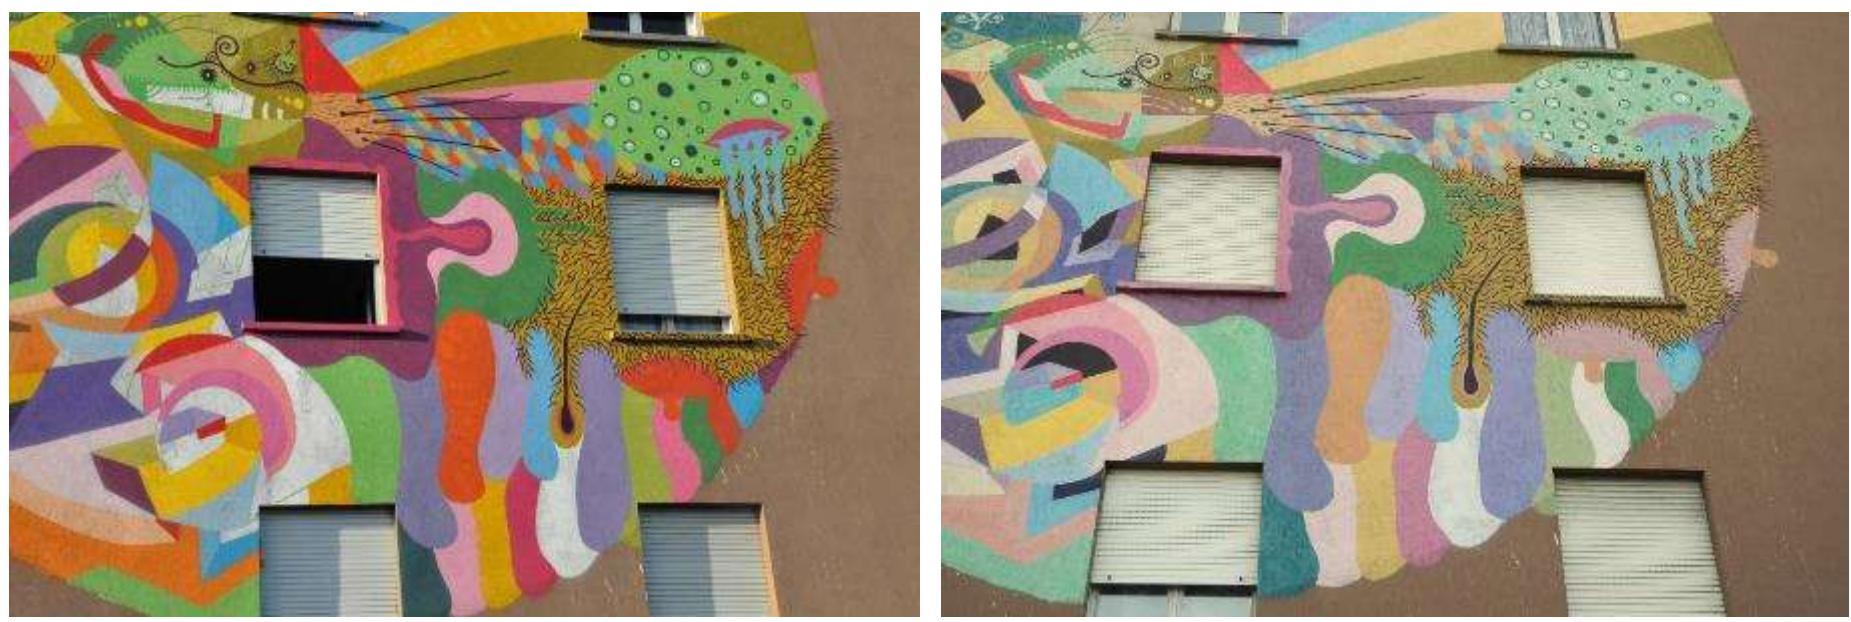
FIG. 2: "MANDALA" BY KENOR, ZOSEN, GOLA HINDUN AND H101 IN 2010 (LEFT) AND 2019 (RIGHT), PARTICULARS. GENERAL FADING (TOTAL FOR ONE DARK PINK) AND CHROMATIC ALTERATION FOR DARK ORANGE AND PLUM PURLPLE (THE ONE AROUND THE CENTRAL WINDOW)

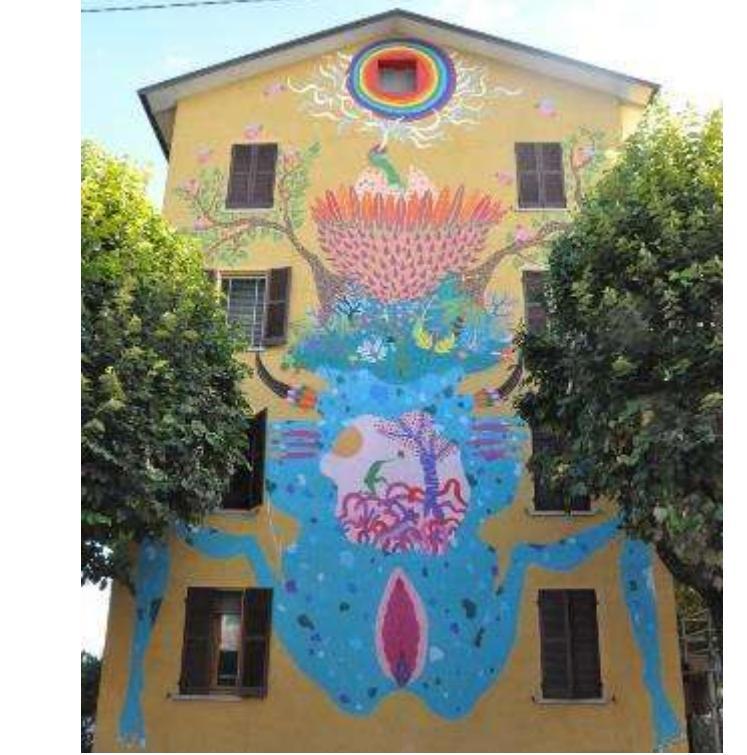
FIG 1: "THE BIG MOTHER" BY GOLA HUNDUN. LEFT: 2010. RIGHT: TODAY; GENERAL AND FADING (PARTIAL OR TOTAL)

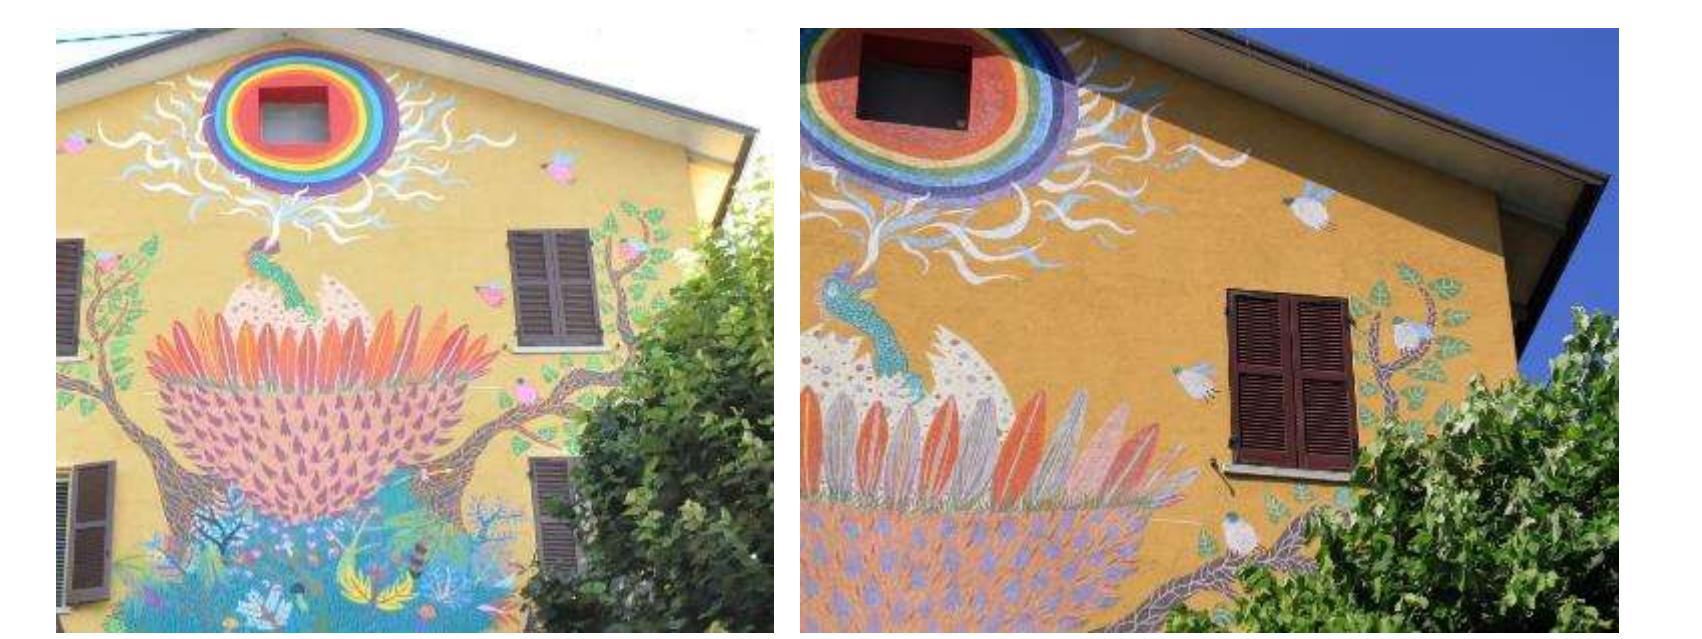
FIG 2: "THE BIG MOTHER" BY GOLA HUNDUN. RIGHT: TODAY (FEBRUARY 2019); GENERAL CHROMATIC ALTERATION AND FADING (PARTIAL OR TOTAL).

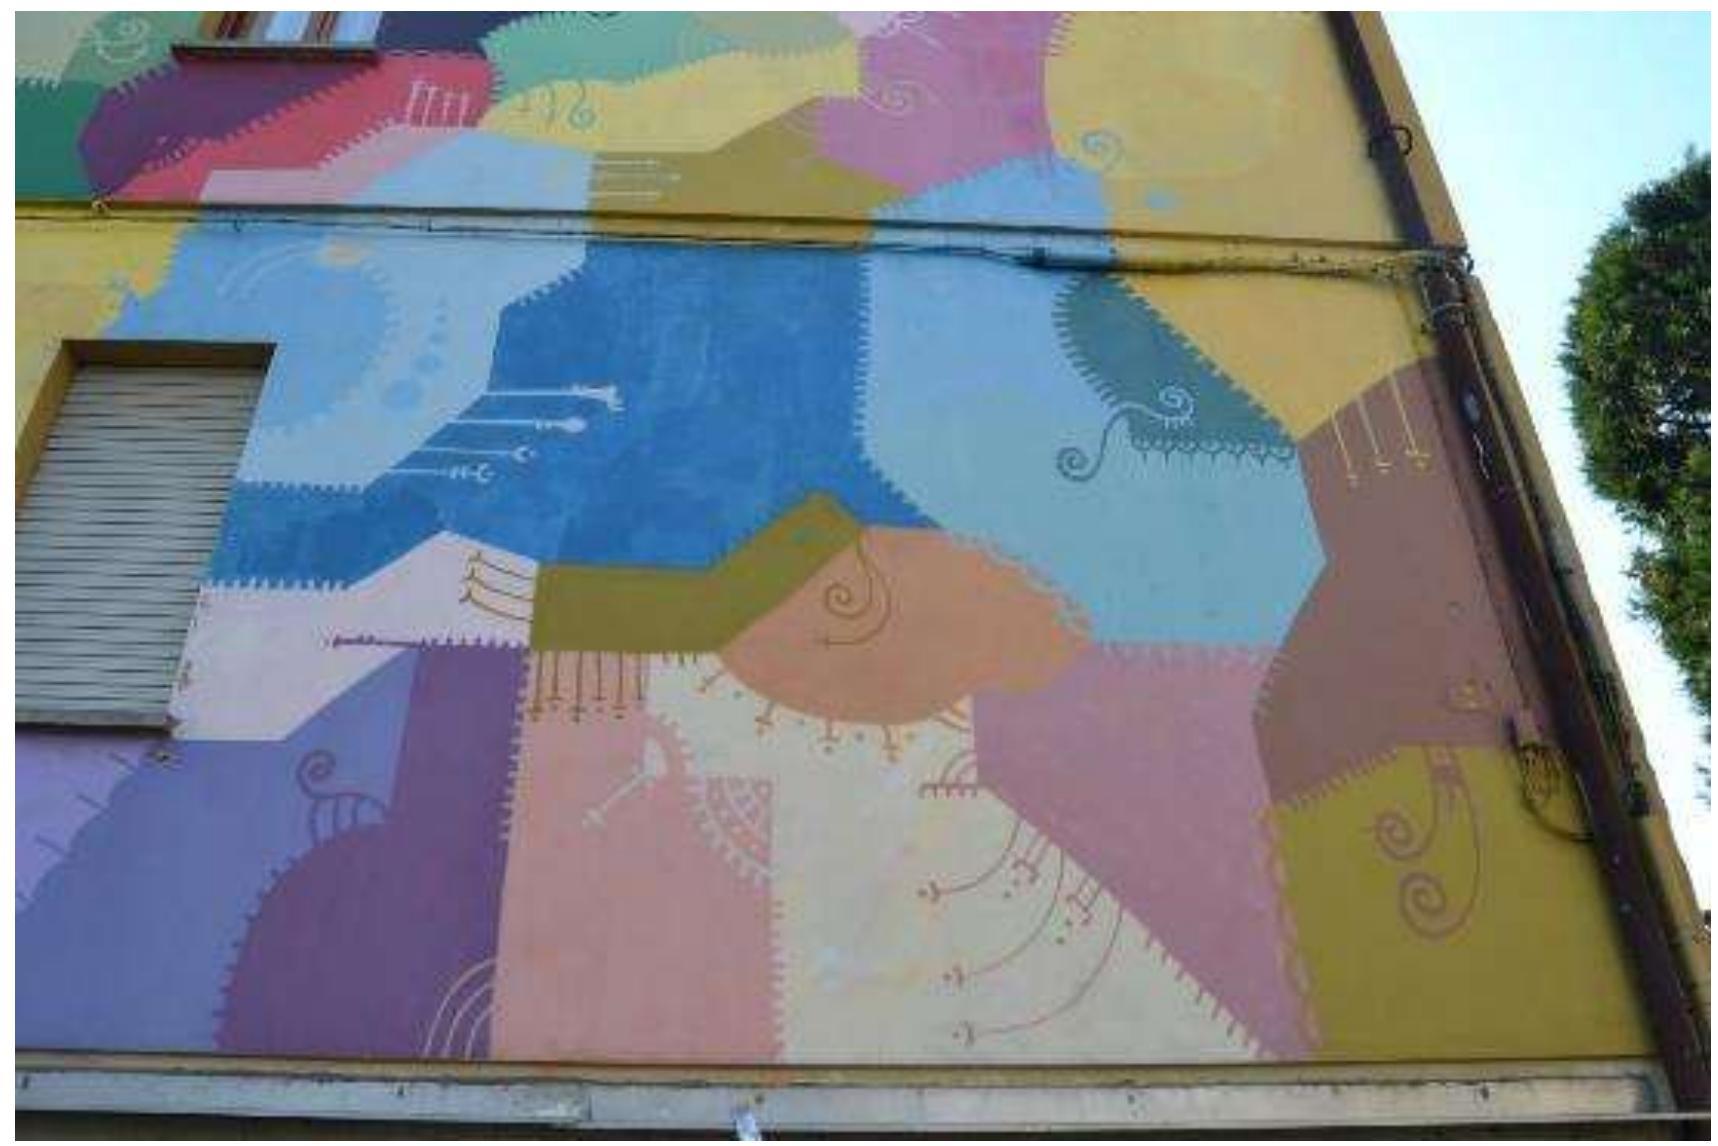
Fig 2: Chromatic alterations (pink), fading (pale yellow in the middle) and darkening (purple and brown)

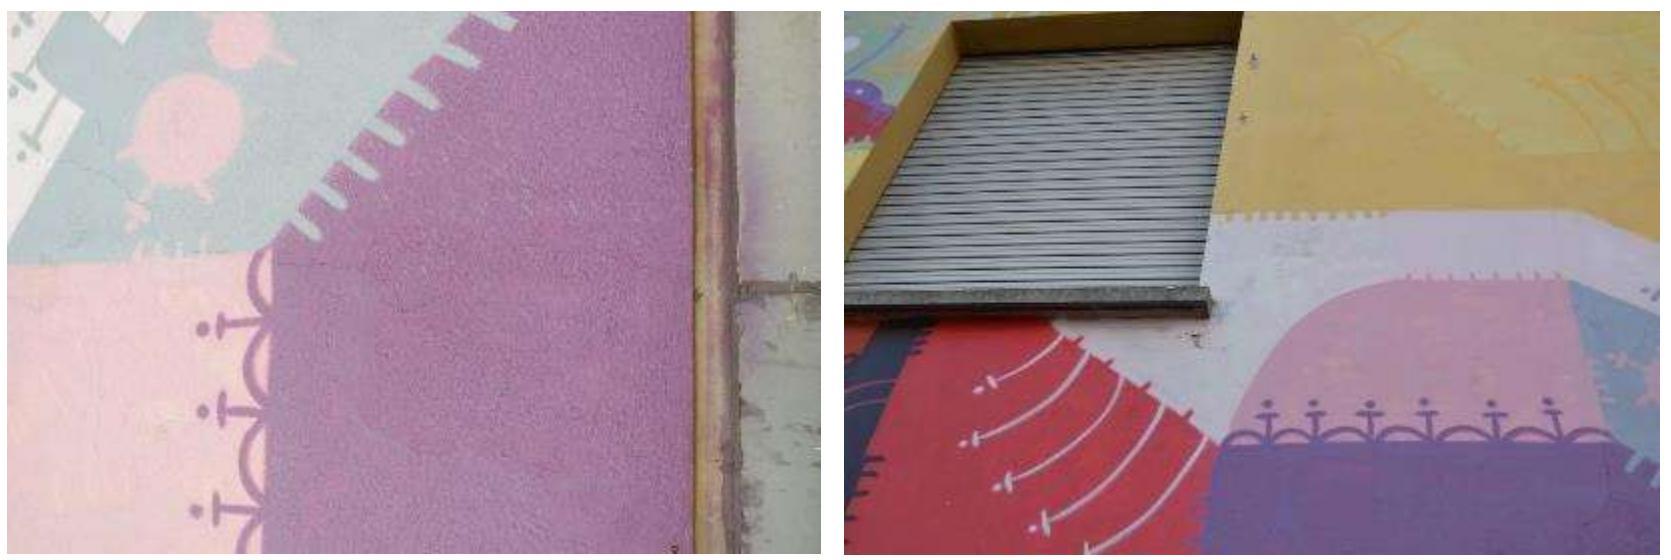
FIG 3: CRAKING (LEFT) AND FLAKING WITH LACUNAS
