UNITO – CCR

CAPuS PROJECT – DETERIORATION (WALL PAINTING)

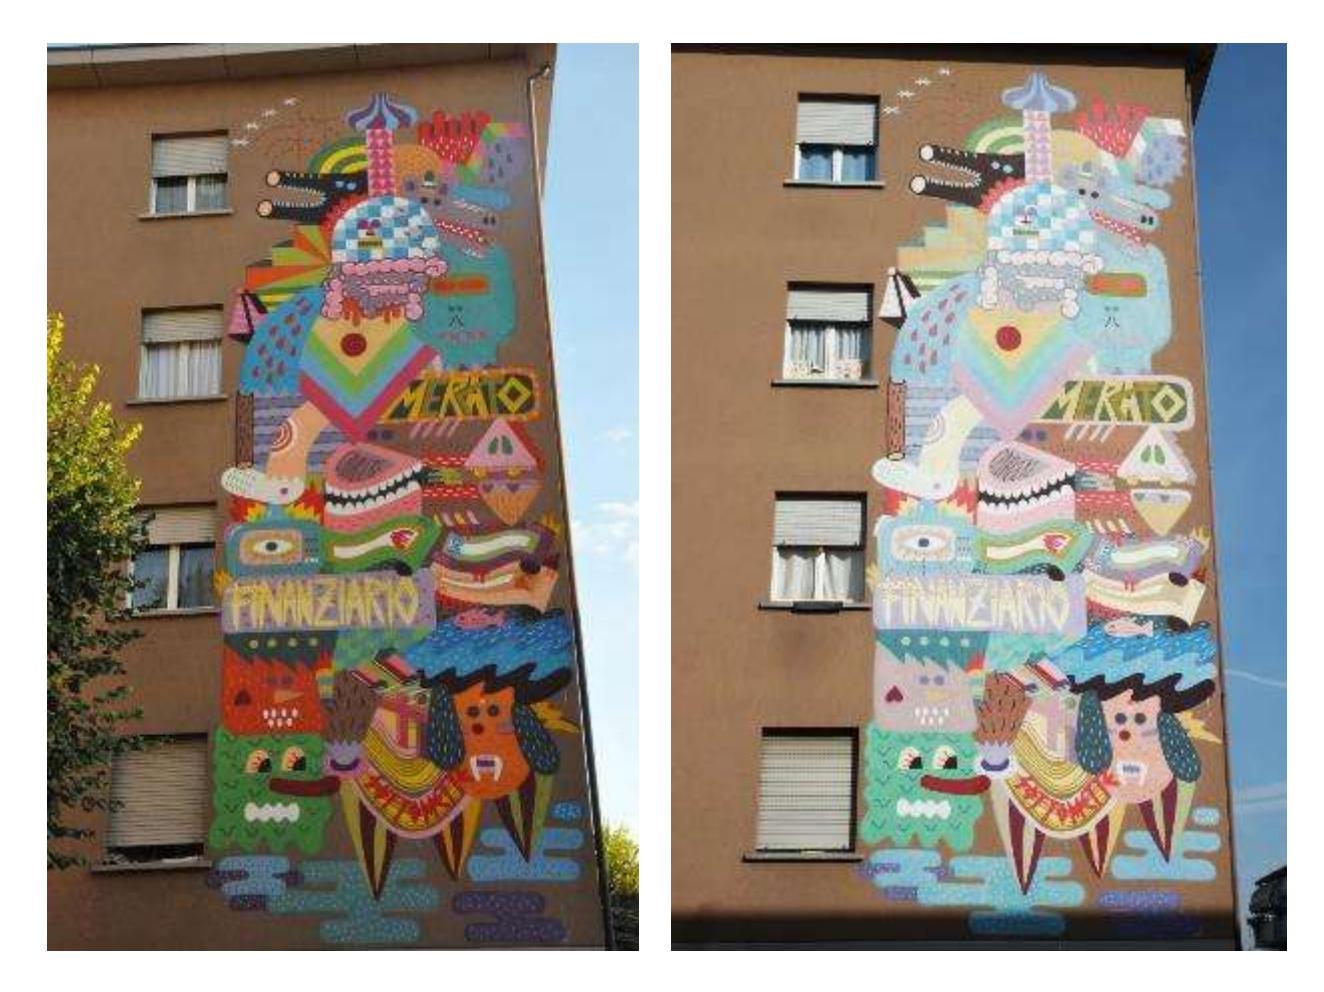
FIG 1: "ECONOMY SUBDUES YOU" BY ZOSEN IN 2010 (LEFT) AND NOW (2019): STRONG CHROMATIC ALTERATION AND FADING (TOTAL AND PARTIAL)

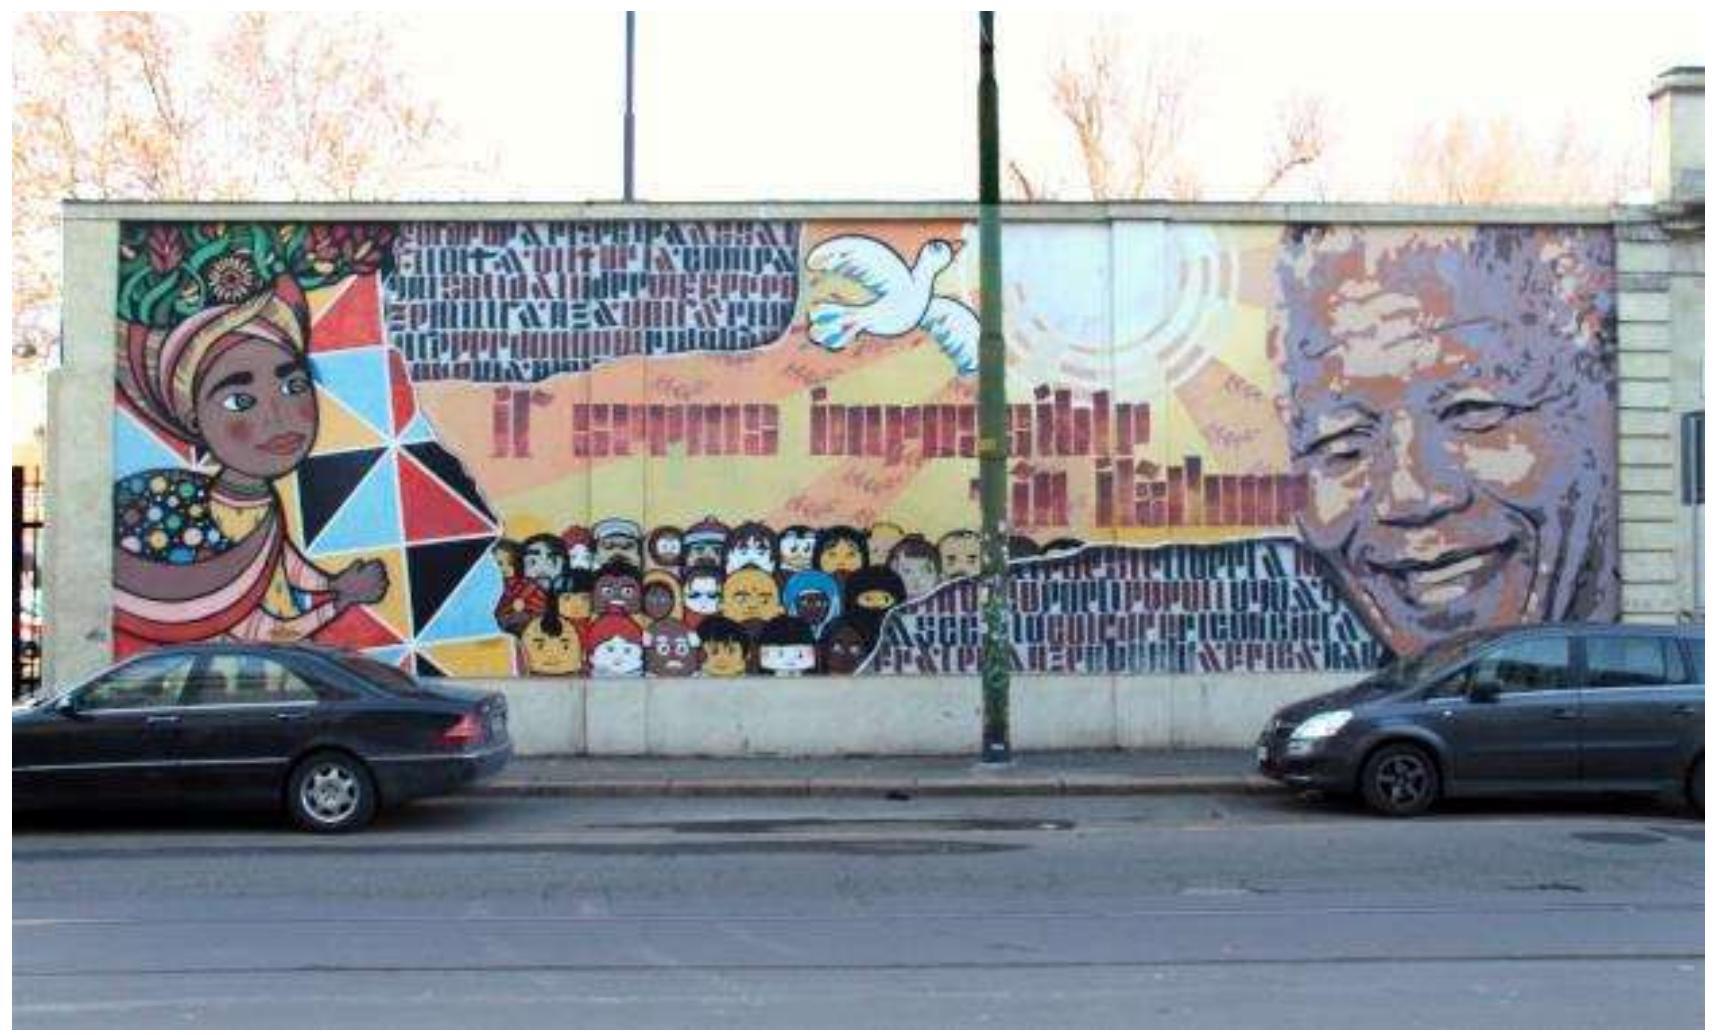
FIG 1: UBUNTU (2014) BY NAIS, PAO, IVAN AND ORTICANOODLES BELOW: THE MURAL PAINTING NOW (APRILE 2019). GENERAL FADING AND STRONG CHROMATIC ALTERATION OF AN ORANGE USED FOR MANDELA'S FACE (TURNED INTO GRAYSH PURPLE)

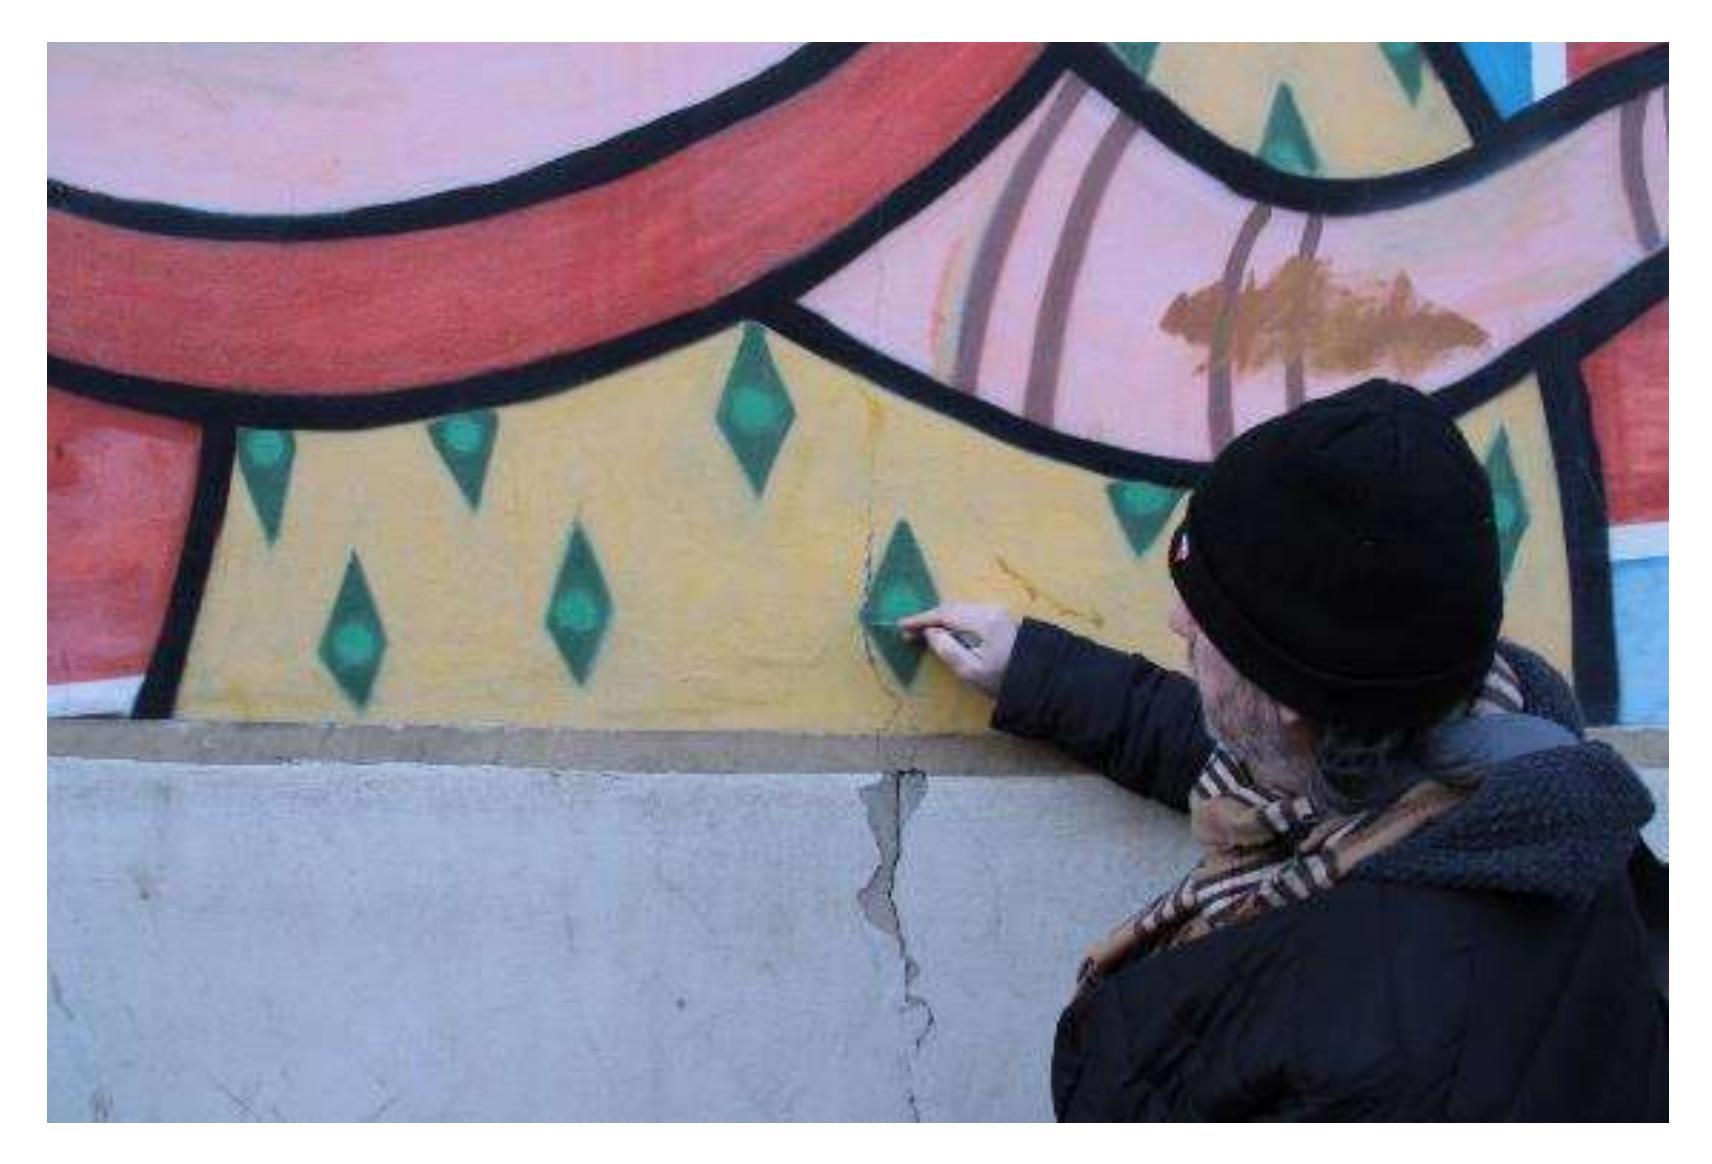
FIG. 2: CRACKING WITH LOSSES (PLASTER AND PAINTING LAYER) DERIVING FROM PREVIOUS PROBLEMS OF THE WALL

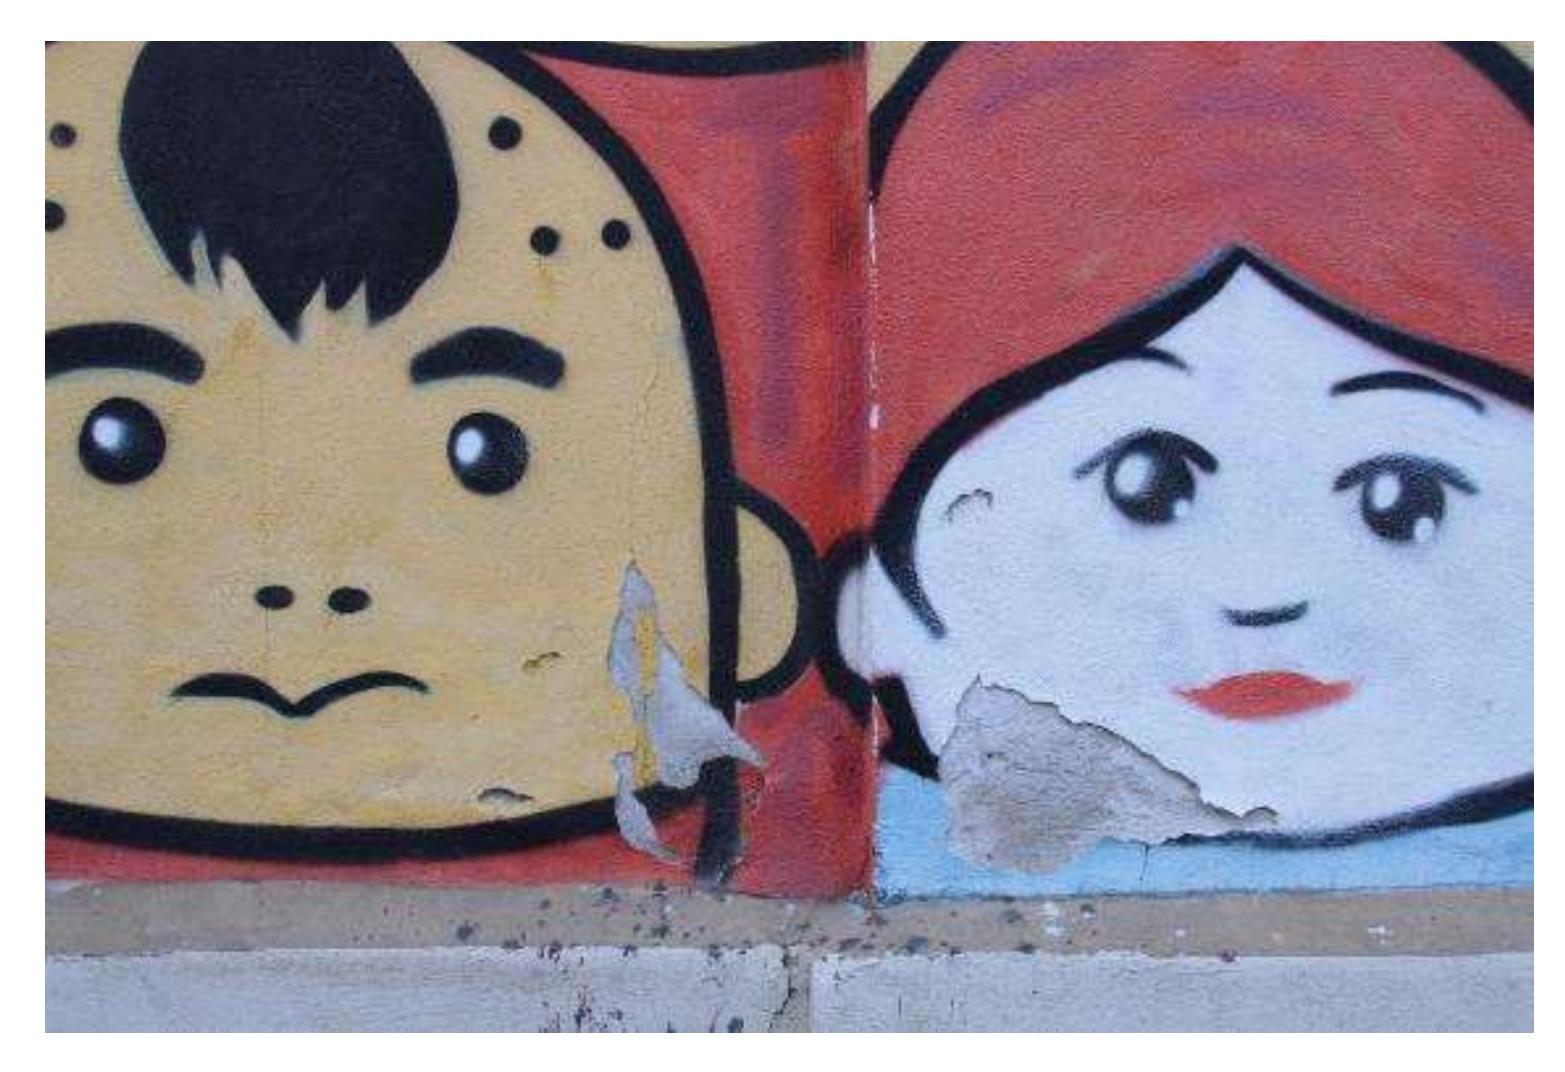
FIG. 3: LOSSES CRACKING AND DELAMINATION ON PAO'S PART. THE WALL SUFFERED OF DECOHESION BEFORE THE PAINTING HAD BEEN REALIZED (SEE COLOR INTO LACUNAS)

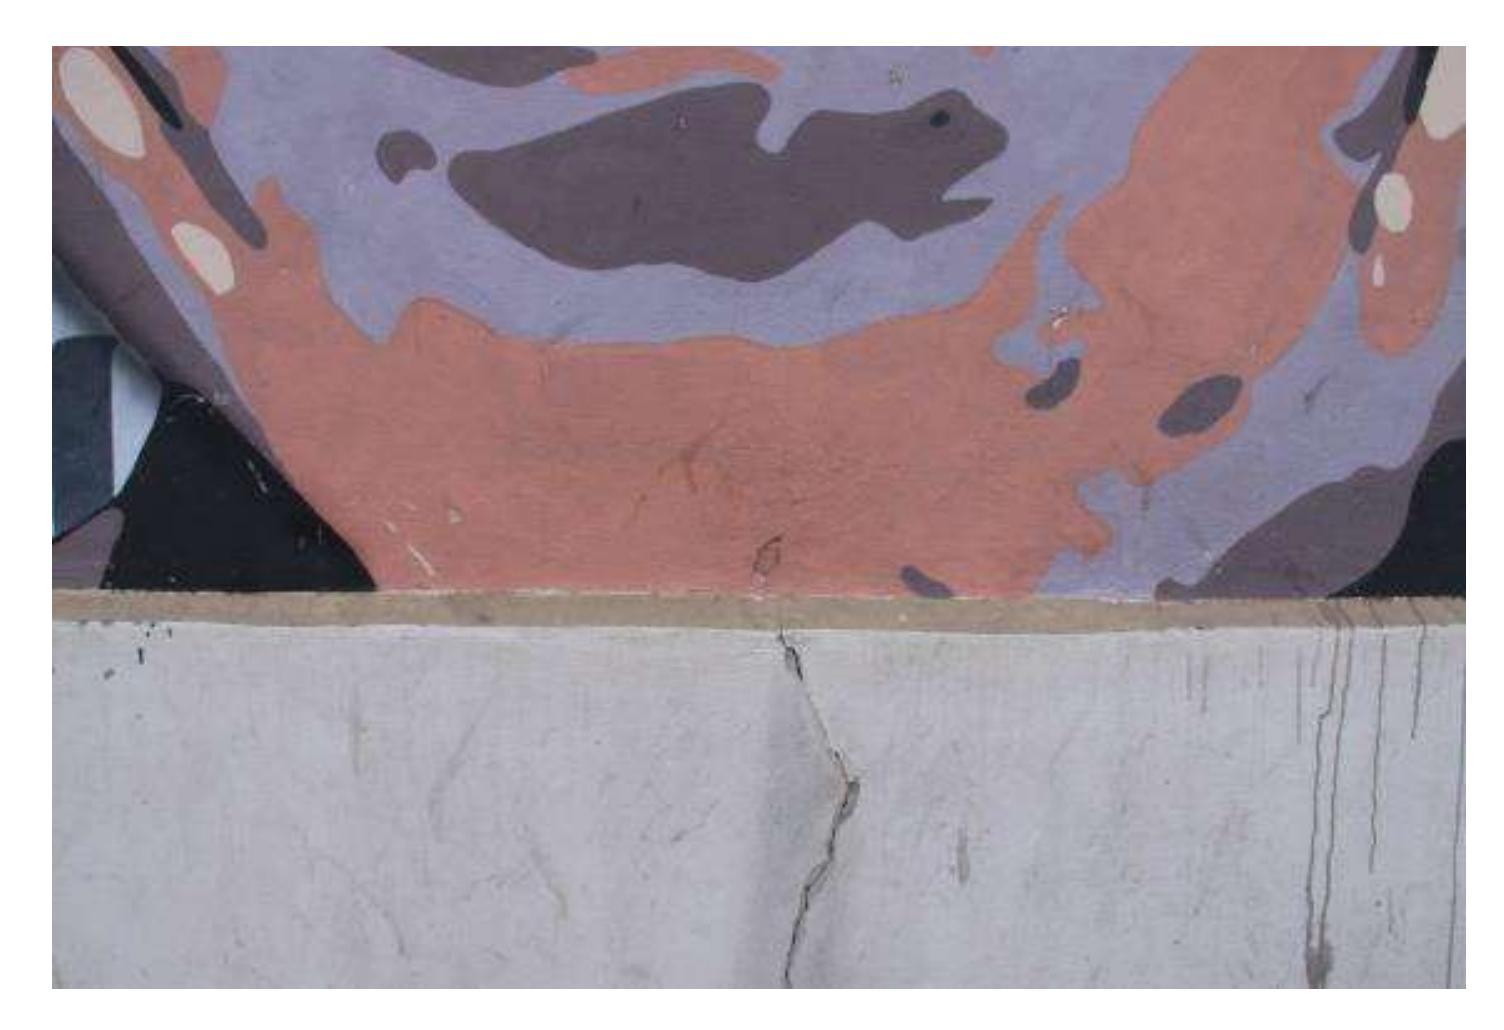
FIG. 4: PARTICULAR OF THE CHROMATIC ALTERATION FROM RED –ORANGE TO GREYSH PURPLE OF ONE OF THE COLORS USED TO MAKE MANDELA'S FACE BY ORTICANOODLE

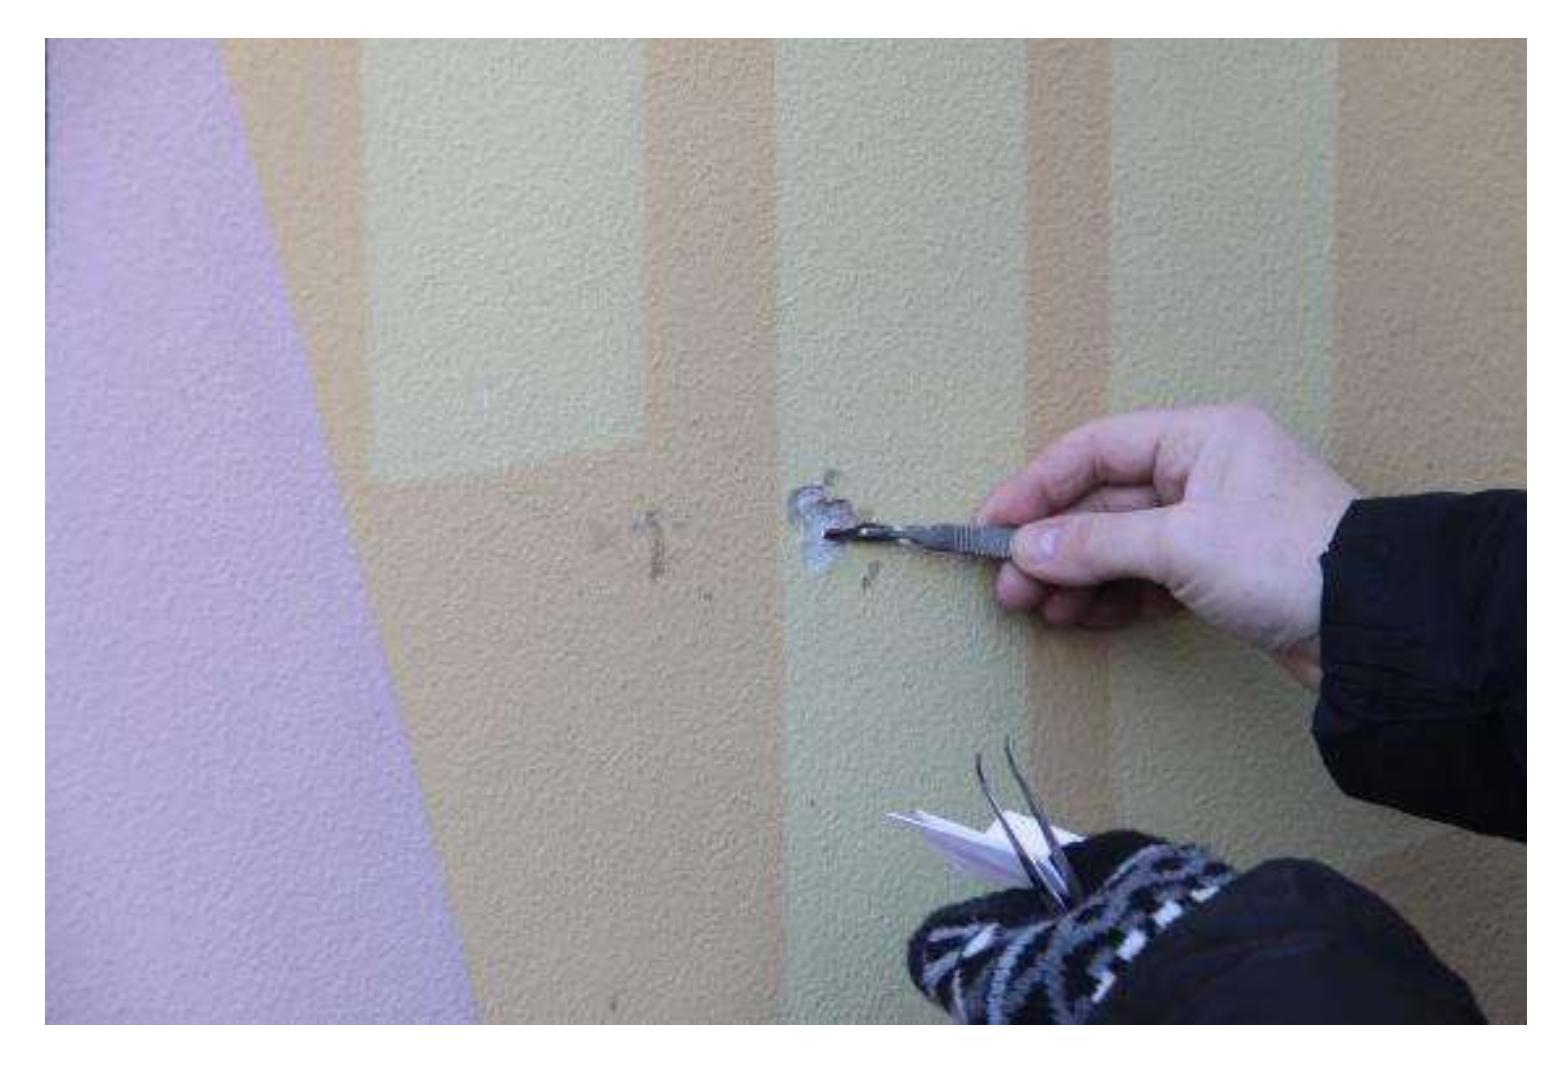
FIG.2 : SMALL LOSSES
