CAPuS PROJECT - CONDITION REPORT

Artist	CORN79, CND, RESER, VESOD, WENS	
Title of the work	No title	
Type of work	Mural	
Materials	Paint, bricks	
Year of execution	2011	
Owner / custodian	Turin Municipality	
Legal protection

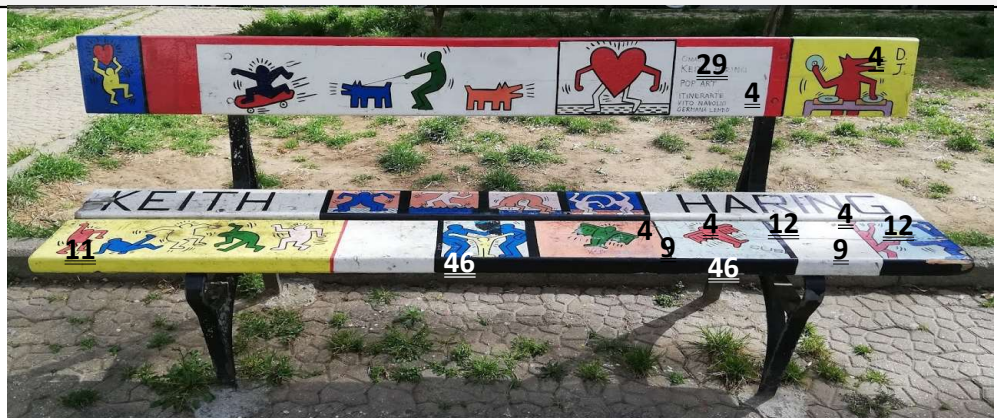
BENCH_2_HARING

- 4 INCISION
- 9 FLAKING
- 11 LOSS
- 12 LACUNA
- 29 FADING
- 46 OVERPAINTING

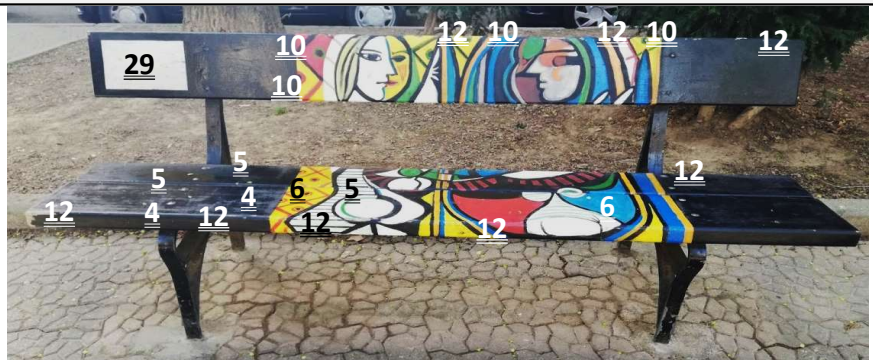
BENCH 4_PICASSO

- 4 INCISION
- 5 FRACTURING
- 6 CRACKING
- 10 SCALING
- 12 LACUNA
- 29 FADING

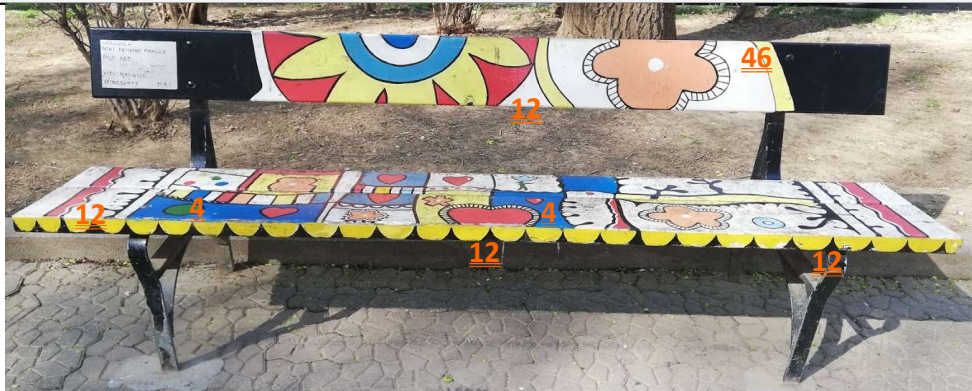
BENCH 8_NIK DE SAINT PHALLE

- 4 INCISION
- 12 LACUNA
- 46 OVERPAINTING

NOTES: An altered superficial film is visible on the surface, it looks a bit yellowed.

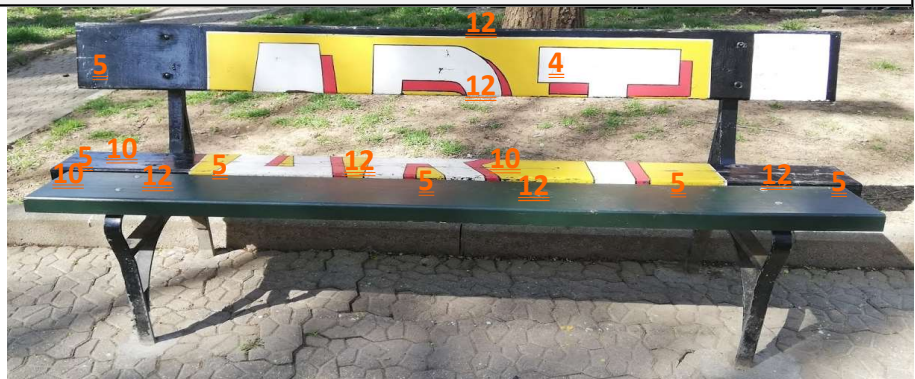
BENCH 10_ROY LICHTESTEIN

- 4 INCISION
- 5 FRACTURING
- 10 SCALING
- 12 LACUNA

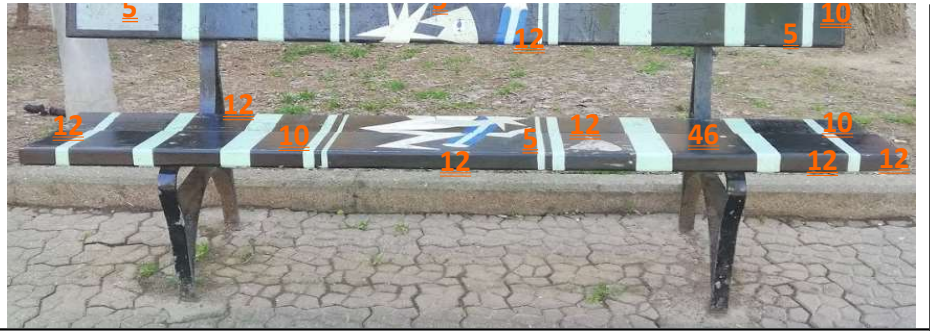
- 5 FRACTURING
- 10 SCALING

12 LACUNA
46 OVERPAINTING

NOTES: al altered film (yellowed) is viible on the whole surface.

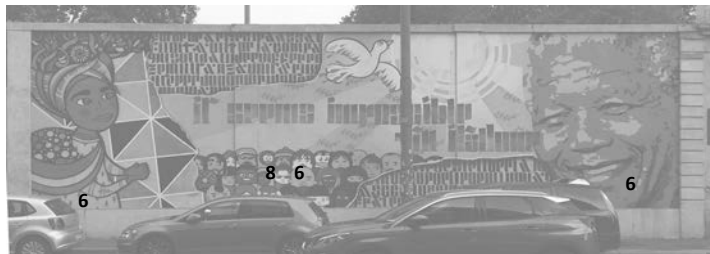
- 1 COLLAPSE
- 2 LOSS OF COHESION
- 3 CRUMBLING
- 4 INCISION
- 5 FRACTURE
- 6 **CRACKING**
- 7 OPEN JOINT
- 8 **DELAMINATION**
- 9 FLAKING
- 10 SCALING

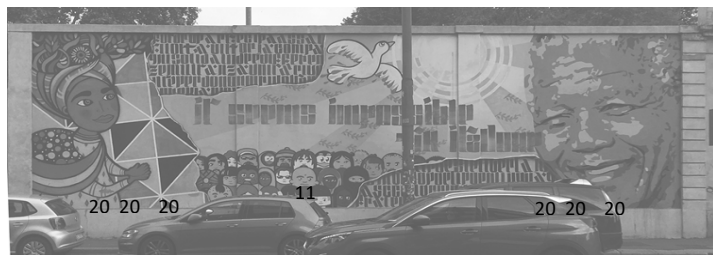
- 11 **LOSS**
- 12 LACUNA
- 13 EROSION
- 14 ABRASION
- 15 ROUNDED/ROUNDING
- 16 PERFORATION
- 17 PITTING
- 18 CAVITY
- 19 ALVEOLIZATION
- 20 **SCRATCH**
- 21 ROUGHENED/ROUGHENING

NOTES THE WALL SUFFERED OF DECOHESION BEFORE THE PAINTING HAD BEEN REALIZED (COLOR INTO LACUNAS)

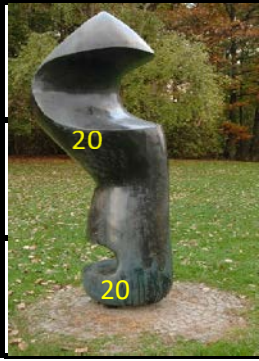
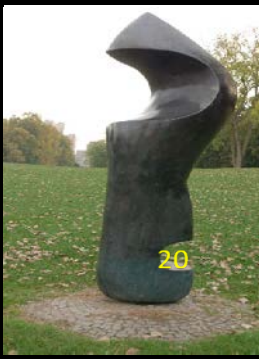
a

- 11 LOSS
- 12 LACUNA
- 13 EROSION
- 14 ABRASION
- 15 ROUNDED/ROUNDING
- 16 PERFORATION
- 17 PITTING
- 18 CAVITY
- 19 ALVEOLIZATION
- 20 SCRATCH
- 21 ROUGHENED/ROUGHENING
