APPENDIX OF GENERAL RAPORT WP3
ANALITICAL RESEARCHES

UNITO – CCR

NUMBER OF PARTNER:	UNITO - CCR
TYPE OF WORK:	Mural (Object 1)
COUNTRY:	Italy
CITY:	Turin
ADDRESS:	Via Ragazzoni
OWNER / CUSTODIAN:	Turin Municipality
ARTIST:	CORN79, CND, RESER, VESOD,WENS
TITLE OF THE WORK:	No title
YEAR OF EXECUTION:	2011
MATERIALS:	Mixed painting on bricks

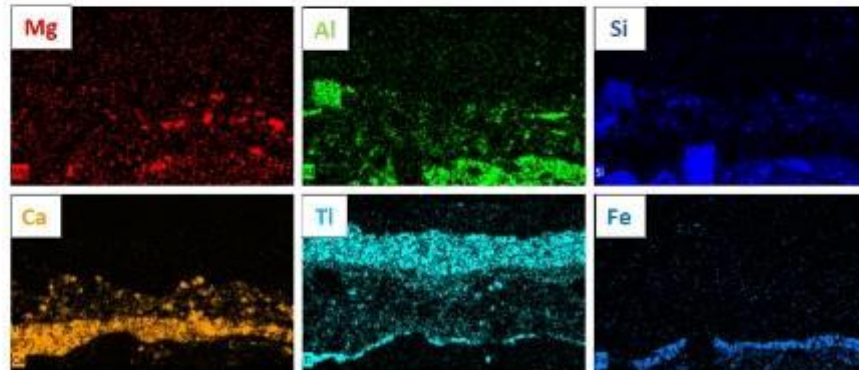
0 – support	Al, Si, K, Mg, Fe, (Na), (Ca)
1 – red	Fe, Si, Ca
2 – white	Ca, Si, Al, Ti
3 – grey	Si, Al, Ca, Ti
4 – red	organic? Ti, (Fe)
5 – yellow	
6 – dark green	
7 – light green	Ti, Na, (Si), (Cl)
8 – dark red	Cl, Ti, (Si), (Al), (Na)
9 – red	Cl, Ti, (Si), (Al)

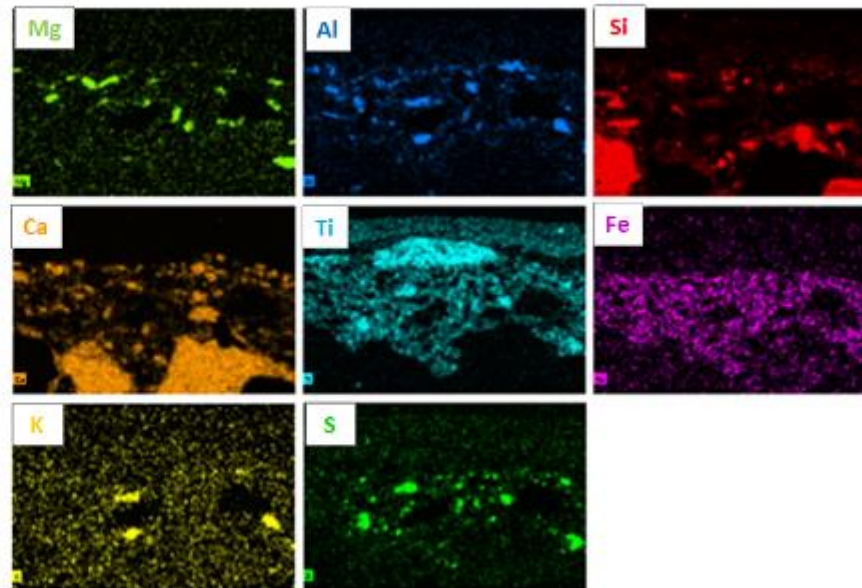
0a - support	Aggregates of Ca, (Mg), (Sr) Aggregates Si, Na, K
0b – support	Ca, Si, Al, Fe, Mg + aggregates of BaSO ₄
1 – blue	Ti, S, Ca, Si, (Al), (Fe)
2 – light blue	Ti, Si, Al, (Ca), (Mg)
3 – light purple	Ti, Si, (Al), (S)
4 – dark purple	Ti, Si, (Al), (S)

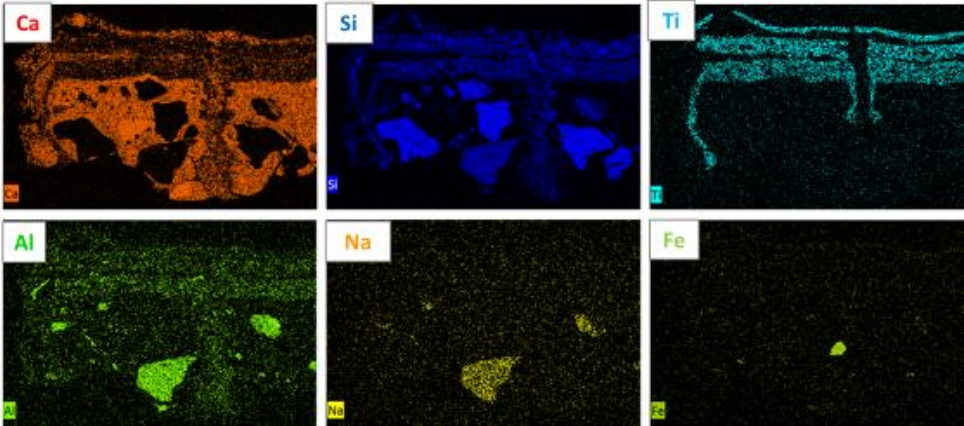
0 – support	Carbonates + and Na, Al, Mg silicate inclusions
1, 2 – yellow	Si, Ti, Ca, (K)
3 – black	Si, Ca, (K), (Mg)
4 – grey	Ti, Si, Ca, Al, Fe

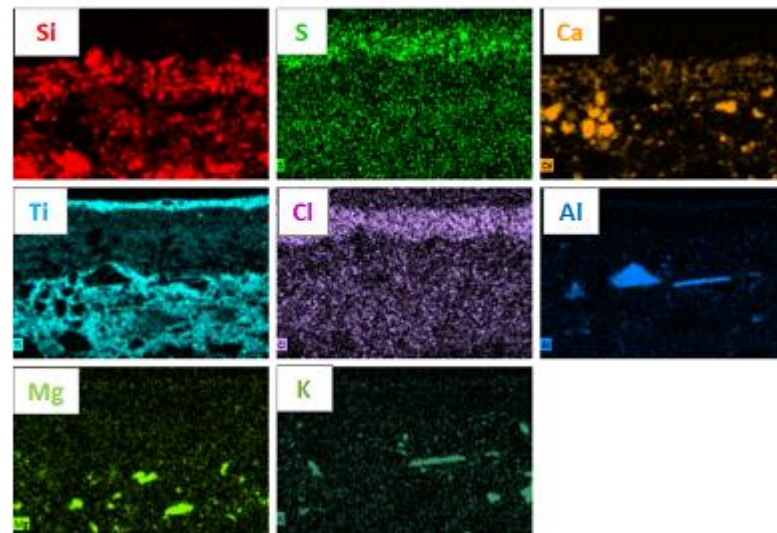
0 – support	Ca, Al, Si, (Ti), (P), (S), (Mg)
1 – green	Si, Ti, Ca, (Al), (Mg), (Cl) + quartz inclusion
2 – white	Si, Ca, Ti, (Al), (Cl)
3 – red	Organic? (Ti), (Cl), (Si) + aggregates of BaSO ₄
4 – white	Ti, (Si), (S), (Al), (Mg), (P), (Cl), (Ca)

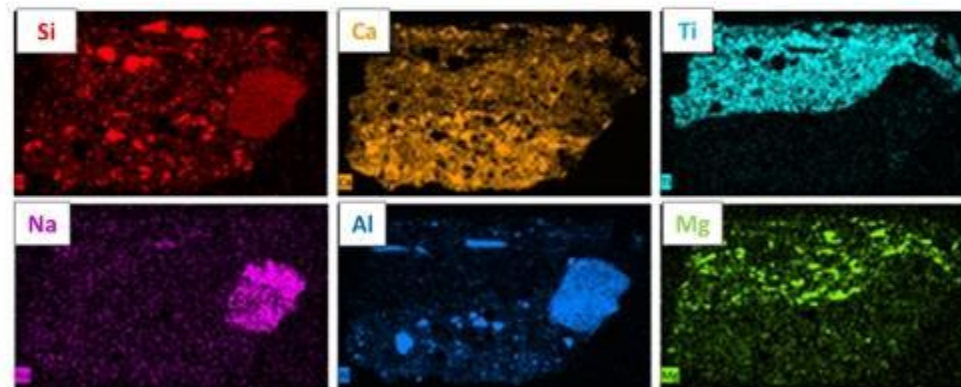
0 – support	Ca, Al, Si, (Na), (S), (Cl) + carbonate aggregates + quartz inclusions + Na,Al-silicate inclusion + Ca-aluminate aggregates
1 – white	Ca, Si, Ti, (Al), (Mg)
2 – pale pink	Si, Ca, Ti, Al, (Mg)
3 – oil green	+ BaSO ₄ aggregates
4 – military green	+ quartz inclusion

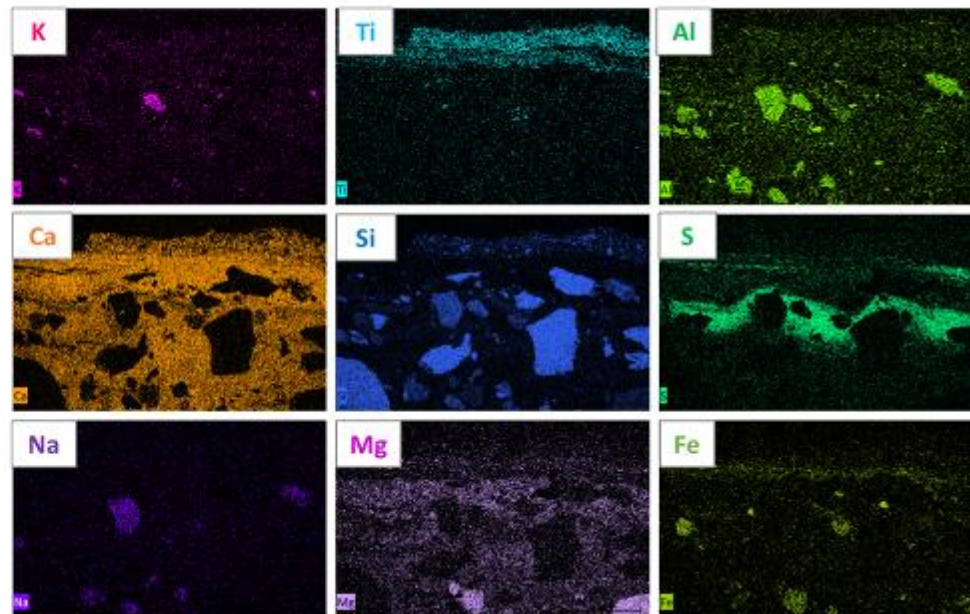
0 – support	Carbonates + quartz and Al,Mg,Fe,K silicates inclusions + gypsum
1 – white	Carbonates + quartz inclusions + barium sulfate inclusions
2 – yellow-brown (3 layers)	Ca, Ti, Fe
3 – yellow	Carbonates + silicates + Ti white
4 – white	Si, Ca, Ti
5 – black	Si, (Ca), (Cu), (Zn)

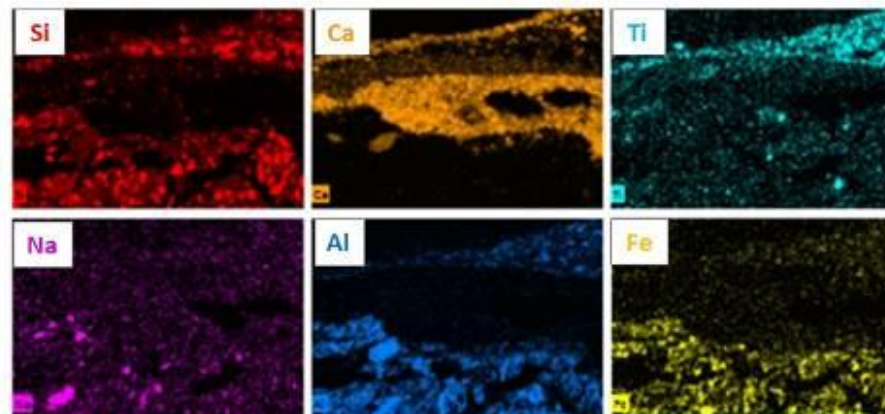
OBJ8_11

0 – support	Si, Al, Fe, (Mg), (Na), (Ti)
1 – yellow	Ca, Si, (Al), (Ti), (Mg), (Fe)
2 – red	organic? Ca, Si, Ti, (Mg), (Al)
3 – light yellow	Si, Al, Ca, Ti, K, (Mg) + quartz inclusions
4 – yellow	Ca, Si, Ti, (Mg), (Bi)

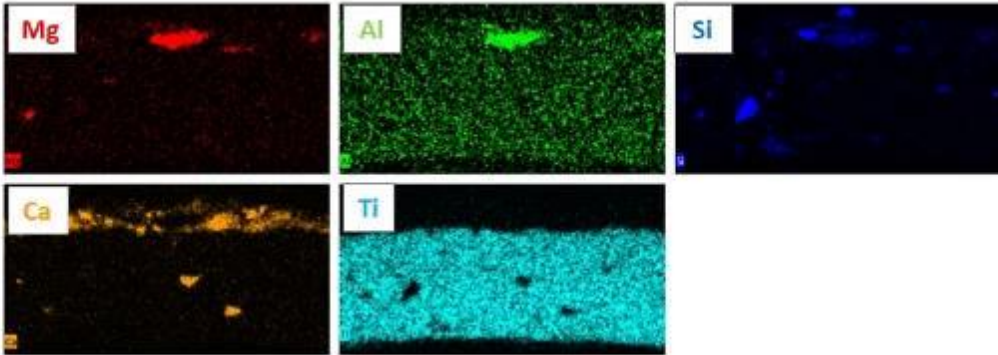
OBJ9_1

1 – white	Ti, (Al), (Si), (Ca) + quartz inclusions + carbonate aggregates + Al-silicate aggregates, with Ca, P
2 – black	Ca, Al, Si, Mg + carbonate aggregates + Mg,Al-silicate aggregates

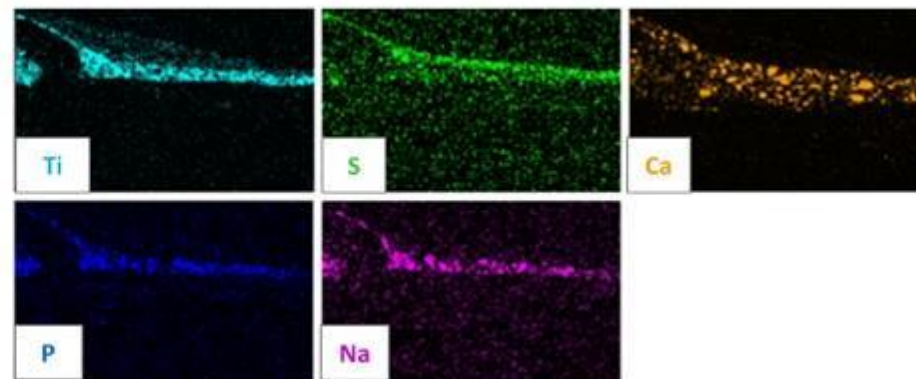
0 – support	wood
1 – green (bench)	Ca, Si, Fe, (Cl)
2 – white	Ti, Ca, Si, P, Al, Na, (Mg), (S)
3 – black	Ba, S, Ca, Mg, (Al)
4 – red	organic? Ti, Cl, (Si)

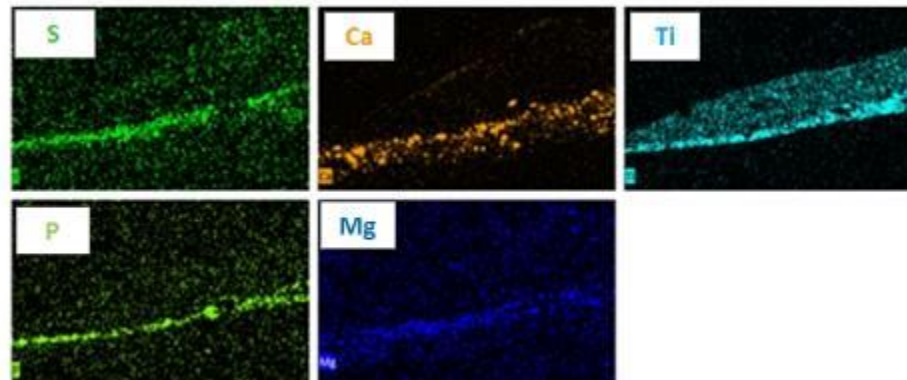
0 – support	wood
1 – green (bench)	Si, Ca, Fe, (Al), (Cl)
2 – white	Ti, Ca, Si, P, Al, Mg, Zn, (S)
3 – black	Ba, S, Si, Mg, (Ca)
4 – blue	organic? Ti
5 – deposit	Si, Al

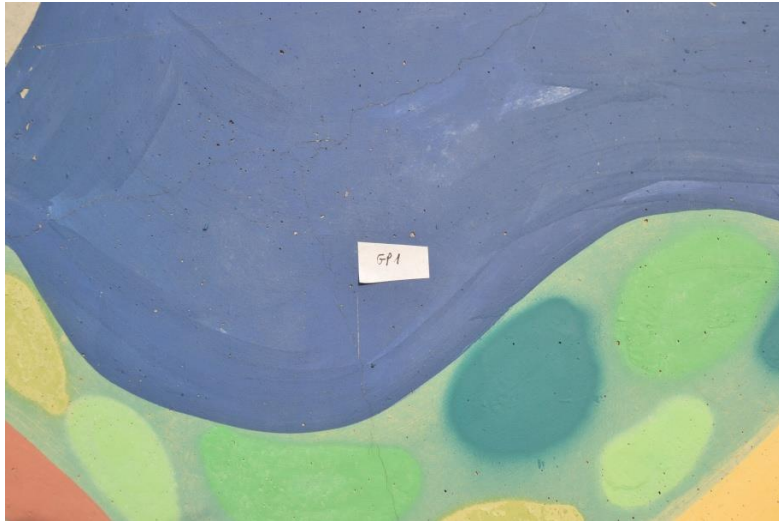
“Two dragons carrying an egg (new creature)” – sample GP1 – before sampling

GP1 sample was collected from a blue area painted by brush (**fig.2**), that hue was originally deeper.

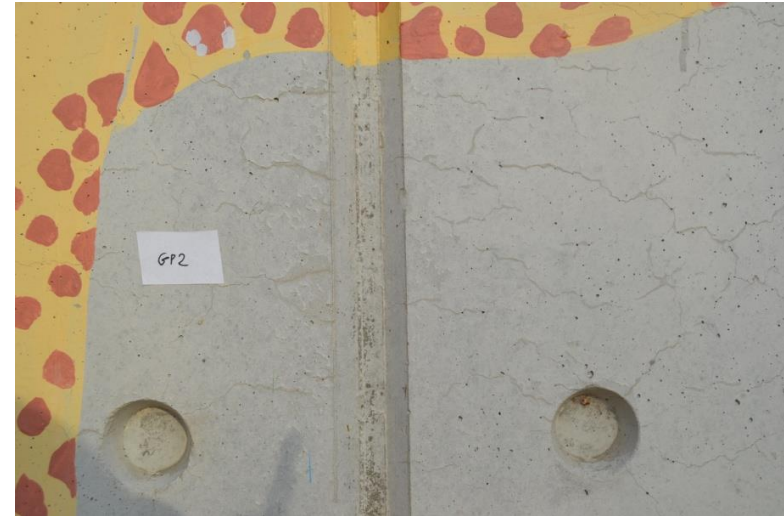
“Two dragons carrying an egg (new creature)” – sample GP2

GP2 was collected from the coating applied by brush/roller on unpainted/painted surface (i.e. *d* layer of the GP1 sample), this whitish and fragile coating is flaking off (**fig.3**). FTIR-ATR spectrum has shown the characteristic absorption of an acrylic emulsion (probably p(*n*BA-MMA) to be confirmed by Py-GC-MS) with likely chalk (**fig.4**) and imaging analyses have allowed to highlight its presence and the bad state of conservation (flaking, cracking) (**fig. 5-6**).

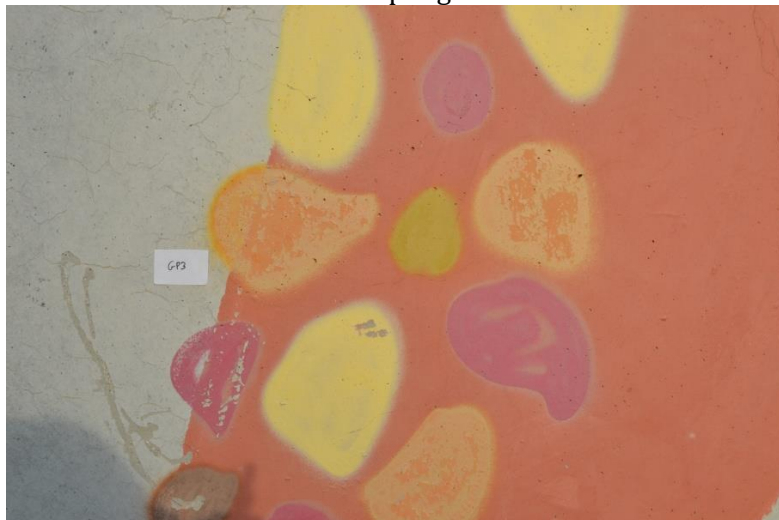
“Two dragons carrying an egg (new creature)” – sample GP3

GP3 was collected from a fragile and flaked pale yellow (yellow-orange former) spray paint layer; it is detaching, together with the coating GP2 (**fig. 7**), from the pink paint layer applied below by brush (**fig. 9**). FTIR-ATR spectra have shown pattern of an acrylic resin for the yellow layer and alkyd-containing resin for the pink layer (**fig.9-10**). This sample has been addressed to Py-GC-MS.

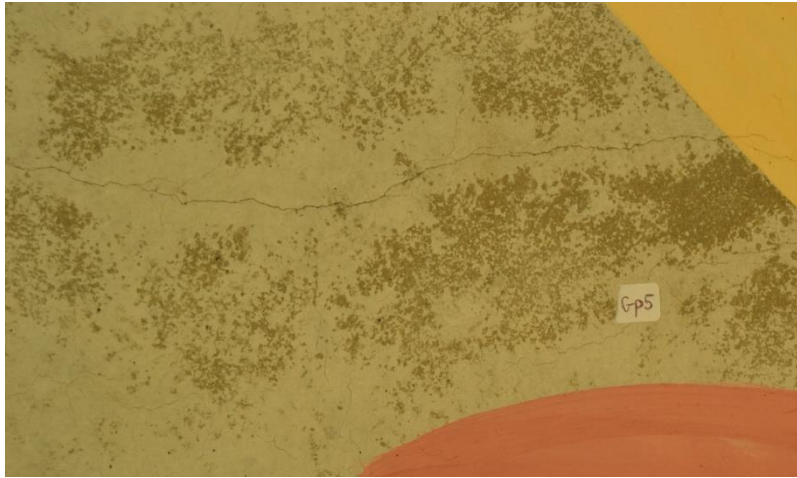
“Two dragons carrying an egg (new creature)” – sample GP5 – before sampling

GP5 was taken several times during the 2019th year from a thin dark grey and compact patina that is spread on not pigmented areas of concrete support following a sort of grid and it is associated with cracks (**fig.2**). Analysis has shown a significant presence of filamentous fungi and yeast, being the black mould *Aureobasidium* the most dominant organism (**fig. 11-14**)

An investigation on concrete preparation techniques has highlighted the use of mineral oil for the detachment of concrete from molds. This procedure leaves in some surface areas dark patinas that could get harder and darker with aging. Probably this organic patina could be subsequently colonised by microorganisms, which enhance the surfaces darkening. In particular some fungal species such as *Aureobasidium*, *Epicoccum*, *Penicillium* and yeast such as *Rhodotorula* are known to effectively degrade mineral or vegetable oil.^{1,2,3,4}

The presence of a biofilm on the surface might contribute to the degradation of the substrate by progressive darkening, water accumulation (and subsequent frost weathering), acidification and leaching.

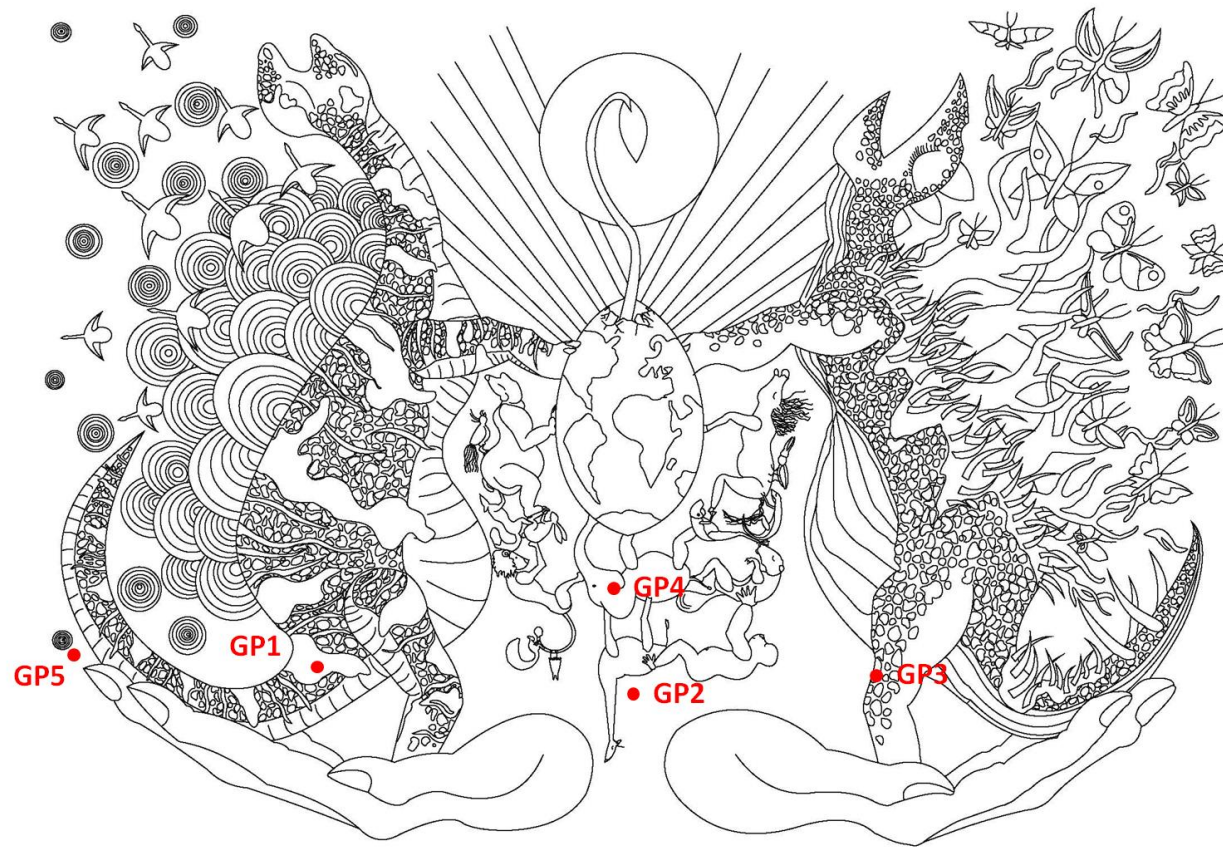
Fig. 2 “Two dragons carrying an egg (new creature)” – sampling location

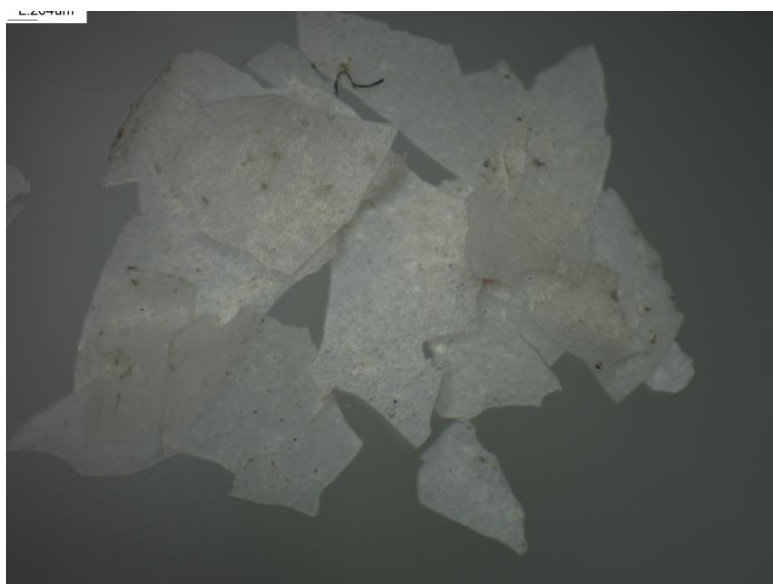
Fig. 3 “Two dragons carrying an egg (new creature)” –GP2 – SM – magnification 20 x

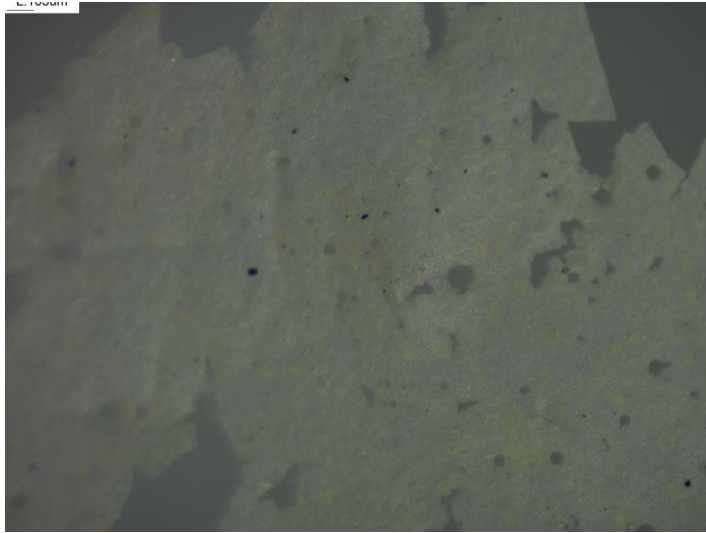
Fig. 7 “Two dragons carrying an egg (new creature)” – sample GP2 – SM – magnification 40 x

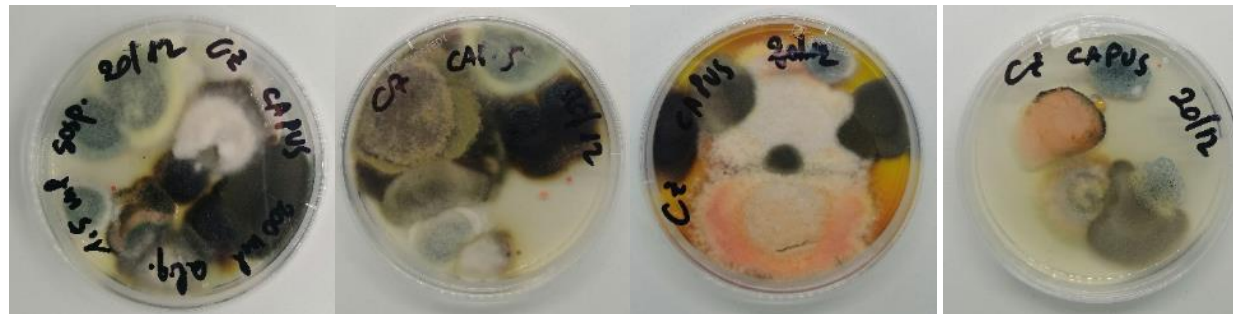
Fig. 13. Total CFU obtained on agar plates form samples collected in December 2019

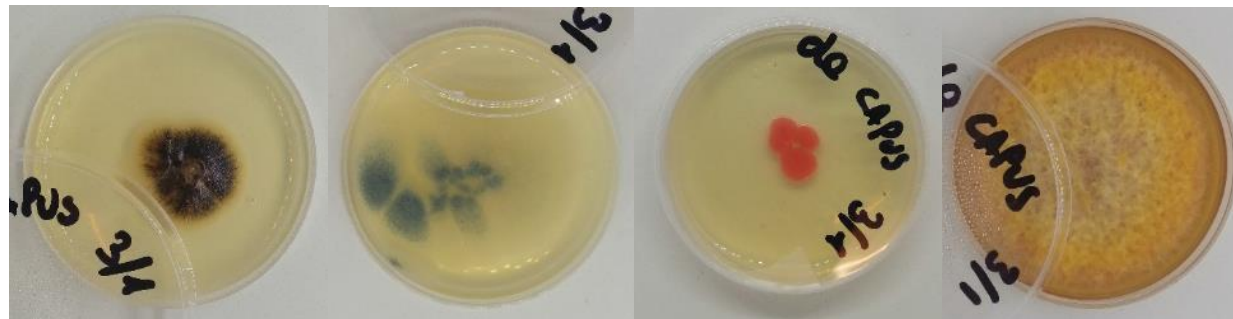
Fig. 14. Co-dominant fungal species isolates (*Aureobasidium*, *Penicillium*, *Rhodotorula*, *Epicoccum*) from samples collected in December 2019

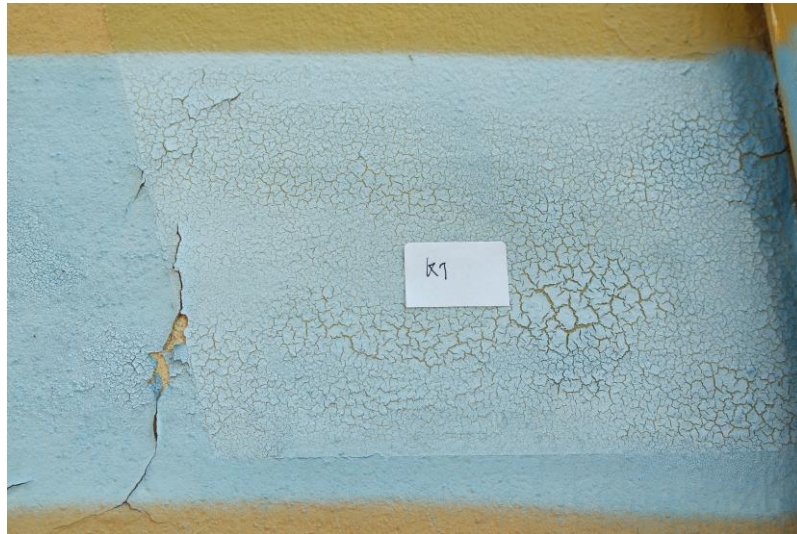
Fig. 1 “ Big Sacral Bird ” – sample K1 – before sampling

K1 sample was collected from a light blue area (spray paint) (**fig.1-5**) affected by cracking and fading, it was originally darker.

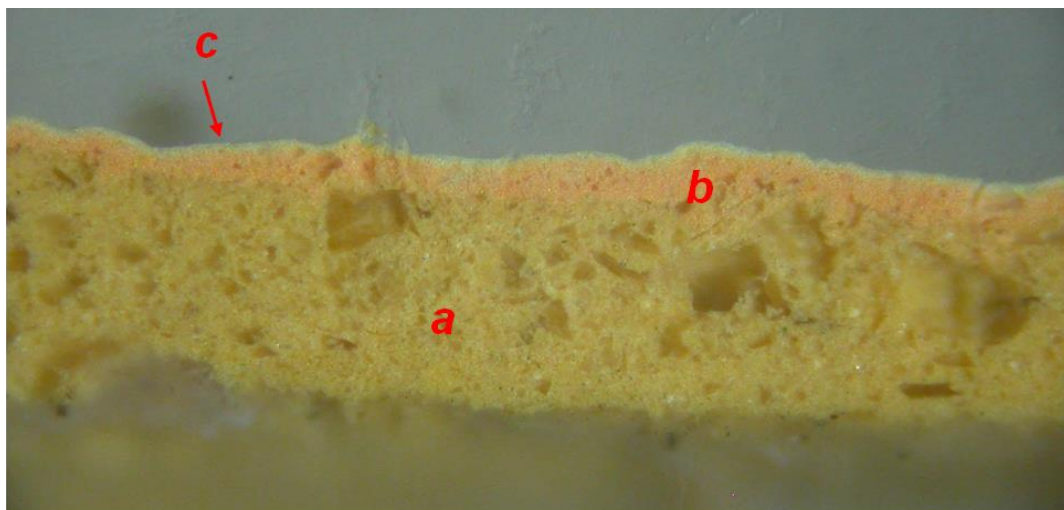
K2 sample was collected along a crack of a pale yellow area (spray paint) (**fig.4,6-8**) that was originally light orange.

- a)** Yellowish ground layer, regular feature and thickness (about 120 μm), containing Calcite, Goethite and Rutile.
- b)** Pale orange paint layer containing red pigment PO34 Diazopyrazolone and yellow pigment PY74 acetoacetic arylide with Rutile. Regular feature, average thickness of 30 μm ; this paint layer has been addressed to Py-GC-MS.
- c)** Pale yellow thin layer (patina) mainly composed of Rutile and alkyd resin probably styrene-modified for the peak of aromatic C-H stretching (**fig. 9**).

Fig. 6 “Big sacral birds” – sample K2 – cross section – reflected Visible light – magnification 180x

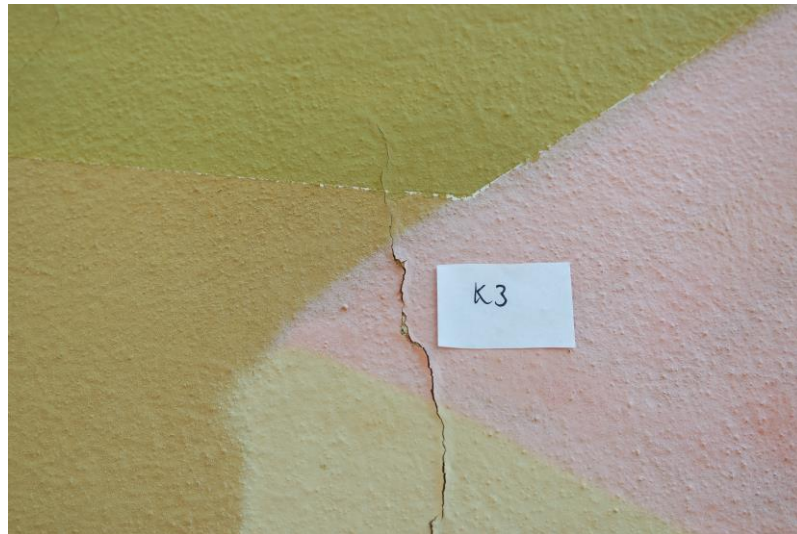
Fig. 10 “Big Sacral Bird” – sample K3 – after sampling

K3 sample was collected along a crack of a pink area (spray paint) (**fig.4,10-11**) that was originally orange.

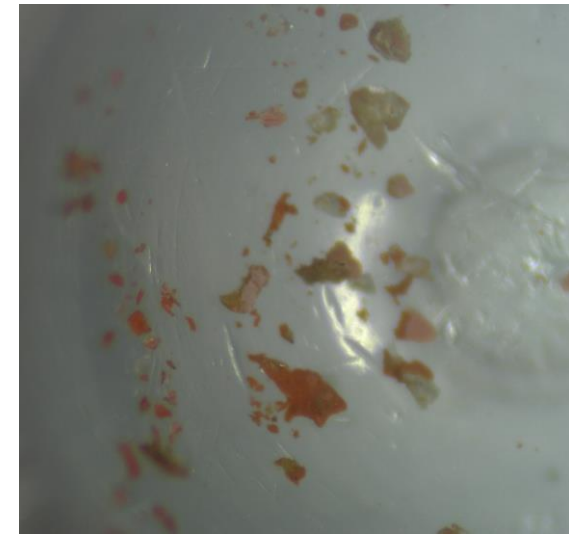
Fig. 11 “Big Sacral Bird” – sample K3 – SM – magnification 45 x

- a)** Yellowish ground layer;
- b)** Orange paint layer;
- c)** Pink thin layer (patina) mainly composed of alkyd resin (**fig. 12**). This paint layer has been addressed to Py-GC-MS.

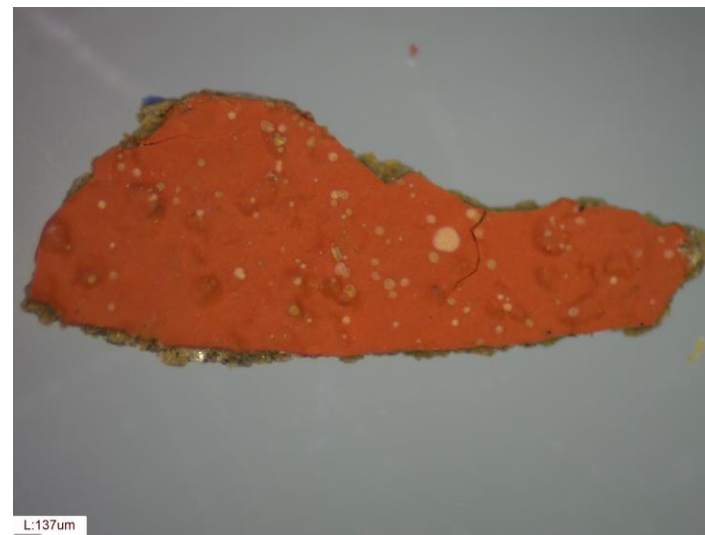
Fig. 14 “ Big Sacral Bird ” – sample K4 – SM – magnification 30 x

K4 sample was collected along a crack of an orange area (spray paint) (fig.4,13-14) that was originally lighter.

- a) Yellowish ground layer;
- b) Orange paint layer with a glossy whitish superficial patina, containing an alkyd resin modified with nitrocellulose, an acetoacetic arylide based pigment (PY74) plus likely goethite (fig. 15). Differences between FTIR spectra collected on the top of the sample and on the inner part have been observed. This paint layer has been addressed to Py-GC-MS.

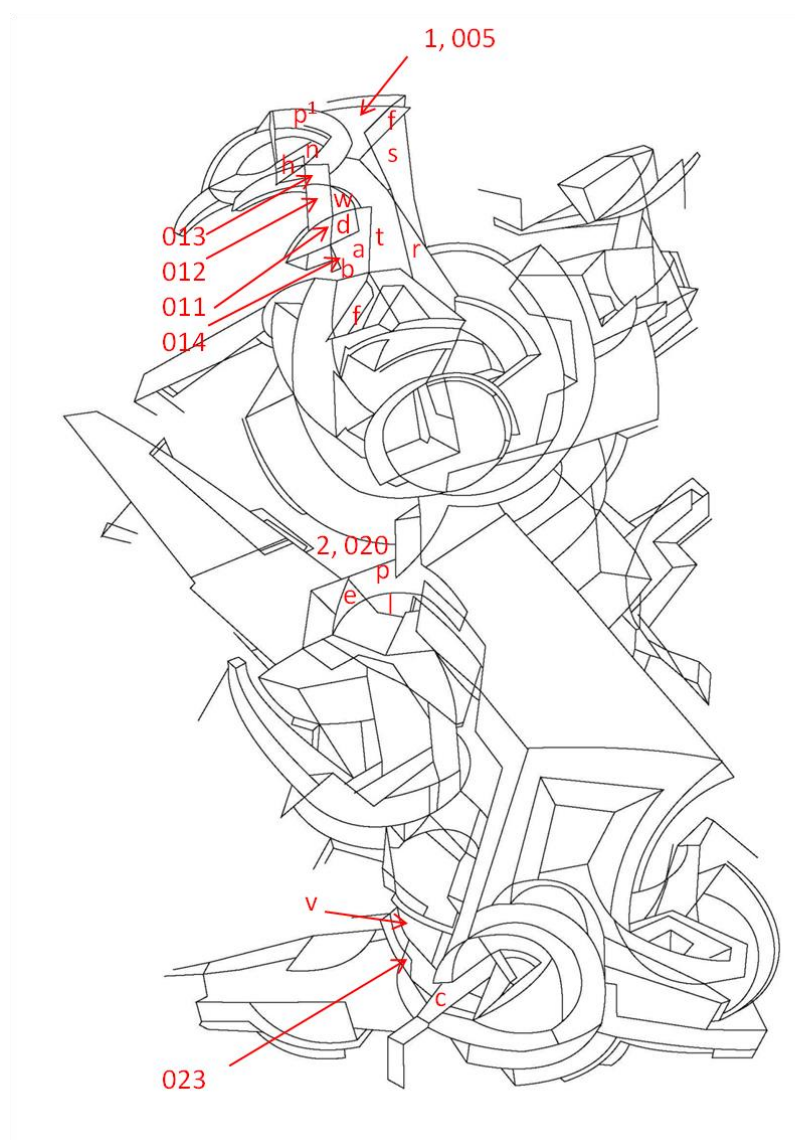
Fig. 16 “ Big Sacral Bird ”– measurement point location

- a. Light orange > pale yellow
- b. Orange > pink
- c. Orange > dark orange (K4)
- d. Orange-red > brown
- e. Orange-red > light purple
- f. Red > light Red (023)
- h. Light pink > white
- l. Salmon pink > whitish color
- n. Pink > white
- p. Orange > pink
- p¹. light violet > dark violet
- r. Purple > violet
- s. Pale yellow > whitish color
- t. Lemon yellow > pale yellow
- v. Gold yellow > light brown (022) ?
- w. Green > greenish color
- 1. Water Green stable color (005)
- 2. Military Green stable color (020)
- 011. Water blue stable color
- 012. Light blue stable color
- 013. Light purple stable color
- 014. Deep blue stable color

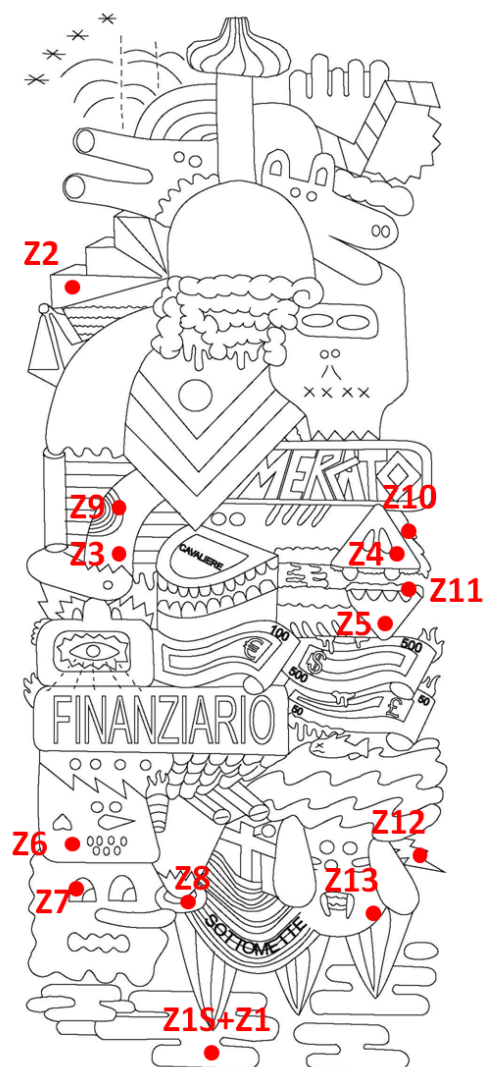
Fig. 3 “ IL MERCATO TI SOTTOMETTE ” – sampling location

Z1S + Z1 turquoise> light turquoise - fading

Z13 orange > light orange – fading

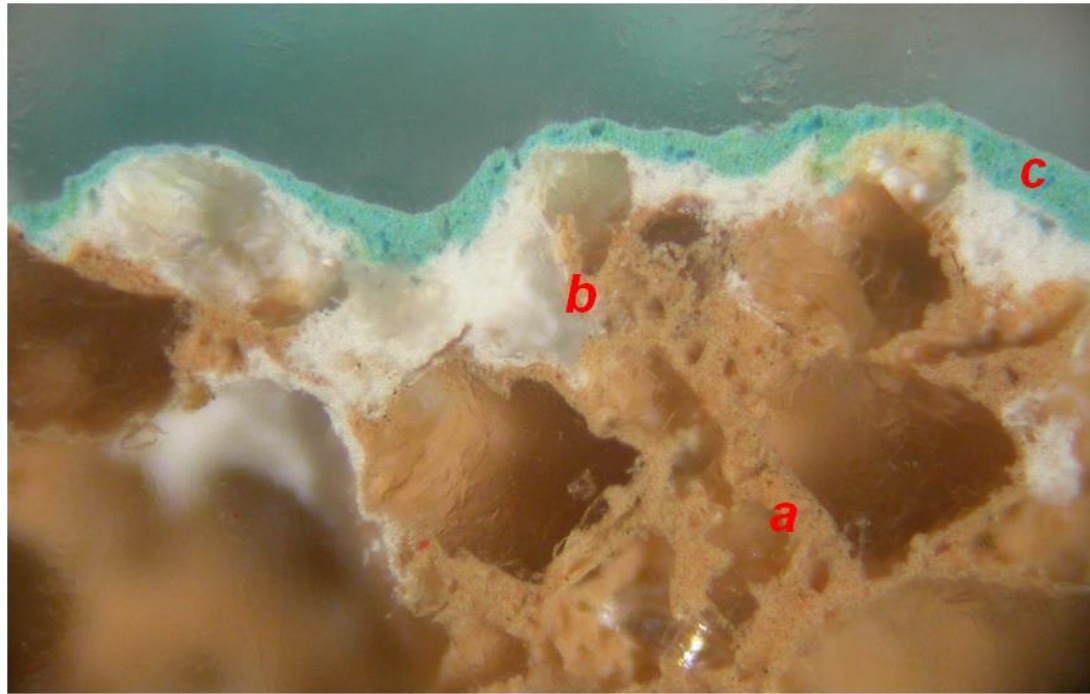
Fig.4 “IL MERCATO TI SOTTOMETTE” – sample Z1S – cross section – reflected Visible light – magnification 200 x

- a) Brown ground layer > 700 μm thick containing Quartz grains and a styrene-acrylic polymer;
- b) White paint layer (prime coating) filling up the roughness of the layer a., irregular thickness under of 30 μm , composed of Rutile and Calcite; this paint layer has been addressed to Py-GC-MS.
- c) Turquoise paint layer containing a mixture of a blue phtalocyanine pigment and yellow azo PY74 based pigment, Calcite and Rutile. Regular feature, average thickness of 30 μm ;
- d) Whitish layer (patina) is hypothesized, it is too thin to be observed under microscope and measured.

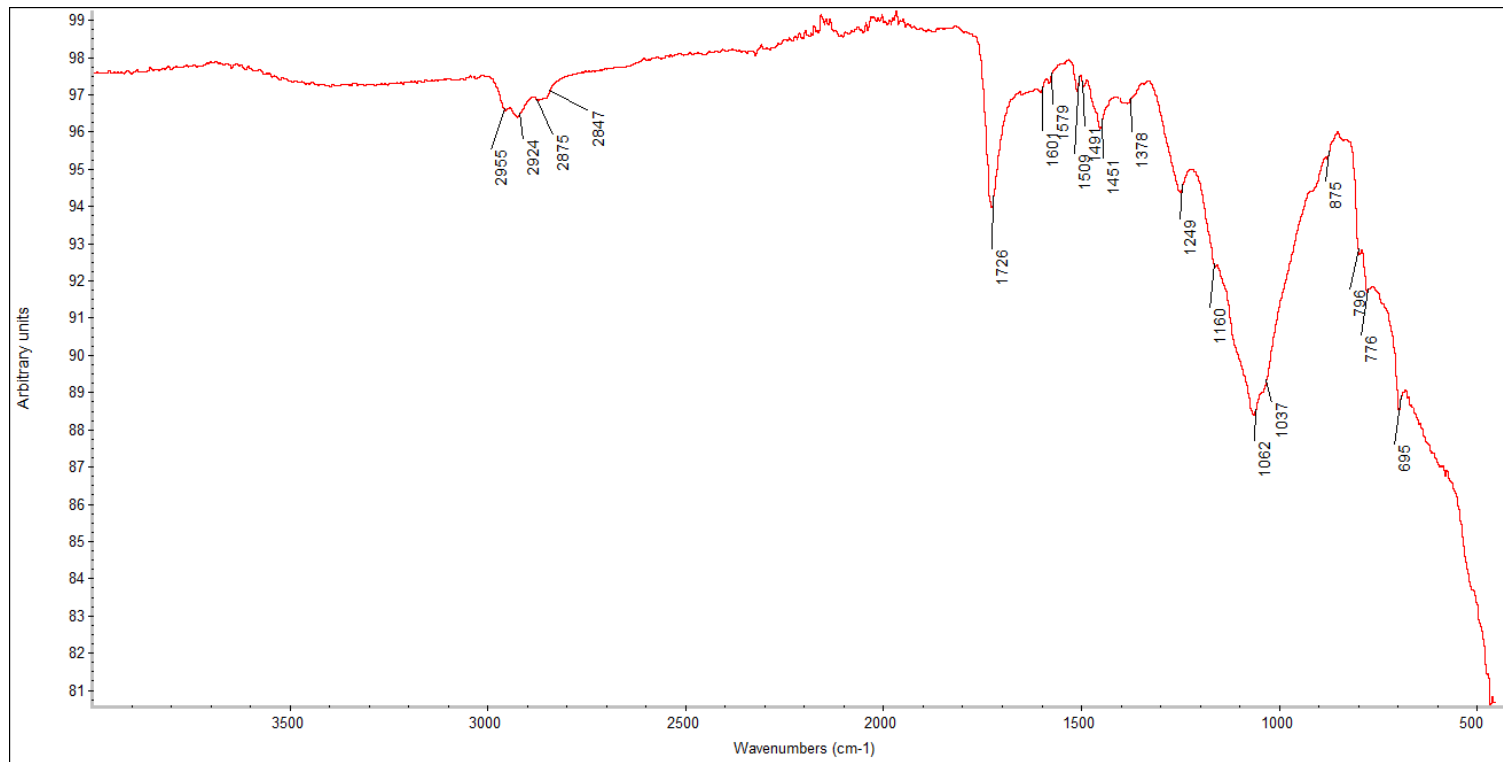
Fig.7 "IL MERCATO TI SOTTOMETTE" – sample Z1S – FTIR-ATR spectrum of the turquoise surface

The FTIR-ATR spectra of the turquoise surface have likely shown the presence of an alkyd resin (**fig. 7**). This paint layer has been addressed to Py-GC-MS.

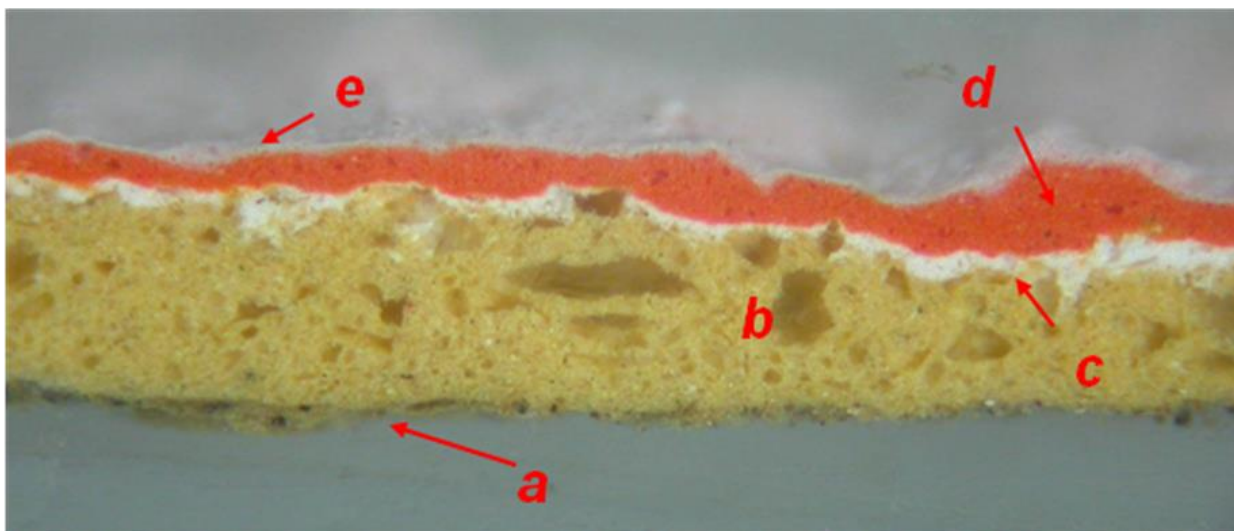
Fig. 1 “Oriental carpet of colors” – sample H1 – cross section – reflected Visible light –OM – magnification 150 x

- e)* Traces of the plaster ground layer;
- f)* Yellowish ground layer, regular feature and thickness (about 130 μm).
The FTIR-ATR spectra collected on *a+b* layers have shown: Calcite, silicates, traces of an acrylic-resin based;
- g)* White paint layer (prime coating) composed of Rutile, Calcite, silicates, likely acrylic based resin, regular feature and irregular thickness, average thickness of 20 μm ;
- h)* Orange paint layer due to PO34 – Diazopyrazolone and containing alkyd resin (**fig. 4**) with likely low amount of styrene, Calcite and Rutile. Regular feature, average thickness of 40 μm ;
- i)* Whitish thin (< 10 μm) layer (patina), same composition of the layer *d*, with less quantities of alkyd resin (**fig. 5**).

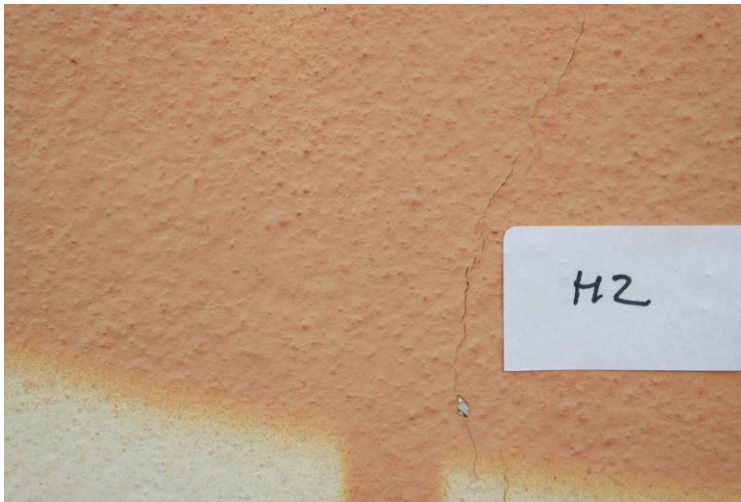
Fig. 6 “Oriental carpet of colors” – sample H2 – after sampling

H2 sample was collected from a salmon pink area painted by spray (**fig.3,6-7**) that was originally orange/red.

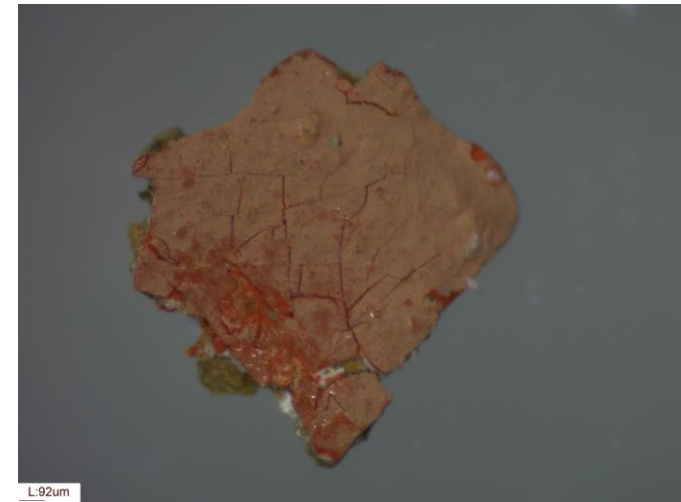
Fig. 7 “Oriental carpet of colors” – sample H2 with the patina partially scraped by scalpel– SM – magnification 45 x

- a)* Traces of the plaster ground layer;
- b)* Yellowish ground layer;
- c)* White paint layer (prime coating);
- d)* Orange paint layer containing an alkyd resin (**fig. 8**);
- e)* Whitish thin and fragile layer (patina) (**fig. 7**) due to optical alteration of the layer *d*. Same composition of the layer *d*, with minor quantities of resin.

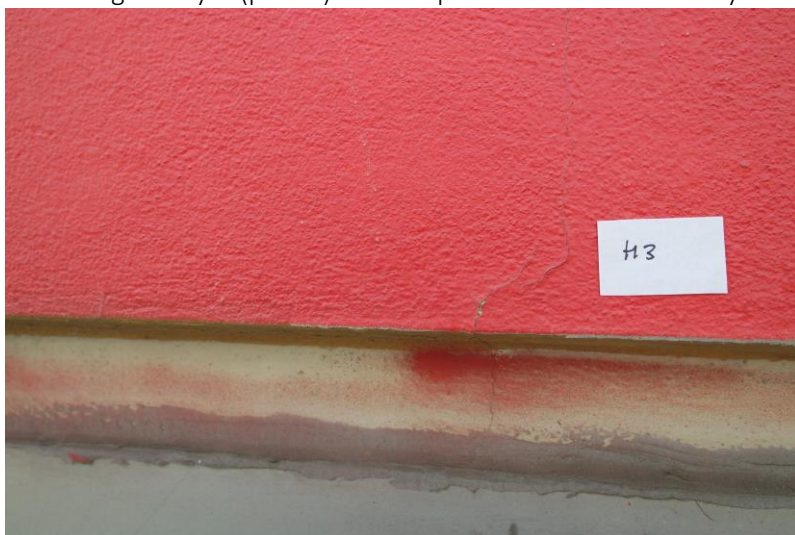
Fig. 9 “Oriental carpet of colors” – sample H3– after sampling

H3 sample was collected from a red area painted by spray (**fig.3,9**) apparently not optically altered.

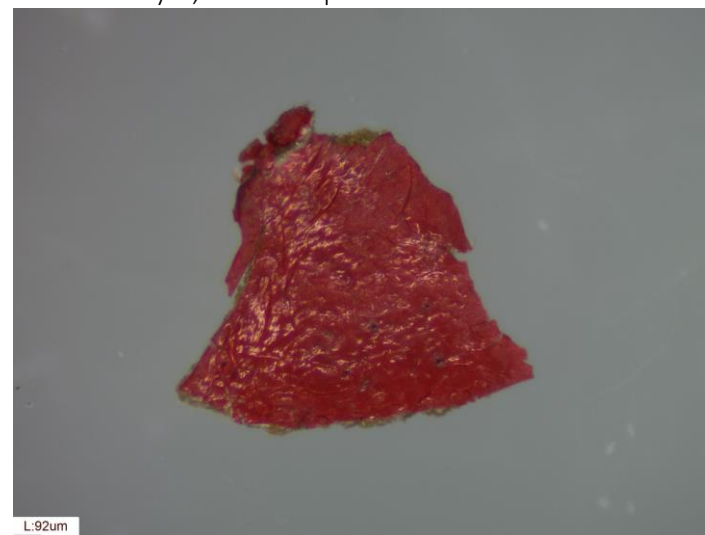
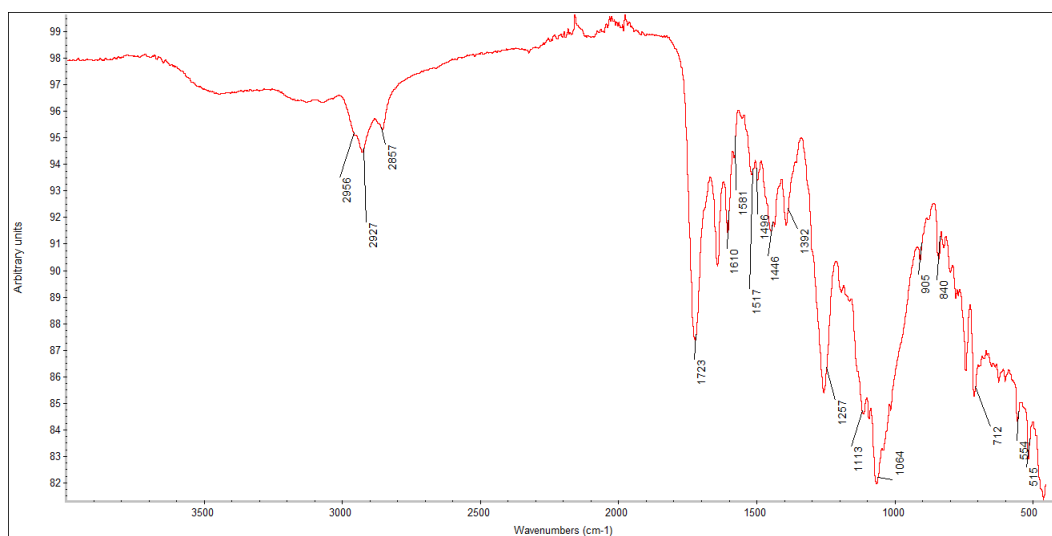
- a)** Traces of the plaster ground layer;
- b)** Yellowish ground layer;
- c)** White paint layer (prime coating);
- d)** Red paint layer containing an alkyd resin (**fig. 10-11**) Rutile and Polycyclic p., diketopyrrolo-pyrrole (DPP), PR254;
- e)** Whitish thin and semigloss layer (patina) due to optical alteration of the layer *d*. About the same FTIR pattern of *d* layer, with less quantities of resin.

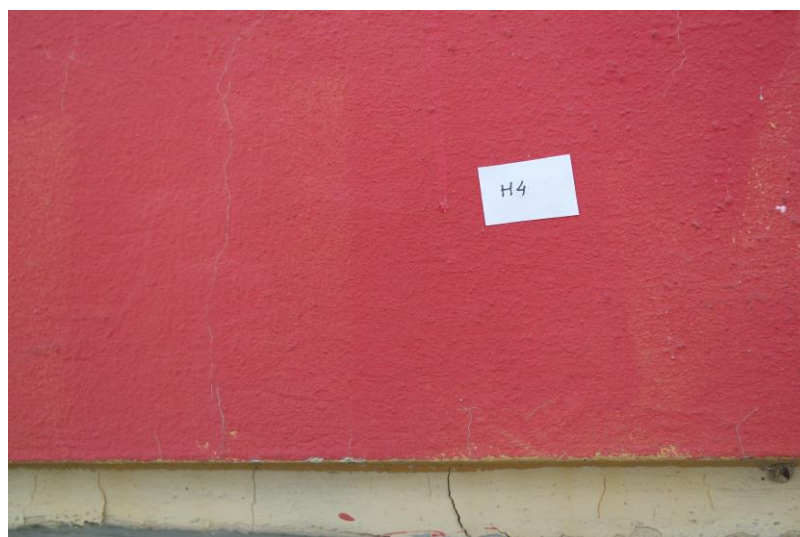
Fig. 12 “Oriental carpet of colors” – sample H4– after sampling

H4 sample was collected from a red area painted by roller (**fig.3,12**). The surface of the paint layer appears slightly darker, less porous and glossier than the inner (**fig. 13**); it is composed of an acrylic binder (**fig. 14**), Calcite as extender, the pigment has not been identified.

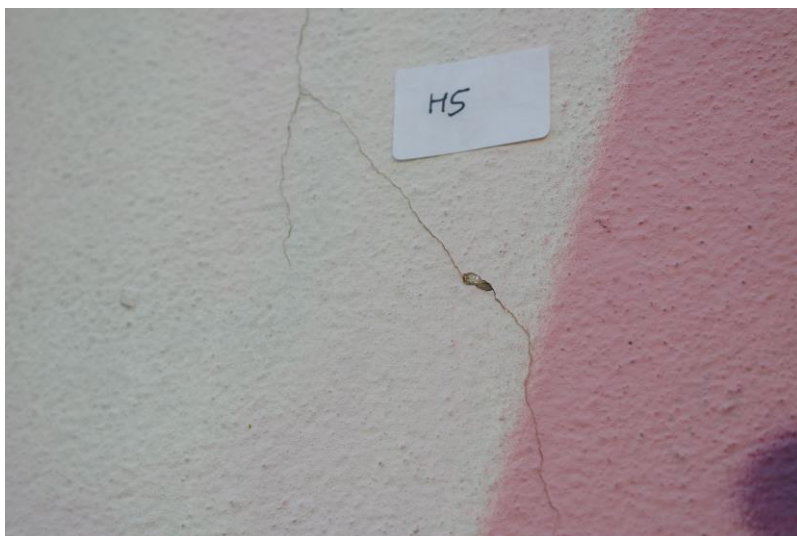
Fig. 15 “Oriental carpet of colors” – sample H5 – after sampling

H5 sample was collected from a white area painted by spray (**fig.3,15-16**) that was originally pink.

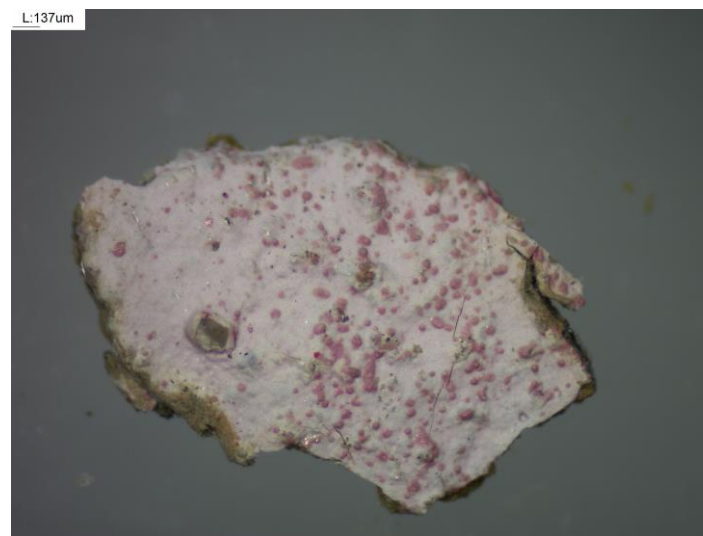
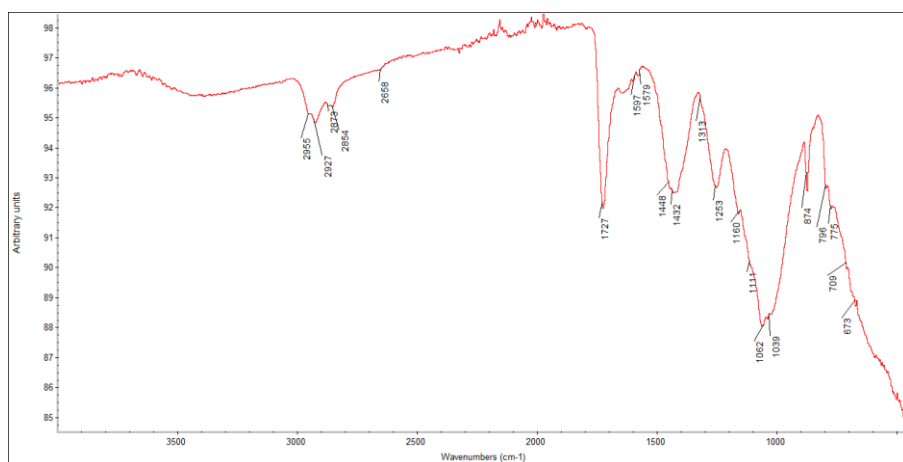
- a)** Traces of the plaster ground layer;
- b)** Yellowish ground layer, 120 μm thick;
- c)** White paint layer (prime coating), 15-50 μm thick;
- d)** Pink paint layer, 4-25 μm thick, containing alkyd resin as a binder and Calcite as extender (**fig. 17**);
- e)** White thin (about 15 μm) layer (**fig. 16**) due to optical alteration of the layer *d*. Same composition of the layer *d*, with minor quantities of resin. Raman spectra have shown peaks of Rutile, and probably disazopigment, pyrazolone PO34. The paint layers *d* and *e* have been addressed to Py-GC-MS.

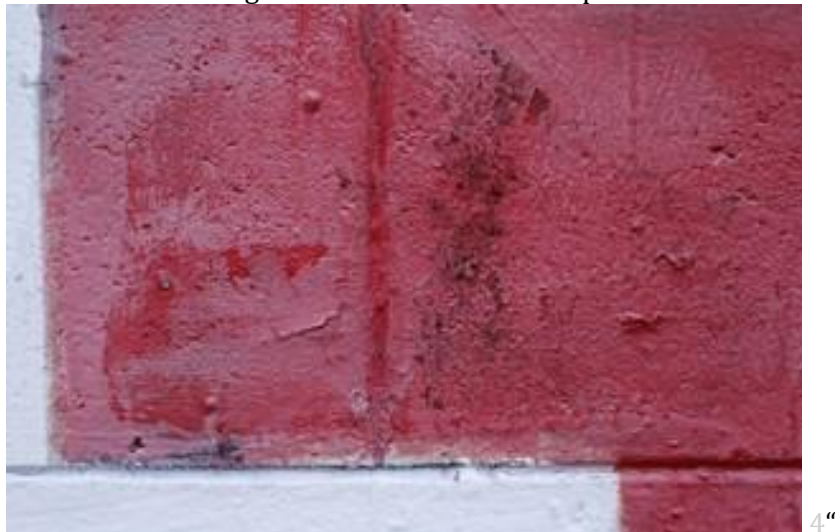
"Niguarda Antifascista" – sample 3

Sample 3 was collected from a deteriorated red area painted by brush (**fig.1**); it is not original.

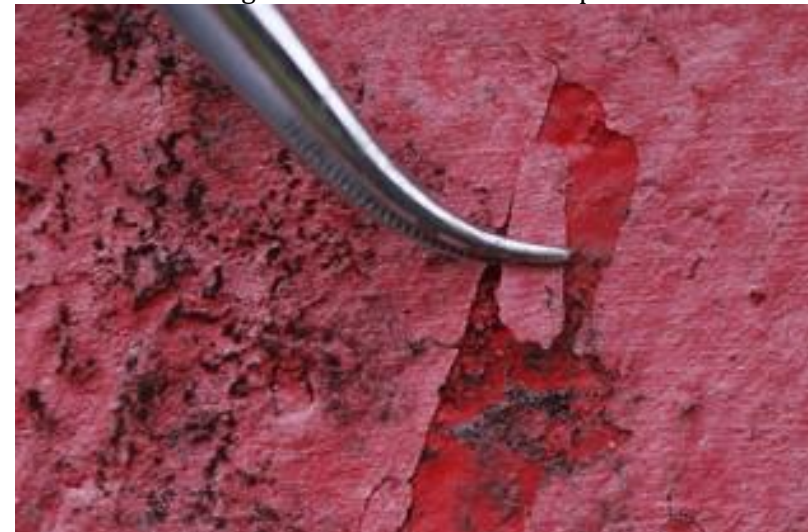
"Niguarda Antifascista" – sample 4

Sample 4 was collected from a biodeteriorated red area painted by brush (**fig.1**); it is not original.

The sample is similar to sample 3 with dark bio patina (**fig.6**).
