APPENDIX OF GENERAL RAPORT WP3
ANALITICAL RESEARCHES

UNITO – CCR

NUMBER OF PARTNER:	UNITO - CCR
TYPE OF WORK:	Mural (Object 1)
COUNTRY:	Italy
CITY:	Turin
ADDRESS:	Via Ragazzoni
OWNER / CUSTODIAN:	Turin Municipality
ARTIST:	CORN79, CND, RESER, VESOD,WENS
TITLE OF THE WORK:	No title
YEAR OF EXECUTION:	2011
MATERIALS:	Mixed painting on bricks

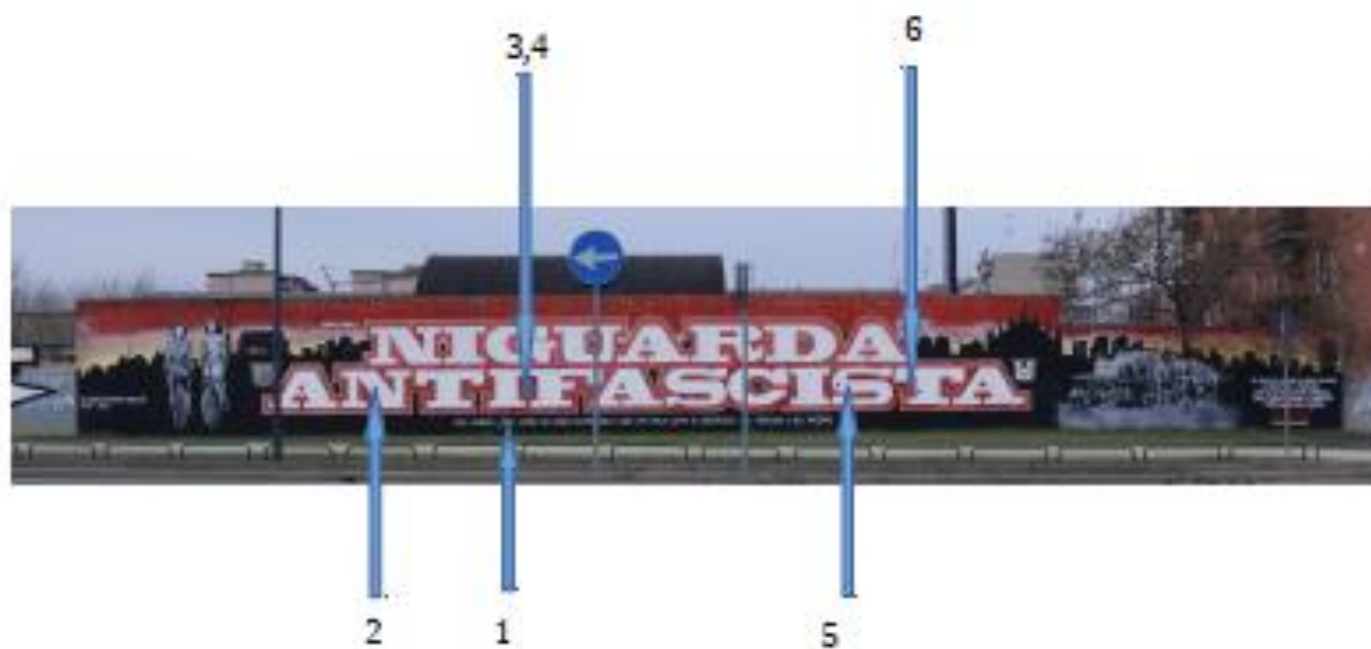
Fig. 1 “ Niguarda Antifascista ” – sampling location

Sample 3 was collected from a deteriorated red area painted by brush (**fig.1**); it is not original.

Sample 4 was collected from a biodeteriorated red area painted by brush (**fig.1**); it is not original.

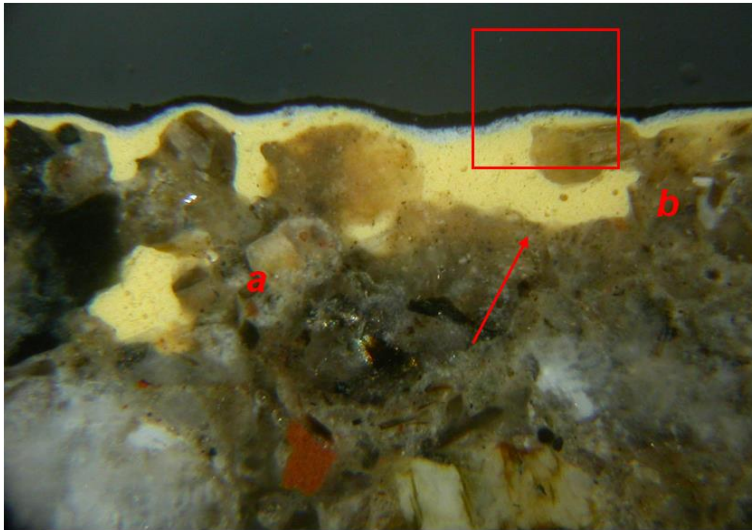
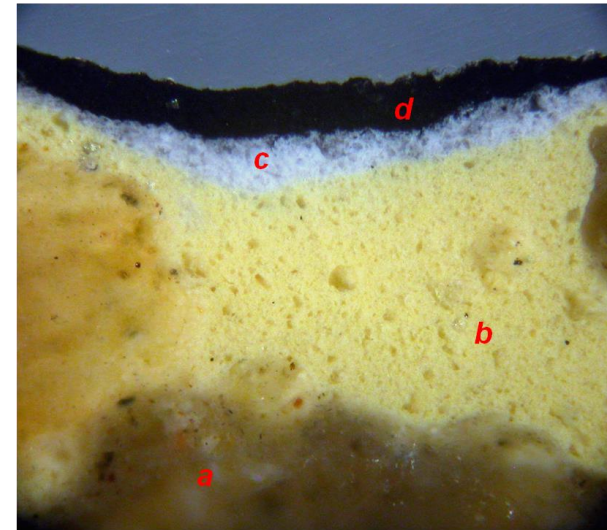
Fig. 2 “Niguarda Antifascista” – sample 1 – cross section – reflected Visible light – magnification 35 x (left) 150 x (right)

- j)* Concrete based plaster support, thickness > 1 cm, at low quality (full of glass and rust fragments) containing crystalline silica mineral Quartz;
- k)* Yellow ground layer at irregular thickness, 300 µm max thick, containing Calcite, Rutile and probably PY74 acetoacetic arylide;
- l)* White paint layer (prime coating) with the same composition of layer *b*, irregular feature, average thickness of 50 µm;
- m)* Black paint layer at regular feature, average thickness of 70 µm, the black pigment has not yet been identified.

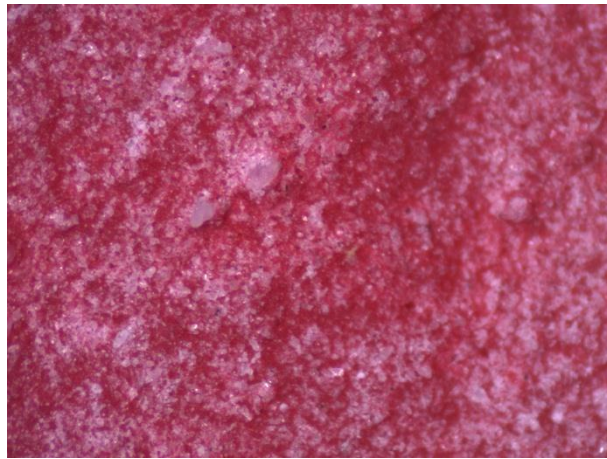
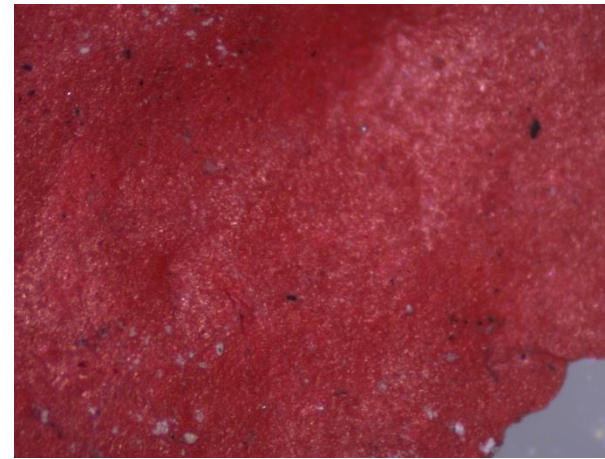
Fig. 5 “ Niguarda Antifascista ” – sample 3 - reflected Visible light – recto (left) e verso (right)- magnification 45 x

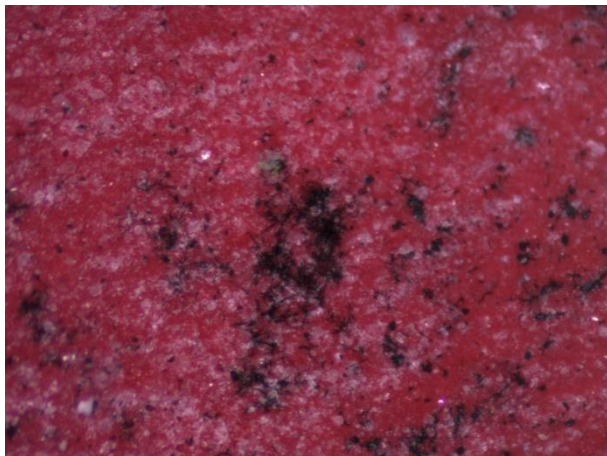
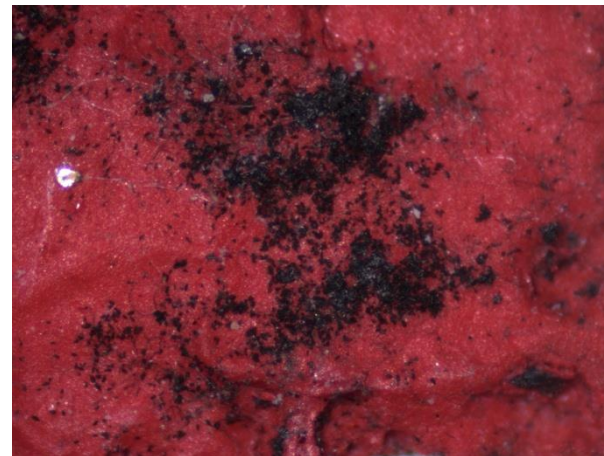
Fig. 6 “ Niguarda Antifascista ” – sample 4 - reflected Visible light – recto (left) e verso (right)- magnification 45 x

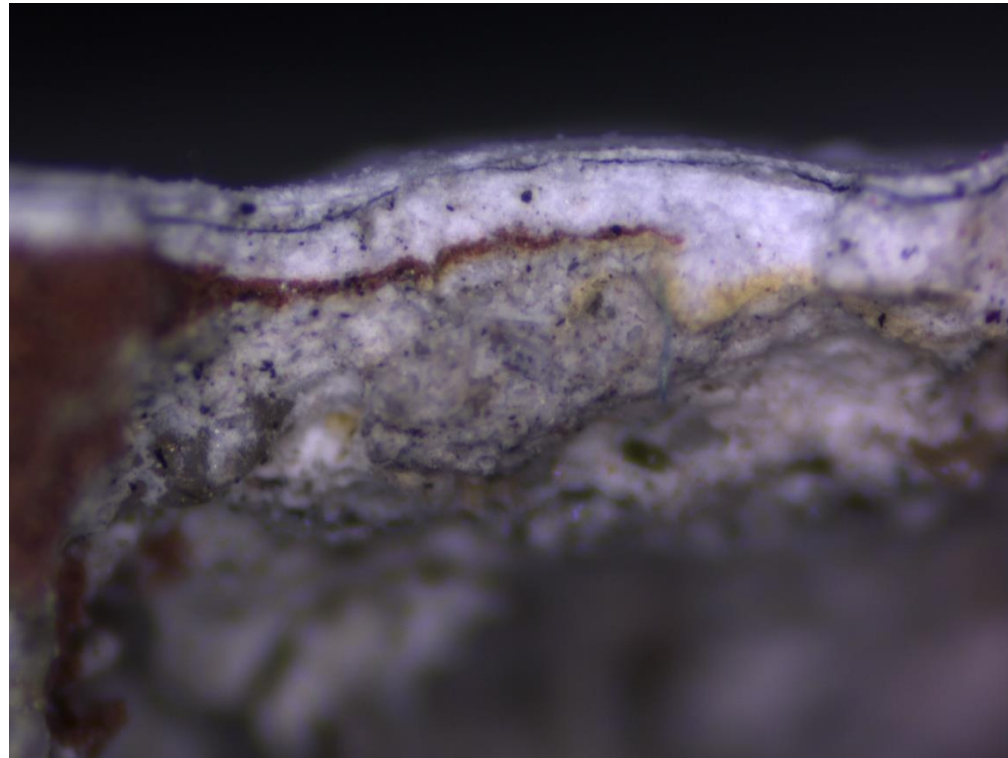
Fig. 7 “ Niguarda Antifascista ” – sample 5 - reflected Visible light - magnification 45 x

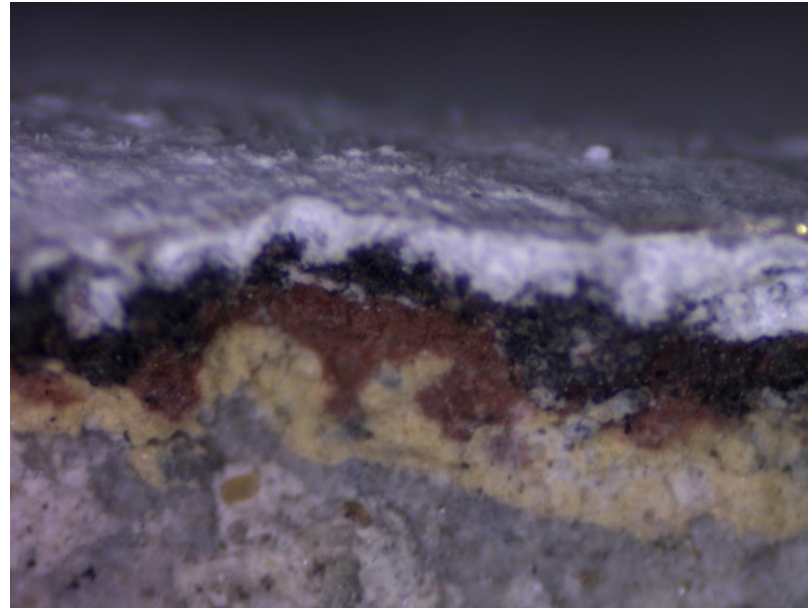
Fig. 8 “ Niguarda Antifascista ” – sample 5 - reflected Visible light - magnification 45 x

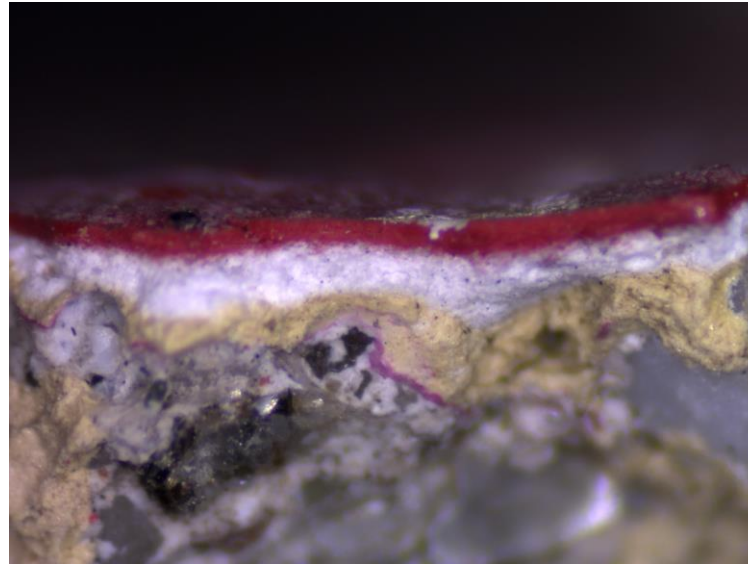
Fig. 9 “ Niguarda Antifascista ” – sample 6 - reflected Visible light - magnification 45 x

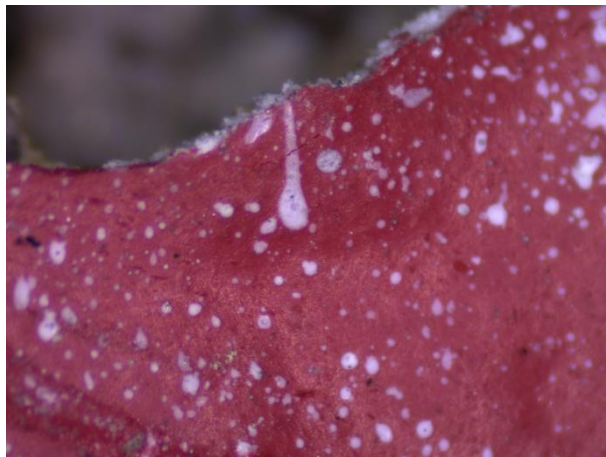
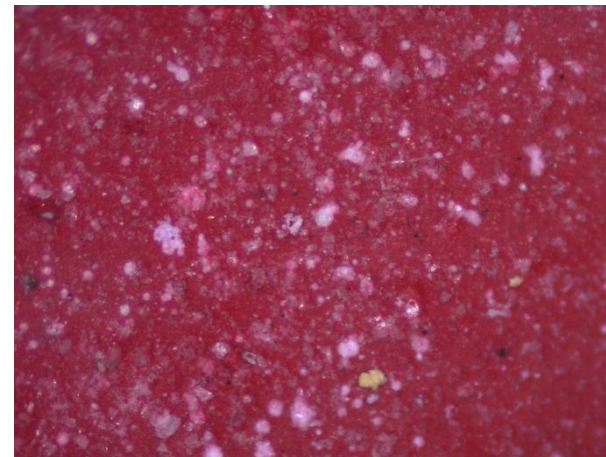
Fig. 10 “ Niguarda Antifascista ” – sample 6 - reflected Visible light - magnification 45 x

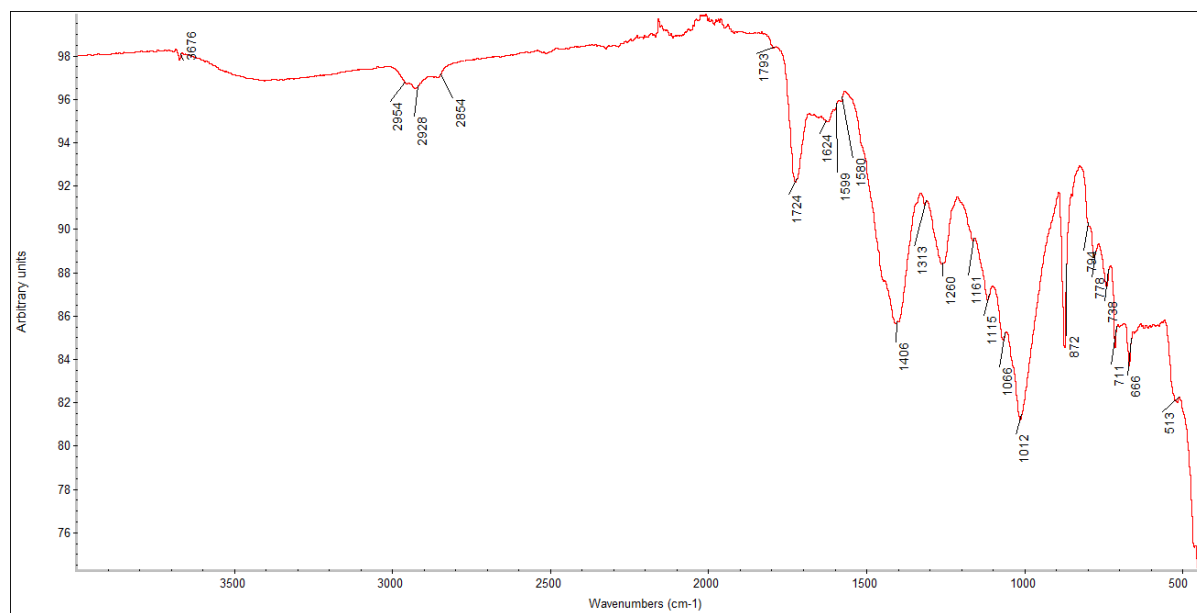
Fig. 11 “ Niguarda Antifascista ” – sample 6 - FTIR-ATR spectrum of the red surface

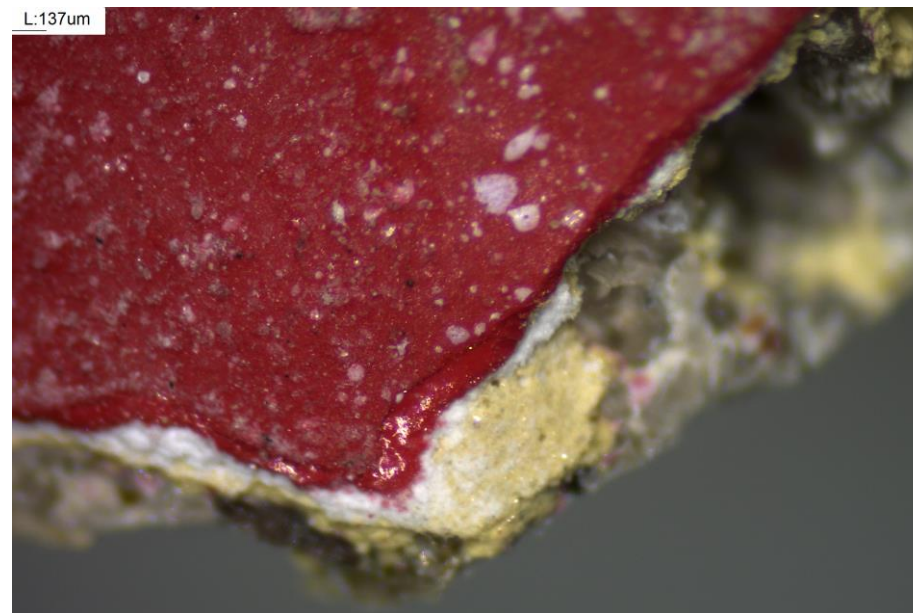
Fig. 12 " Niguarda Antifascista " – sample 6 - reflected Visible light - magnification 30 x

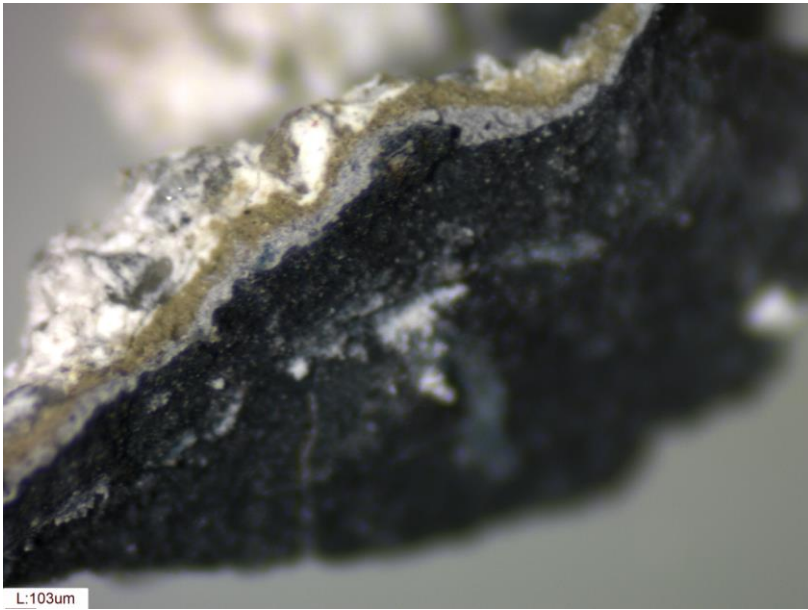
- a)* Brown plaster of the support, fine particles;
- b)* White-grey plaster of the support at low quality;
- c)* Light brown-grey ground layer;
- d)* Pink-brownish paint layer orange former; the surface appears matt, scabrous and grains belonging to the support have been observed.

Fig.2 “Ubuntu” – sample 1 M– reflected Visible light –SM- magnification 40 x

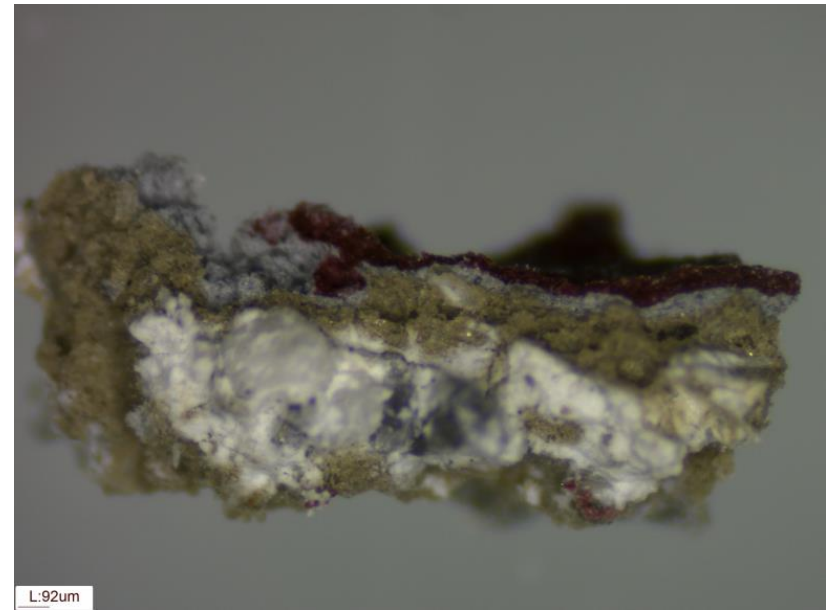
- a)* White-grey plaster of the support at low quality;
- b)* Light brown-grey ground layer;
- c)* Grey paint layer (prime coating);
- d)* Red-brownish paint layer; the surface appears matt, scabrous and a sort of white patina has been observed.

Fig.5 “Ubuntu” – sample 4 M – reflected Visible light –SM- magnification 40x
(right, support)

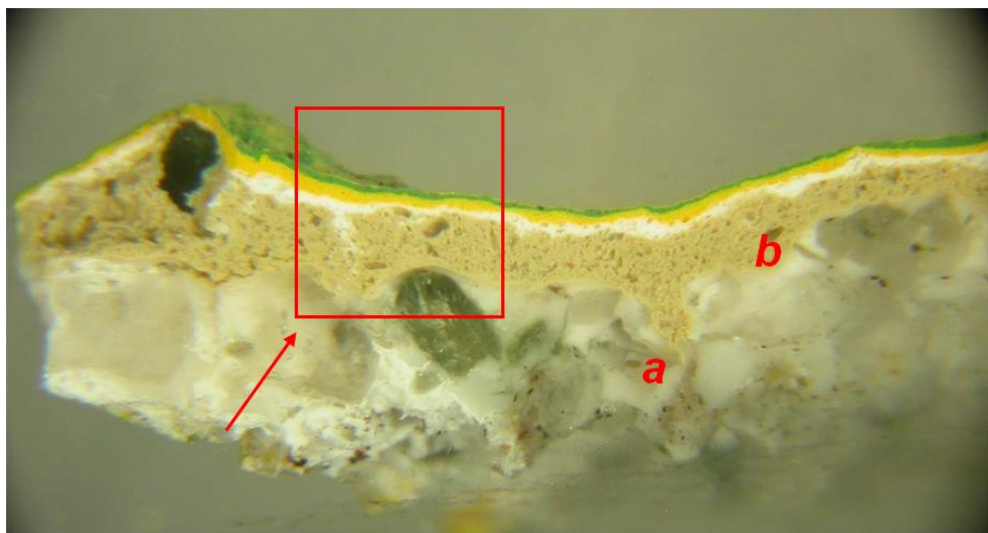
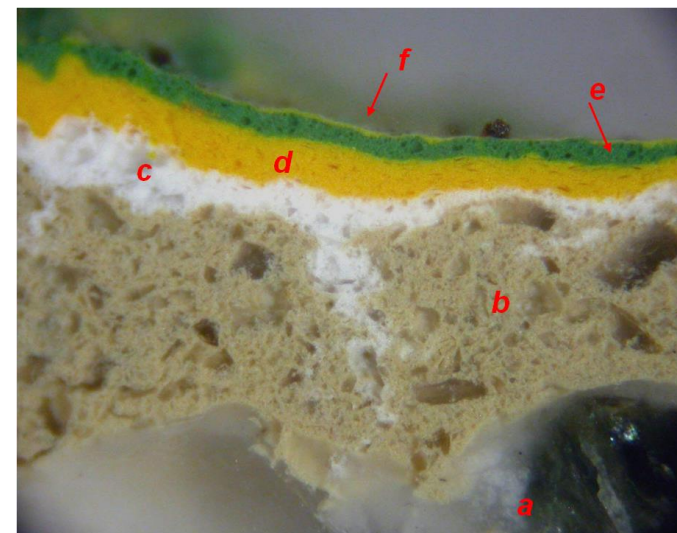
- a)* Plaster of the support > 600 µm thick;
- b)* Light brown-grey ground layer, irregular thickness of about 200 µm;
- c)* White paint layer (prime coating) composed of Calcite from preliminary Raman data. Regular feature, irregular thickness, average thickness of 50 µm;
- d)* Yellow paint layer containing azo pigment PY74 and a binding medium quite similar to that found in the layer *e*. Regular feature, average thickness of 50 µm;
- e)* Green paint layer containing Hostasol Green and a styrene modified alkyd resin (to be confirmed) and Calcite. Regular feature, average thickness of 25 µm;
- f)* Traces of a yellow thin layer < 10µm thick.

Fig.6 “Ubuntu” – sample 5M – cross section – reflected Visible light – magnification 40 x (left) and 180 x (right)

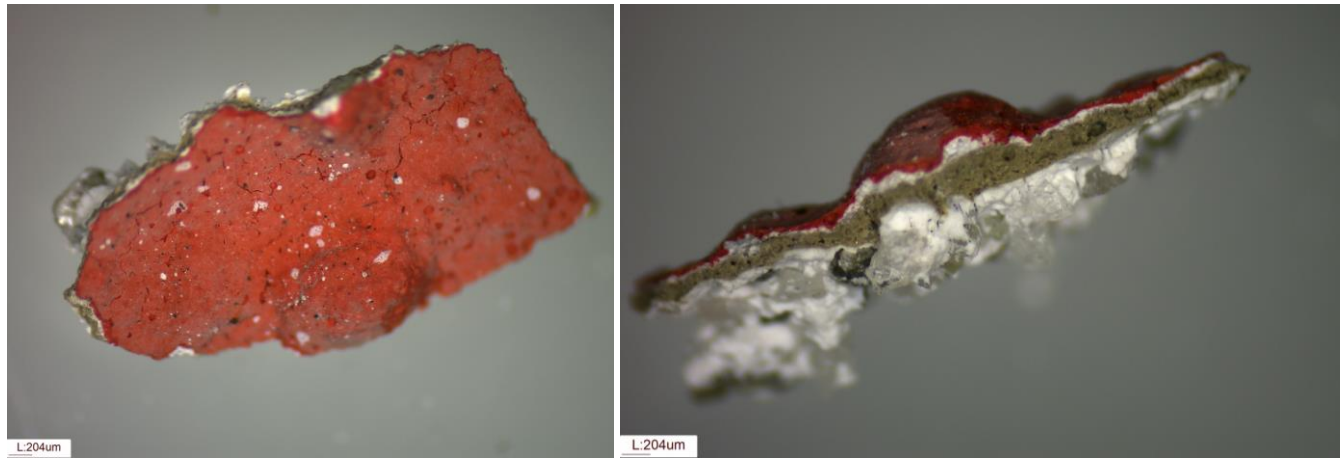
- a)* Plaster of the support ;
- b)* Light brown-grey ground layer;
- c)* White paint layer (prime coating);
- d)* Red paint layer with porous surface, cracking, black particles and small white stains. Fading phenomenon has been observed on the top of the sample.

Fig.9 “Ubuntu” – sample 6 M – reflected Visible light –SM- magnification 20 x

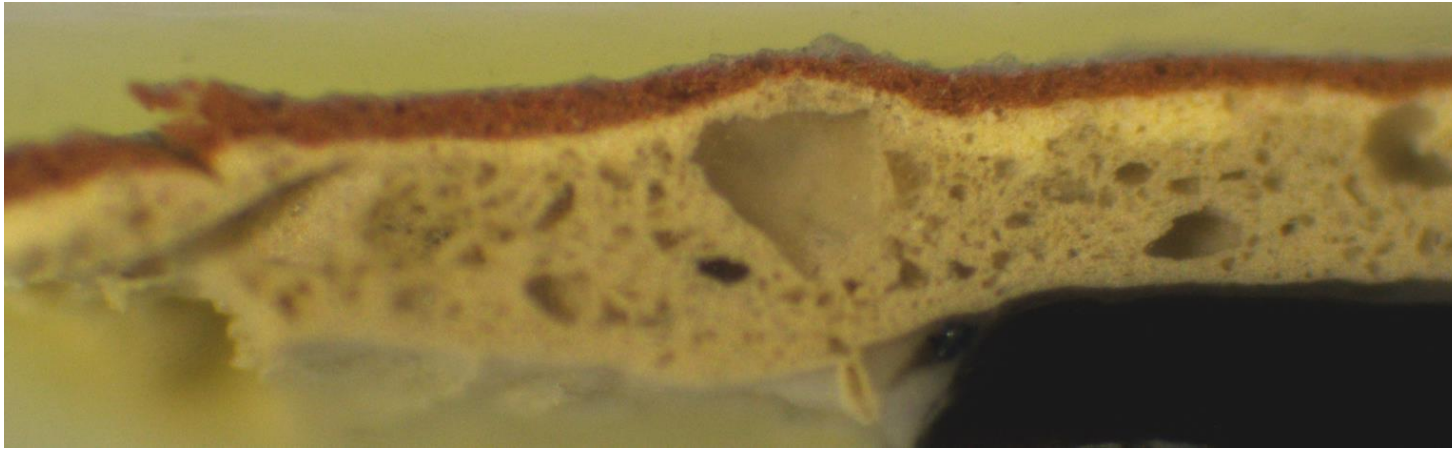
- a)* Plaster of the support ;
- b)* Light brown-grey ground layer;
- c)* Yellow paint layer (prime coating);
- d)* Orange paint layer
- e)* Very thin whitish patina that causes superficial purple and matt color. This paint layer has been addressed to Py-GC-MS.

Fig.10 “Ubuntu” – sample 9 M – reflected Visible light –OM- magnification 100 x

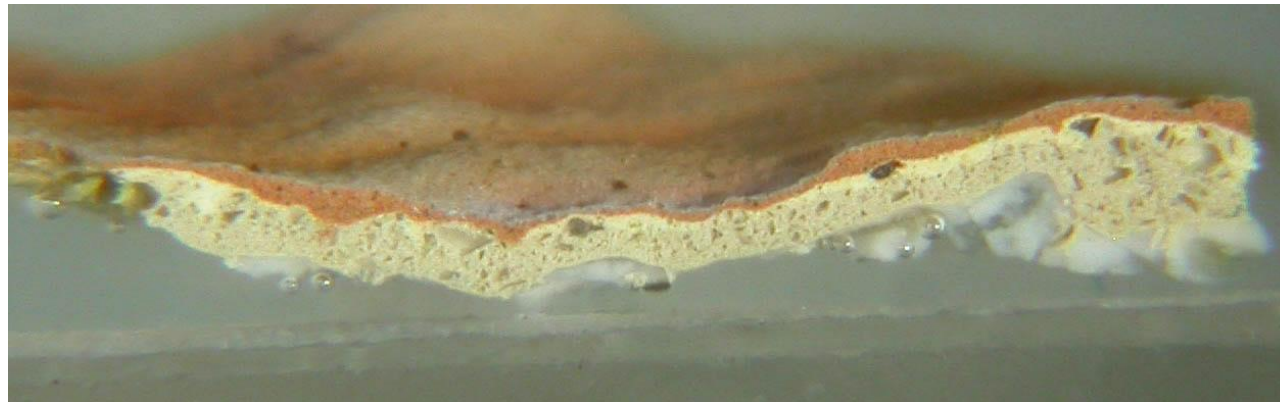
- a)* Plaster of the support > 500 µm thick;
- b)* Light brown-grey ground layer, irregular thickness up to 250 µm;
- g)* Yellow paint layer (prime coating). Regular feature, average thickness of 30 µm;
- c)* Orange paint layer. Irregular feature, average thickness of 50 µm;
- d)* Very thin (5 µm) grey-whitish layer (color less, a sort of patina) at regular thickness; this layer causes superficial purple and matt color.

Fig.11 “Ubuntu” – sample 10 M – reflected Visible light –OM- magnification 40 x

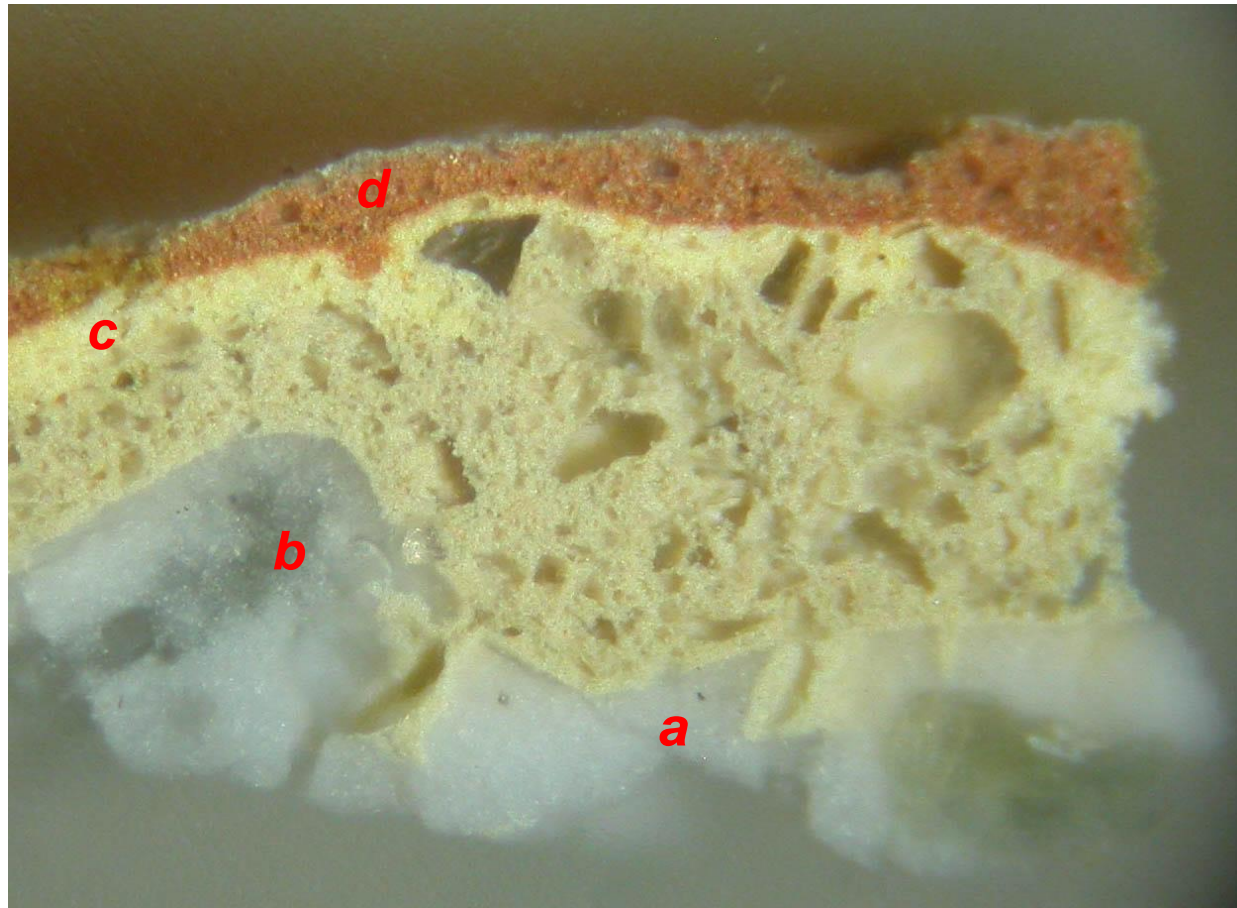
Fig.12 "Ubuntu" – sample 10 M – reflected Visible light –OM- magnification 170 x

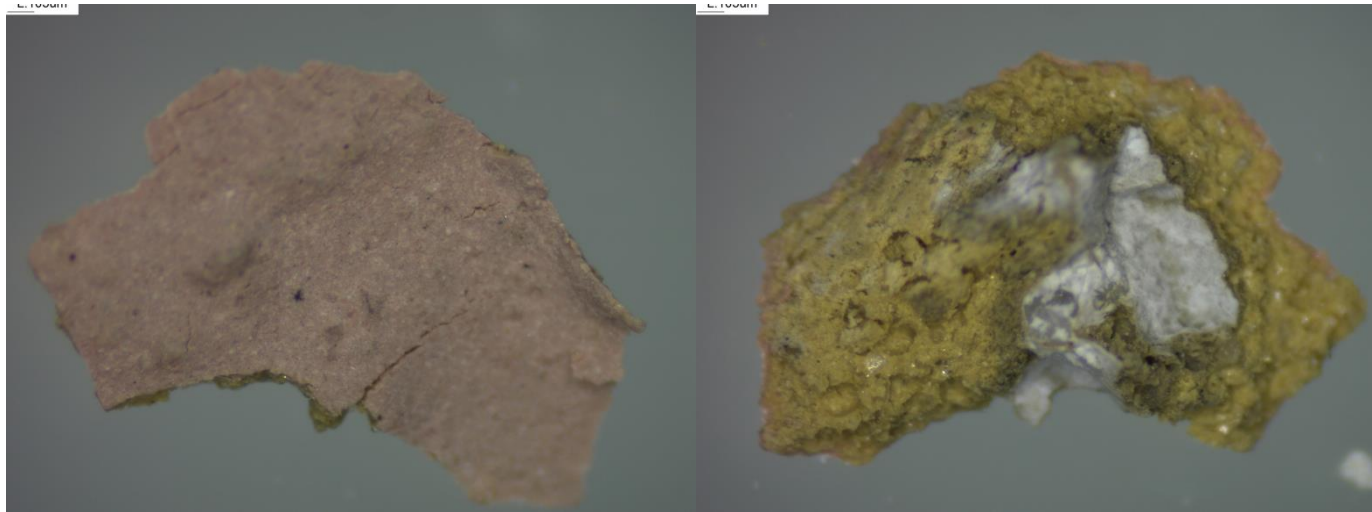
- a)** Plaster of the support;
- b)** Light brown-grey ground layer;
- c)** Yellow paint layer (prime coating);
- d)** Matt pink-brownish paint layer with crack.

Fig.5 “Ubuntu” – sample 4 K – reflected Visible light –SM- magnification 40x
